Orange Unified School District

Facilities Condition Assessment for:

**Canyon High School
220 S. Imperial Highway
Anaheim, CA 92807**

Campus Report

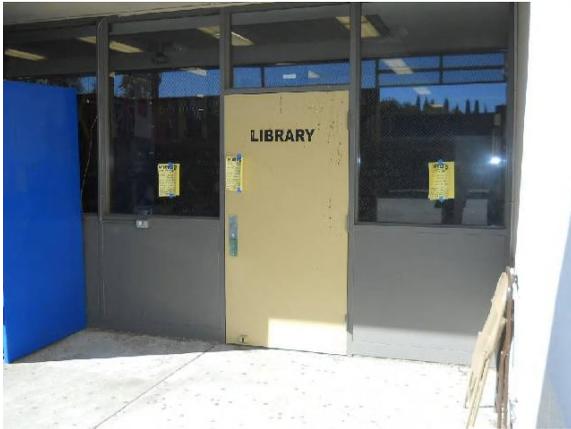
Location: All exterior doors
Material: Steel, Painted
Distress: Beyond Expected Life
Category: Deferred Maintenance
Priority: 3 - Necessary/Not Yet Critical (Years 2-5)
Correction: Replace 3'-0" x 7'-0" steel, insul. core, ptd. doo
Qty: 7-Ea.
Estimate: \$26,279.06
Assessor Name: Dave Cunningham
Date Created: 01/21/2013

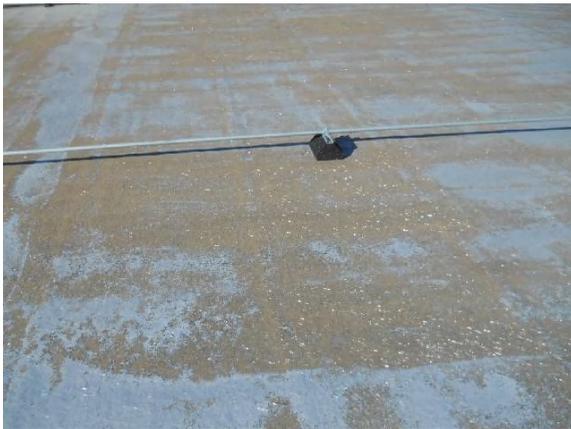
Location: Roof
Material: Built-Up Roofing
Distress: Failing
Category: Deferred Maintenance
Priority: 1 - Currently Critical (Immediate)
Correction: Minor membrane repairs - (2% of roof area) built-u
Qty: 111-Sq.
Estimate: \$16,273.31
Assessor Name: Dave Cunningham
Date Created: 01/21/2013

Notes: Roof was installed in 1998. The reflective roof covering has work away and is no longer functional. Replace the roof coating. There are no reported roof leaks in this building

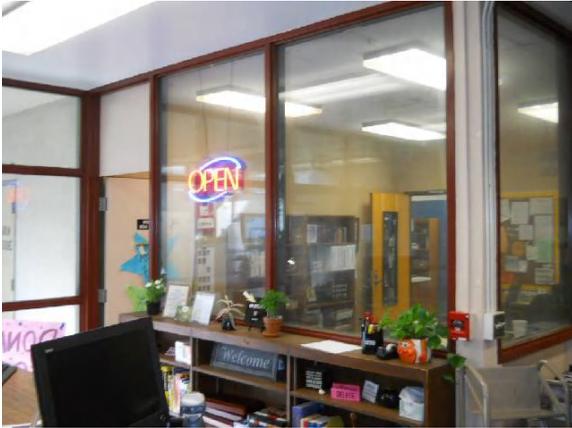
Location: Office 07, Librarian
Material: Demountable Partitions
Distress: Inadequate
Category: Deferred Maintenance
Priority: 1 - Currently Critical (Immediate)
Correction: Remove and reinstall demountable partitions
Qty: 1-C.L.F.
Estimate: \$7,020.09
Assessor Name: Dave Cunningham
Date Created: 01/22/2013

Notes: The glass partition walls are not safety glass. Office staff has been warned to immediately evacuate the area around these glass panels during earthquake tremors. Replace partition walls.

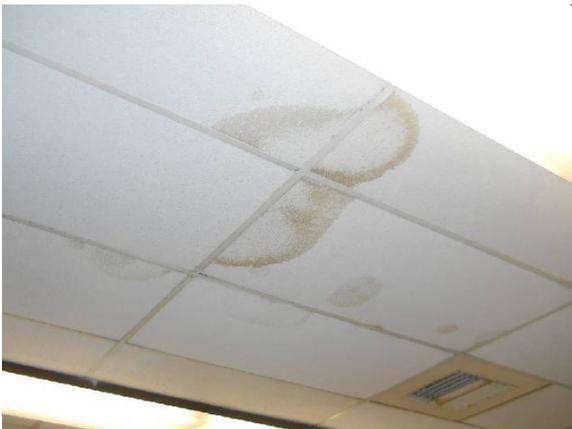
Location: All rooms except the Media Center which was renovated in 2005
Material: Acoustic Tile
Distress: Beyond Expected Life
Category: Deferred Maintenance
Priority: 3 - Necessary/Not Yet Critical (Years 2-5)
Correction: Replace acoustic tile ceiling, non fire-rated
Qty: 70-C.S.F.
Estimate: \$46,670.40
Assessor Name: Dave Cunningham
Date Created: 01/21/2013

Notes: All ceiling grid and tile systems are beyond expected useful service life. Damaged and stained tile throughout the building. No reported roof leaks at this time.

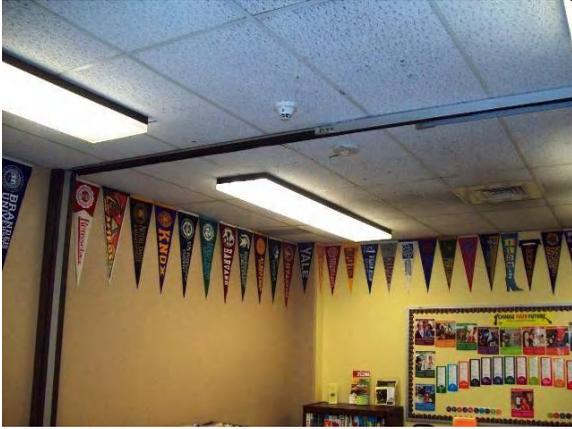
Location: System-Typical for all building locations.
Material: System
Distress: Beyond Expected Life
Category: Capital Renewal
Priority: 4 - Recommended (Years 6-10)
Correction: Renew System
Qty: 1-Ea.
Estimate: \$282,547.74
Assessor Name: Sonny Satterfield
Date Created: 01/28/2013

Notes: The building light fixtures, lamps and ballast were upgraded to T8 fluorescent type in 2008 in most classrooms; however we recommend replacing all lighting in the building during next remodel or renovation.

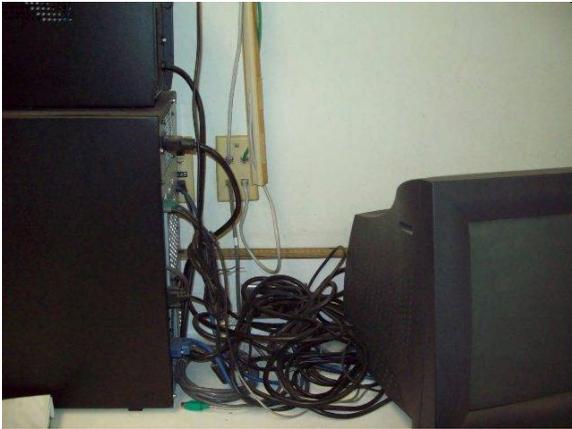
Location: All classroom locations, offices and media center
Material: Lan System
Distress: Inadequate
Category: Capital Renewal
Priority: 4 - Recommended (Years 6-10)
Correction: Replace LAN System Drop CAT6
Qty: 40-Ea.
Estimate: \$15,693.98
Assessor Name: Sonny Satterfield
Date Created: 01/28/2013

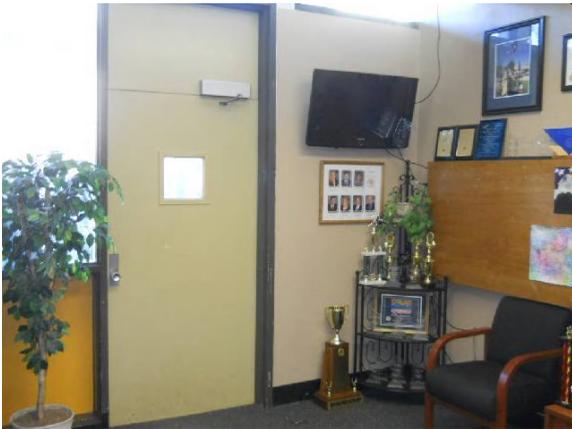
Location: All interior doors, throughout the office areas in Bld A-2
Material: Solid Core Interior Doors
Distress: Beyond Expected Life
Category: Deferred Maintenance
Priority: 2 - Potentially Critical (Year 1)
Correction: Replace 3'-0" x 7'-0" solid core wood door interio
Qty: 31-Ea.
Estimate: \$70,835.64
Assessor Name: Dave Cunningham
Date Created: 01/21/2013

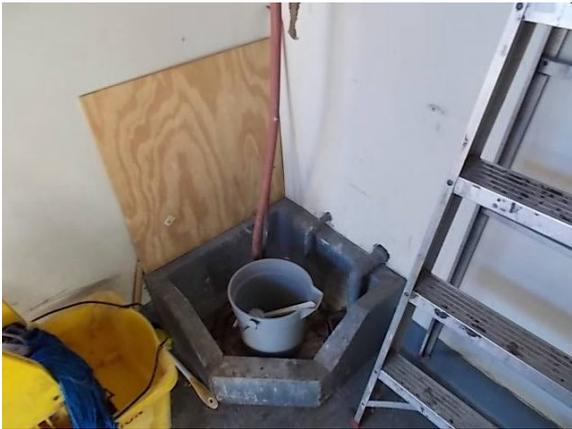
Location: System-Typical for all building locations.
Material: System
Distress: Beyond Expected Life
Category: Capital Renewal
Priority: 4 - Recommended (Years 6-10)
Correction: Renew System
Qty: 1-Ea.
Estimate: \$225,118.08
Assessor Name: Sonny Satterfield
Date Created: 01/29/2013

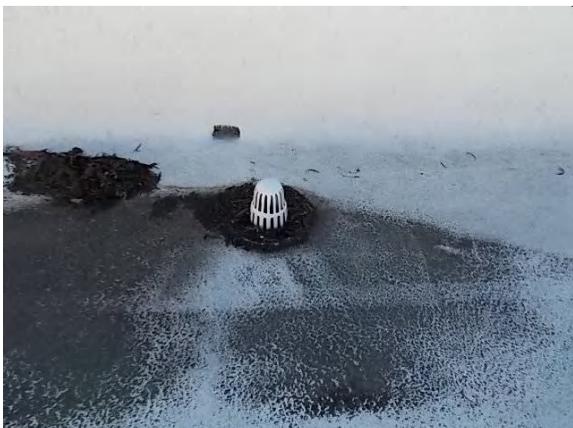
Location: System-Typical for all building locations.
Material: System
Distress: Beyond Expected Life
Category: Capital Renewal
Priority: 4 - Recommended (Years 6-10)
Correction: Renew System
Qty: 1-Ea.
Estimate: \$36,919.37
Assessor Name: Sonny Satterfield
Date Created: 01/29/2013

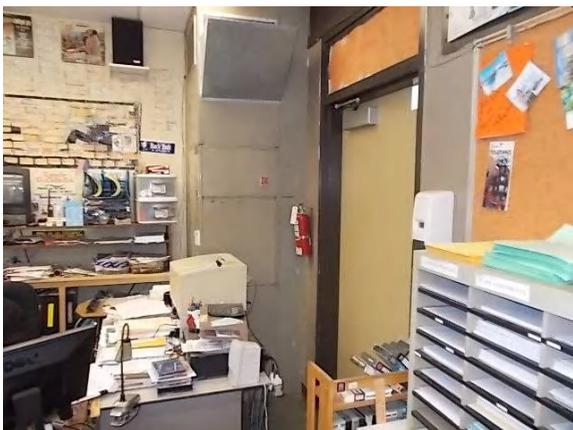
Location: Typical for all required locations
Material: System
Distress: Beyond Expected Life
Category: Capital Renewal
Priority: 4 - Recommended (Years 6-10)
Correction: Renew System
Qty: 1-Ea.
Estimate: \$897,320.67
Assessor Name: Sonny Satterfield
Date Created: 01/29/2013

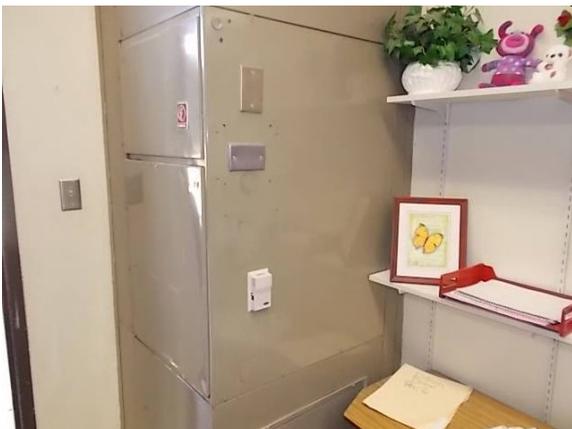
Location: Typical for all locations
Material: System
Distress: Beyond Expected Life
Category: Capital Renewal
Priority: 4 - Recommended (Years 6-10)
Correction: Renew System
Qty: 1-Ea.
Estimate: \$222,416.66
Assessor Name: Sonny Satterfield
Date Created: 01/29/2013

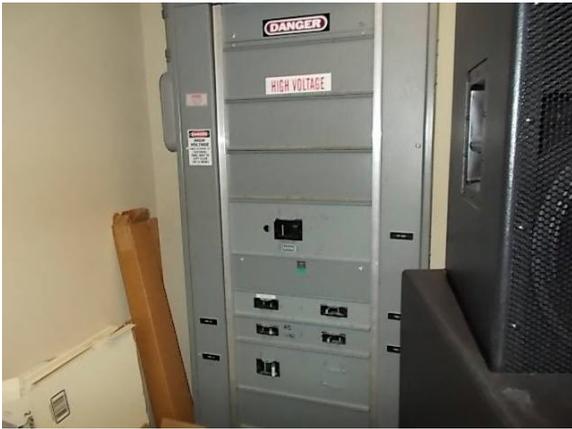
Location: System-Typical for all building locations.
Material: System
Distress: Beyond Expected Life
Category: Capital Renewal
Priority: 4 - Recommended (Years 6-10)
Correction: Renew System
Qty: 1-Ea.
Estimate: \$336,326.41
Assessor Name: Sonny Satterfield
Date Created: 01/29/2013

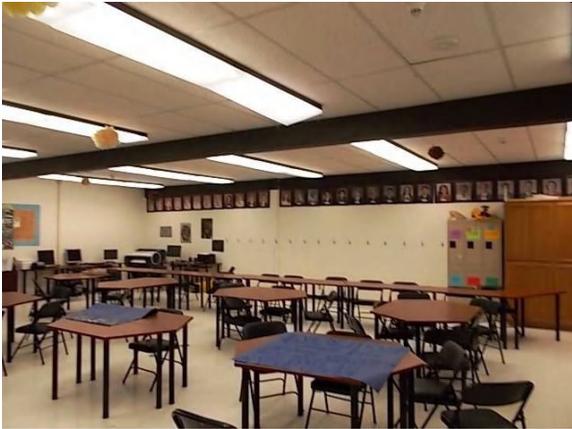
Location: System-Typical for all building locations.
Material: System
Distress: Beyond Expected Life
Category: Capital Renewal
Priority: 4 - Recommended (Years 6-10)
Correction: Renew System
Qty: 1-Ea.
Estimate: \$764,951.24
Assessor Name: Sonny Satterfield
Date Created: 01/29/2013

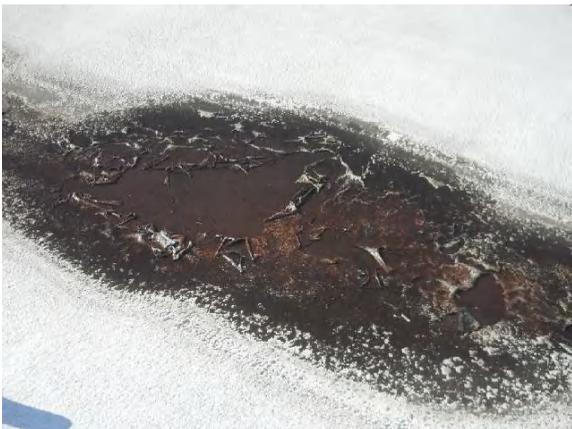
Location: Roof
Material: Built-Up Roofing
Distress: Damaged
Category: Deferred Maintenance
Priority: 1 - Currently Critical (Immediate)
Correction: Minor membrane repairs - (2% of roof area) built-u
Qty: 10-Sq.
Estimate: \$1,472.26
Assessor Name: Dave Cunningham
Date Created: 01/23/2013

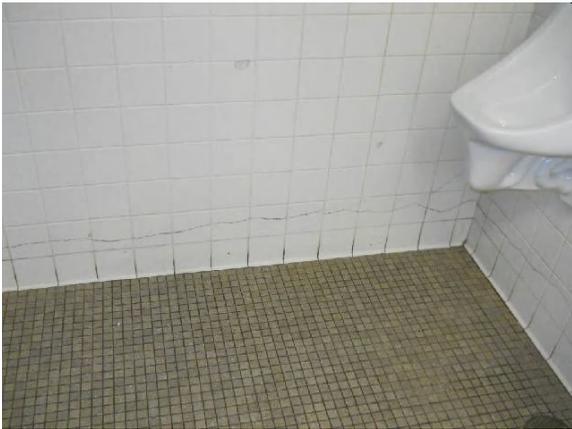
Location: All Restrooms
Material: Tile
Distress: Beyond Expected Life
Category: Deferred Maintenance
Priority: 3 - Necessary/Not Yet Critical (Years 2-5)
Correction: Replace 4" x 4" thin set ceramic tile
Qty: 20-C.S.F.
Estimate: \$30,412.80
Assessor Name: Dave Cunningham
Date Created: 01/23/2013

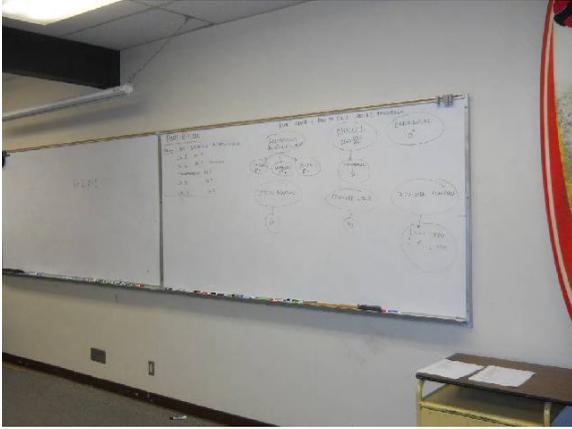
Location: All interior wall finishes
Material: Wall Finishes
Distress: Beyond Service Life
Category: Deferred Maintenance
Priority: 4 - Recommended (Years 6-10)
Correction: Refinish/Repaint
Qty: 19,000-S.F.
Estimate: \$11,217.60
Assessor Name: Dave Cunningham
Date Created: 01/23/2013

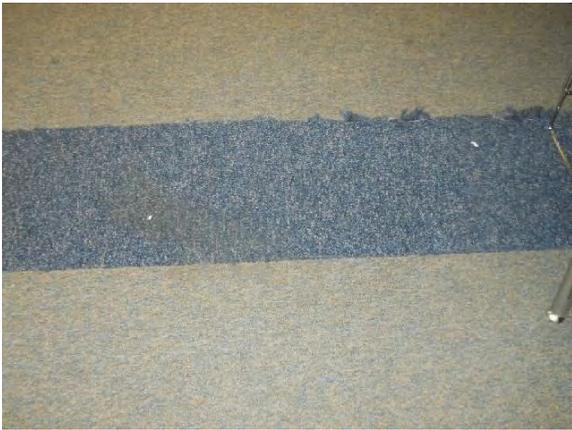
Location: Carpeted rooms; 200, 201, 202, 209, 210
Material: Carpet
Distress: Beyond Expected Life
Category: Deferred Maintenance
Priority: 3 - Necessary/Not Yet Critical (Years 2-5)
Correction: Replace carpet
Qty: 554-S.Y.
Estimate: \$55,958.86
Assessor Name: Dave Cunningham
Date Created: 01/23/2013

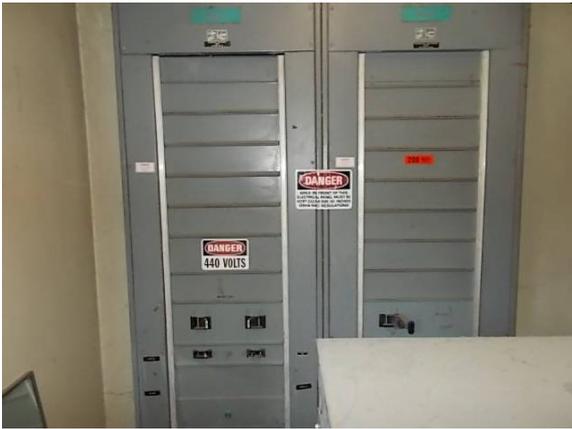
Location: Typical for all locations
Material: System
Distress: Beyond Expected Life
Category: Capital Renewal
Priority: 4 - Recommended (Years 6-10)
Correction: Renew System
Qty: 1-Ea.
Estimate: \$197,306.75
Assessor Name: Sonny Satterfield
Date Created: 01/29/2013

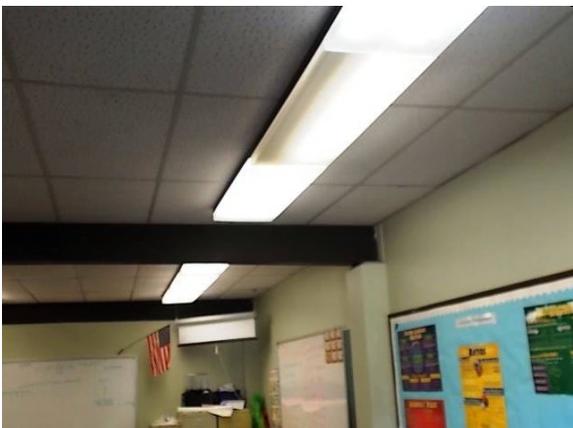
Location: System-Typical for all building locations.
Material: System
Distress: Beyond Expected Life
Category: Capital Renewal
Priority: 4 - Recommended (Years 6-10)
Correction: Renew System
Qty: 1-Ea.
Estimate: \$448,259.11
Assessor Name: Sonny Satterfield
Date Created: 01/29/2013

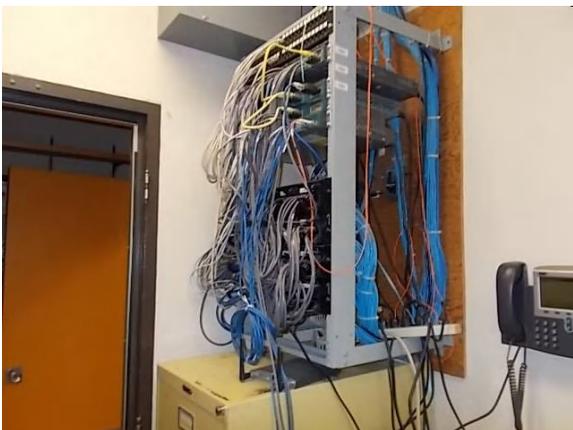
Location: System-Typical for all building locations.
Material: Lan System
Distress: Inadequate
Category: Capital Renewal
Priority: 4 - Recommended (Years 6-10)
Correction: Replace LAN System Drop CAT6
Qty: 32-Ea.
Estimate: \$12,555.19
Assessor Name: Sonny Satterfield
Date Created: 01/29/2013

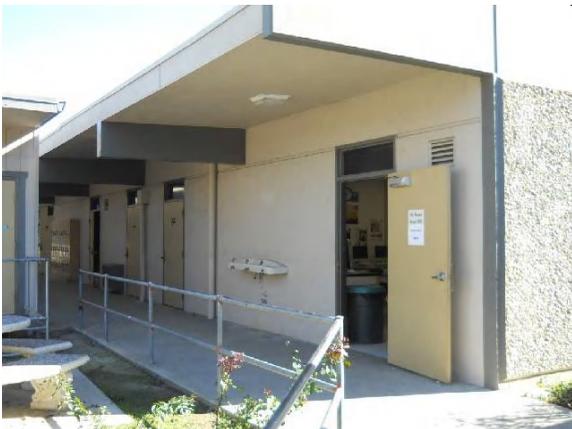
Location: All exterior windows, above the exterior doors
Material: System
Distress: Beyond Service Life
Category: Deferred Maintenance
Priority: 3 - Necessary/Not Yet Critical (Years 2-5)
Correction: Renew System
Qty: 1-Ea.
Estimate: \$15,414.54
Assessor Name: Dave Cunningham
Date Created: 01/23/2013

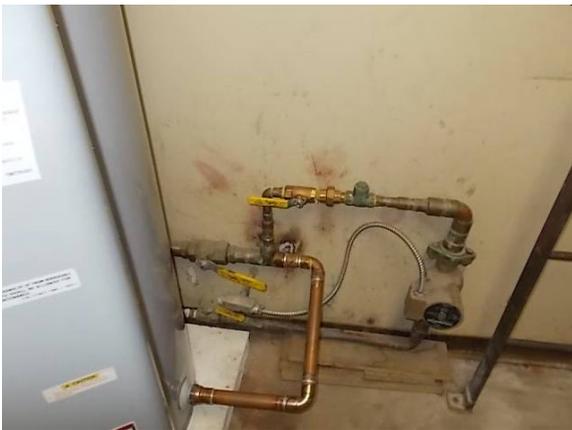
Location: System-Typical for all building locations.
Material: System
Distress: Beyond Expected Life
Category: Capital Renewal
Priority: 4 - Recommended (Years 6-10)
Correction: Renew System
Qty: 1-Ea.
Estimate: \$103,192.47
Assessor Name: Sonny Satterfield
Date Created: 01/29/2013

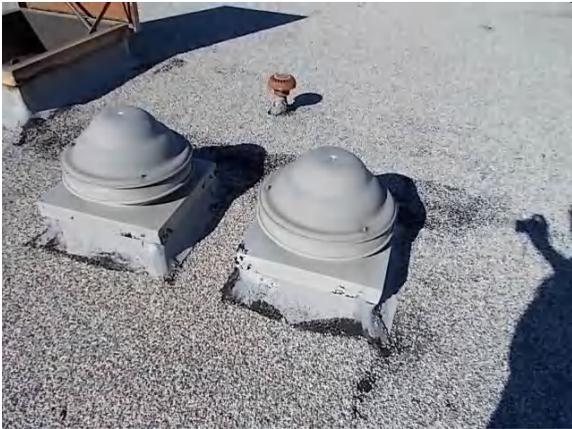
Location: System-Typical for all building locations.
Material: System
Distress: Beyond Expected Life
Category: Capital Renewal
Priority: 4 - Recommended (Years 6-10)
Correction: Renew System
Qty: 1-Ea.
Estimate: \$262,481.98
Assessor Name: Sonny Satterfield
Date Created: 01/29/2013

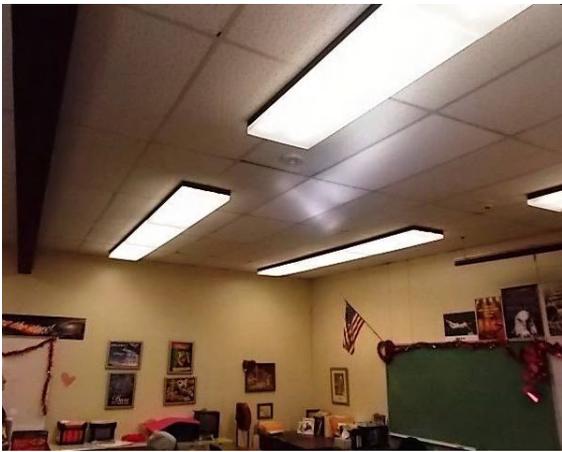
Location: System-Typical for all building locations.
Material: System
Distress: Beyond Expected Life
Category: Capital Renewal
Priority: 4 - Recommended (Years 6-10)
Correction: Renew System
Qty: 1-Ea.
Estimate: \$223,735.88
Assessor Name: Sonny Satterfield
Date Created: 01/29/2013

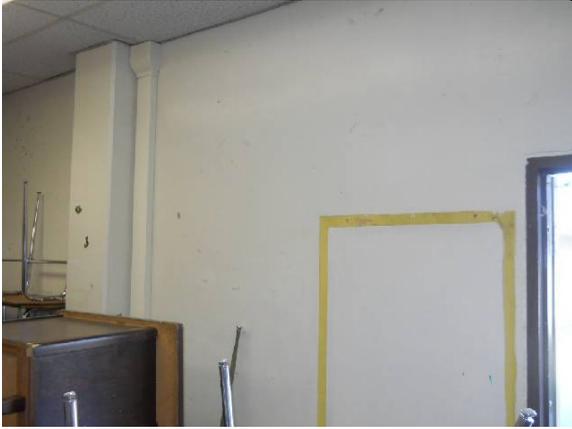
Location: Throughout the building
Material: System
Distress: Beyond Service Life
Category: Deferred Maintenance
Priority: 3 - Necessary/Not Yet Critical (Years 2-5)
Correction: Renew System
Qty: 1-Ea.
Estimate: \$144,067.27
Assessor Name: Dave Cunningham
Date Created: 01/23/2013

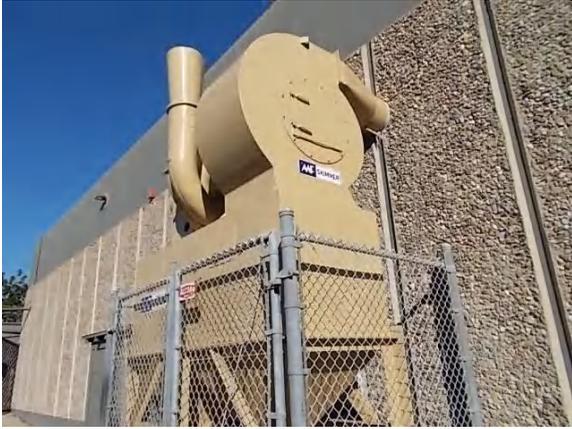
Location: Rooms 500, 502
Material: System
Distress: Beyond Expected Life
Category: Capital Renewal
Priority: 4 - Recommended (Years 6-10)
Correction: Renew System
Qty: 1-Ea.
Estimate: \$87,582.08
Assessor Name: Sonny Satterfield
Date Created: 01/30/2013

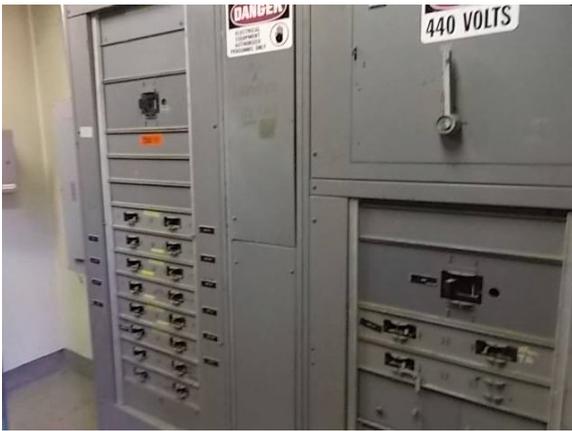
Location: System-Typical for all building locations.
Material: System
Distress: Beyond Service Life
Category: Capital Renewal
Priority: 4 - Recommended (Years 6-10)
Correction: Renew System
Qty: 1-Ea.
Estimate: \$104,858.14
Assessor Name: Dave Cunningham
Date Created: 01/23/2013

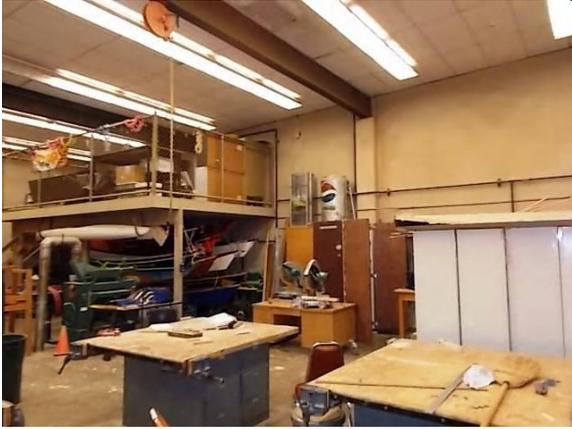
Location: System-Typical for all building locations.
Material: System
Distress: Inadequate
Category: Capital Renewal
Priority: 4 - Recommended (Years 6-10)
Correction: Renew System
Qty: 1-Ea.
Estimate: \$238,409.55
Assessor Name: Dave Cunningham
Date Created: 01/23/2013

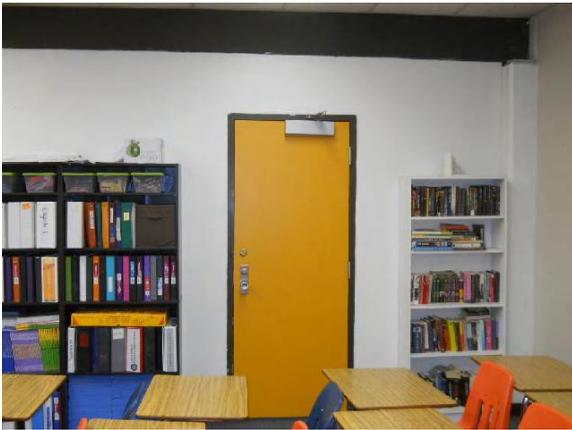
Location: All interior doors
Material: System
Distress: Beyond Service Life
Category: Deferred Maintenance
Priority: 3 - Necessary/Not Yet Critical (Years 2-5)
Correction: Renew System
Qty: 1-Ea.
Estimate: \$57,864.33
Assessor Name: Dave Cunningham
Date Created: 01/23/2013

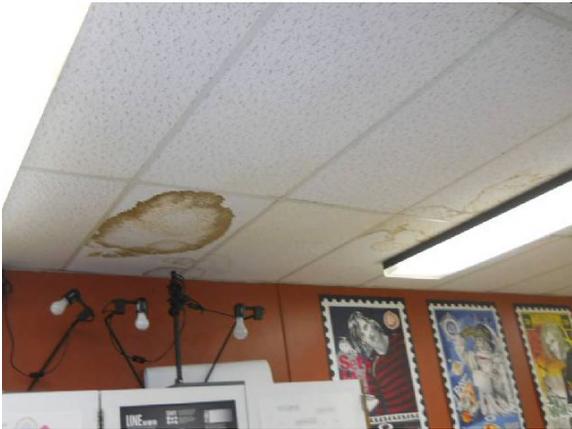
Location: Throughout the classroom building
Material: System
Distress: Beyond Service Life
Category: Deferred Maintenance
Priority: 3 - Necessary/Not Yet Critical (Years 2-5)
Correction: Renew System
Qty: 1-Ea.
Estimate: \$254,542.40
Assessor Name: Dave Cunningham
Date Created: 01/23/2013

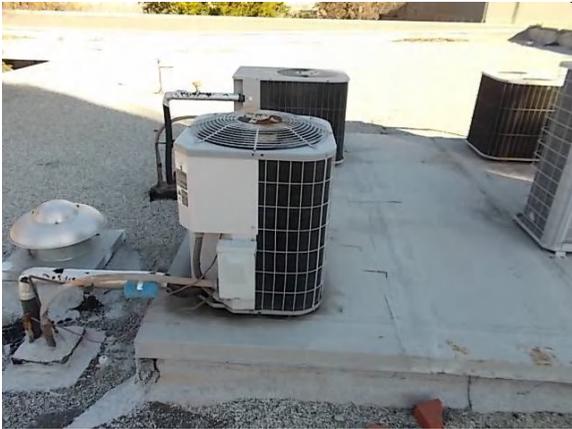
Location: System-Typical for all building locations
Material: System
Distress: Inadequate
Category: Capital Renewal
Priority: 4 - Recommended (Years 6-10)
Correction: Renew System
Qty: 1-Ea.
Estimate: \$358,319.33
Assessor Name: Dave Cunningham
Date Created: 01/23/2013

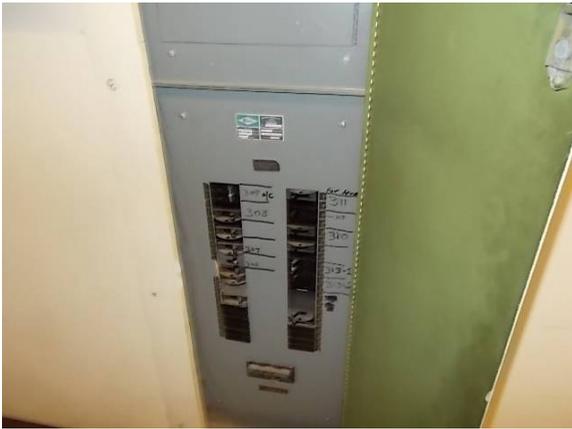
Location: System-Typical for all building locations.
Material: System
Distress: Beyond Expected Life
Category: Capital Renewal
Priority: 4 - Recommended (Years 6-10)
Correction: Renew System
Qty: 1-Ea.
Estimate: \$121,110.26
Assessor Name: Dave Cunningham
Date Created: 01/23/2013

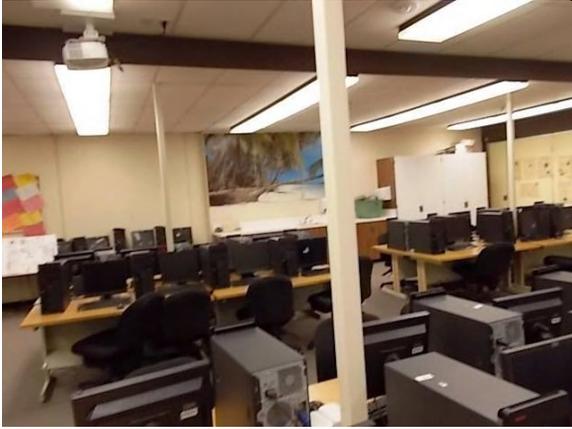
Location: System-Typical for all building locations.
Material: System
Distress: Beyond Service Life
Category: Capital Renewal
Priority: 4 - Recommended (Years 6-10)
Correction: Renew System
Qty: 1-Ea.
Estimate: \$275,463.21
Assessor Name: Dave Cunningham
Date Created: 01/23/2013

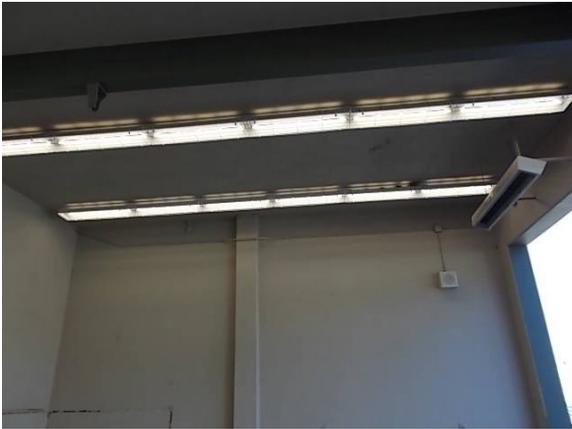
Location: System-Typical for all required building locations.
Material: Lan System
Distress: Inadequate
Category: Capital Renewal
Priority: 4 - Recommended (Years 6-10)
Correction: Replace LAN System Drop CAT6
Qty: 24-Ea.
Estimate: \$9,416.39
Assessor Name: Sonny Satterfield
Date Created: 01/30/2013

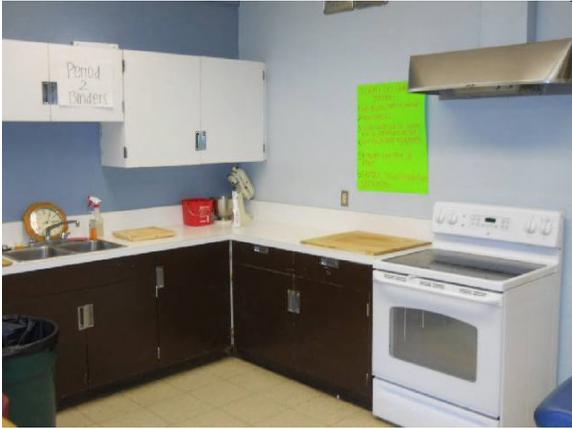
Location: Foods Classroom 313
Material: Kitchen Equipment
Distress: Beyond Service Life
Category: Deferred Maintenance
Priority: 4 - Recommended (Years 6-10)
Correction: Home Economics Kitchen Class Set-up
Qty: 6-Ea.
Estimate: \$71,873.48
Assessor Name: Dave Cunningham
Date Created: 01/24/2013

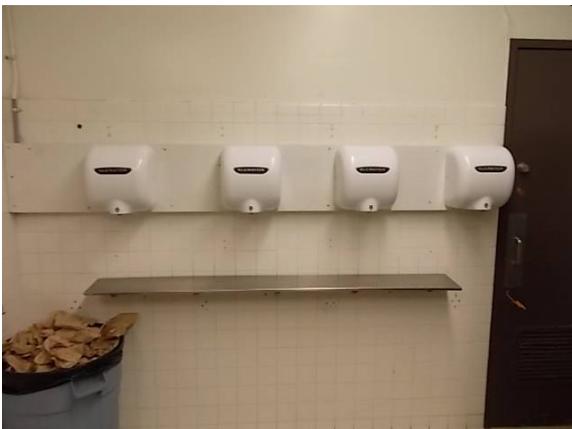
Location: Typical for all locations except as listed in notes
Material: System
Distress: Inadequate
Category: Capital Renewal
Priority: 4 - Recommended (Years 6-10)
Correction: Renew System
Qty: 1-Ea.
Estimate: \$795,245.22
Assessor Name: Dave Cunningham
Date Created: 01/24/2013

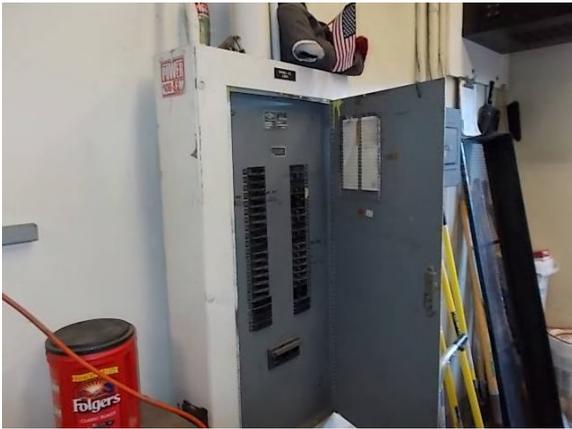
Location: System-Typical for all building locations.
Material: System
Distress: Beyond Expected Life
Category: Capital Renewal
Priority: 4 - Recommended (Years 6-10)
Correction: Renew System
Qty: 1-Ea.
Estimate: \$339,170.83
Assessor Name: Dave Cunningham
Date Created: 01/24/2013

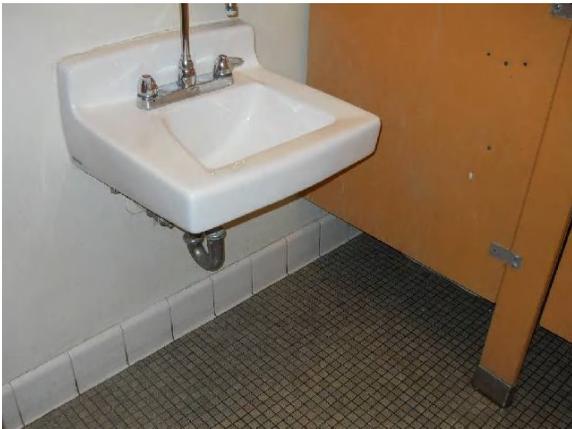
Location: Throughout bld. Restrooms
Material: System
Distress: Beyond Expected Life
Category: Capital Renewal
Priority: 3 - Necessary/Not Yet Critical (Years 2-5)
Correction: Renew System
Qty: 1-Ea.
Estimate: \$28,769.40
Assessor Name: Dave Cunningham
Date Created: 01/28/2013

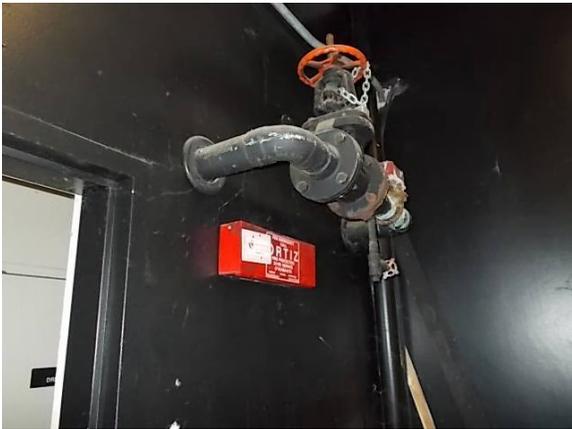
Location: System-Typical for all required building locations.
Material: System
Distress: Missing
Category: Capital Renewal
Priority: 5 - Codes or Standards Compliance
Correction: Renew System
Qty: 1-Ea.
Estimate: \$139,243.90
Assessor Name: Dave Cunningham
Date Created: 01/24/2013

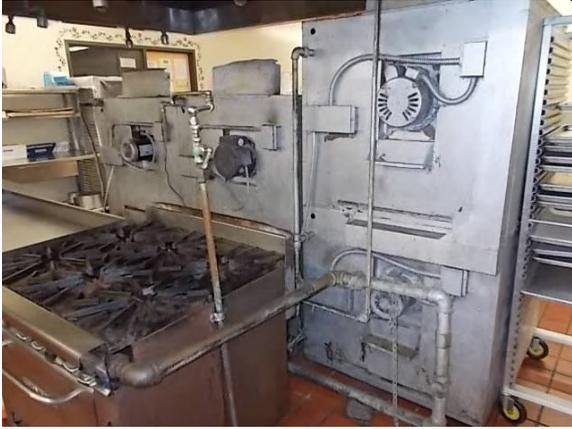
Location: System-Typical for most kitchen equipment.
Material: System
Distress: Beyond Expected Life
Category: Capital Renewal
Priority: 4 - Recommended (Years 6-10)
Correction: Renew System
Qty: 1-Ea.
Estimate: \$267,900.65
Assessor Name: Dave Cunningham
Date Created: 01/24/2013

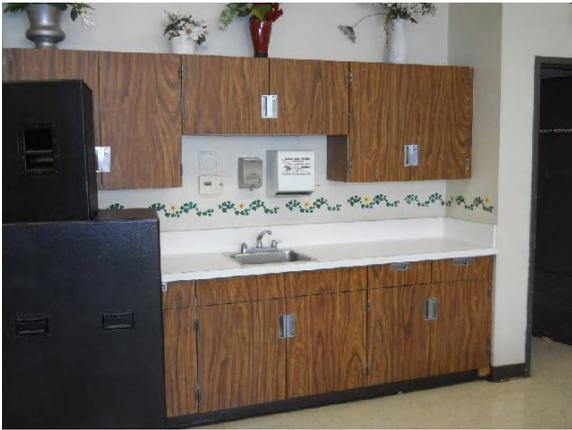
Location: Staff Lounge
Material: Fixed Casework
Distress: Beyond Expected Life
Category: Deferred Maintenance
Priority: 4 - Recommended (Years 6-10)
Correction: Replace Casework OUSD
Qty: 38-L.F.
Estimate: \$44,850.70
Assessor Name: Dave Cunningham
Date Created: 01/24/2013

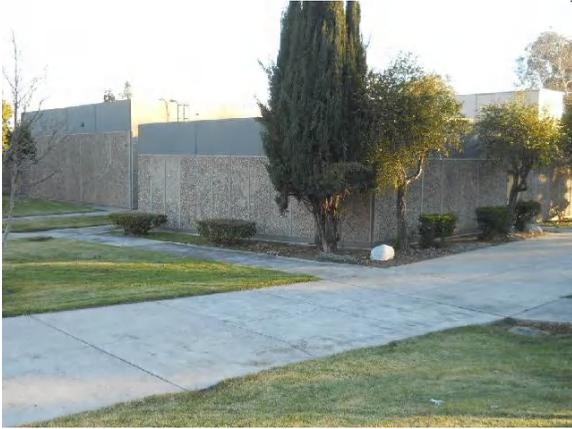
Location: Interior or exterior roof ladder
Material: System
Distress: Missing
Category: Capital Renewal
Priority: 4 - Recommended (Years 6-10)
Correction: Renew System
Qty: 1-Ea.
Estimate: \$11,243.71
Assessor Name: Dave Cunningham
Date Created: 01/24/2013

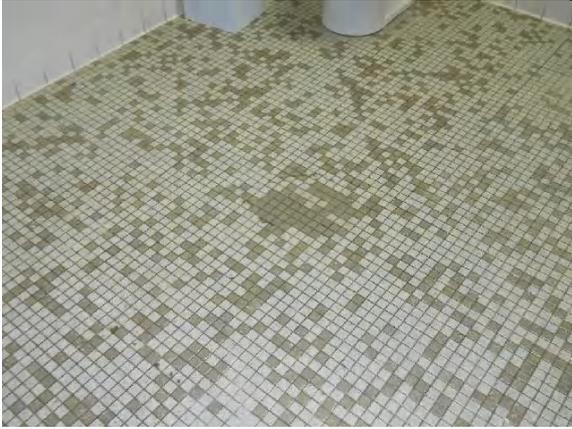
Location: Boys RR, Girls RR
Material: System
Distress: Beyond Service Life
Category: Capital Renewal
Priority: 3 - Necessary/Not Yet Critical (Years 2-5)
Correction: Renew System
Qty: 1-Ea.
Estimate: \$20,037.60
Assessor Name: Dave Cunningham
Date Created: 01/24/2013

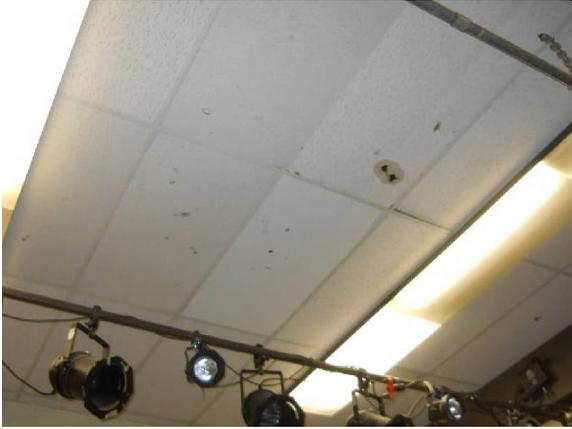
Location: Throughout the building
Material: System
Distress: Beyond Service Life
Category: Capital Renewal
Priority: 4 - Recommended (Years 6-10)
Correction: Renew System
Qty: 1-Ea.
Estimate: \$189,666.58
Assessor Name: Dave Cunningham
Date Created: 01/24/2013
