Campus Report

Campus: Fred Kelly Stadium

Report: Mar 11, 2013

Fred Kelly Stadium

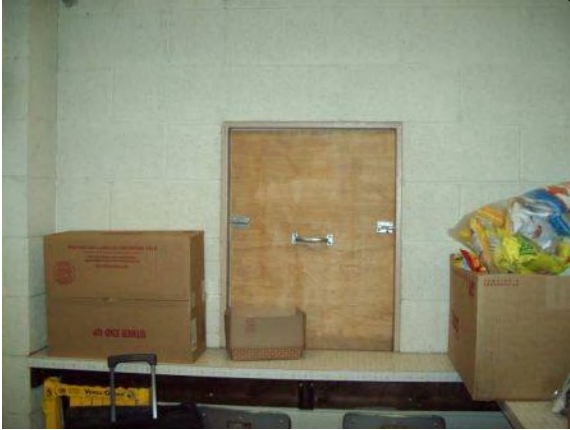
System: B2020 - Exterior Windows

Location: Ticket windows on exterior corridor.

Notes: Transaction windows are beyond their expected life. System renewal is recommended.

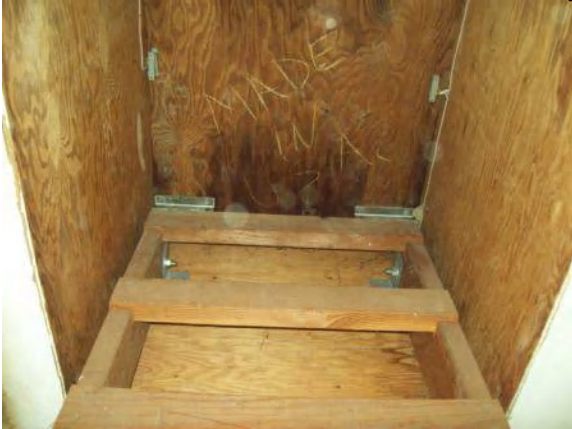
System: B3020 - Roof Openings

Location: Access from storage room.

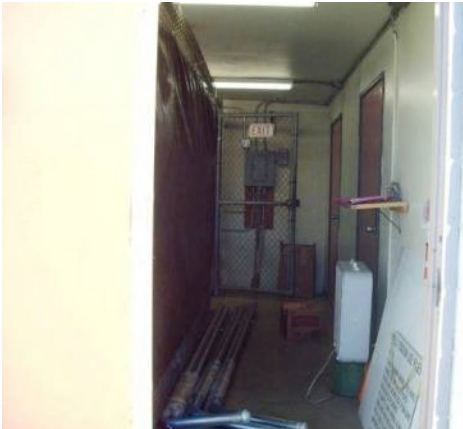
System: C1020 - Interior Doors

Location: Interior doors.s

Notes: Interior doors are original to the building. System renewal at the next renovation is recommended.

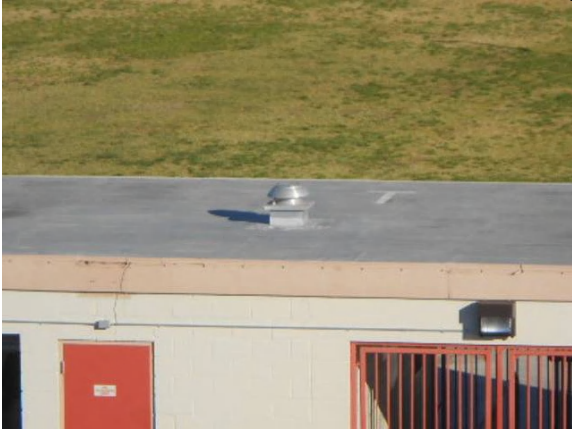
System: D3040 - Distribution Systems

Location: Typical for entire building
Material: System
Distress: Beyond Expected Life
Category: Capital Renewal
Priority: 4 - Recommended (Years 6-10)
Correction: Renew System
Qty: 1-Ea.
Estimate: \$22,231.76
Assessor Name: Eduardo Lopez
Date Created: 01/29/2013

Notes: Recommend to be replaced during next remodel or renovation.

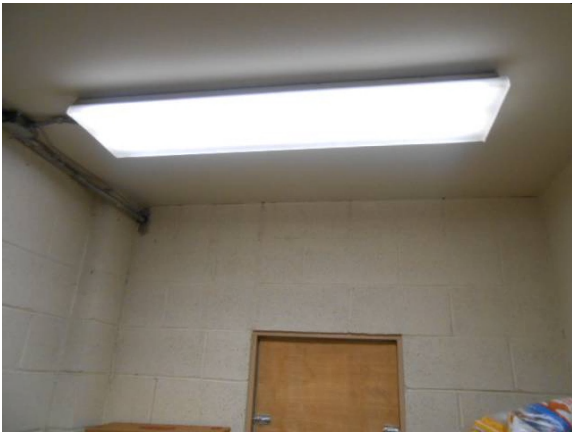
System: D3050 - Terminal & Package Units

Location: Typical for entire building
Material: System
Distress: Missing
Category: Capital Renewal
Priority: 4 - Recommended (Years 6-10)
Correction: Renew System
Qty: 1-Ea.
Estimate: \$24,649.57
Assessor Name: Eduardo Lopez
Date Created: 01/29/2013

Notes: Building is missing a Terminal & Package Unit and it is recommended to be added for all enclosed areas during next major renovation.

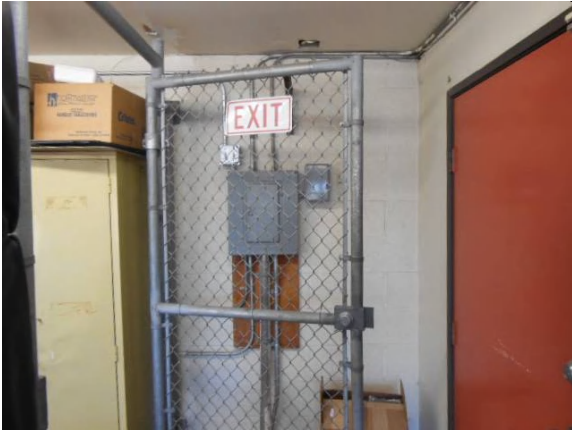
System: D5010 - Electrical Service/Distribution

Location: Typical for entire building
Material: System
Distress: Beyond Expected Life
Category: Capital Renewal
Priority: 4 - Recommended (Years 6-10)
Correction: Renew System
Qty: 1-Ea.
Estimate: \$8,333.11
Assessor Name: Eduardo Lopez
Date Created: 01/29/2013

Notes: The main electrical panels, distribution panel boards and feeders are mostly original to the building age. It is recommended to be replaced during the next major renovation.

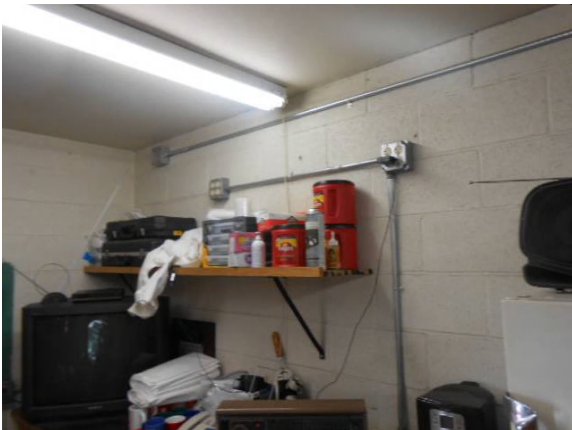
System: D5020 - Branch Wiring

Location: Typical for entire building
Material: System
Distress: Beyond Expected Life
Category: Capital Renewal
Priority: 3 - Necessary/Not Yet Critical (Years 2-5)
Correction: Renew System
Qty: 1-Ea.
Estimate: \$22,855.22
Assessor Name: Eduardo Lopez
Date Created: 01/29/2013

Notes: The branch wiring, electrical panels and devices are mostly original to the building age. It is recommended to be replaced during the next major renovation.

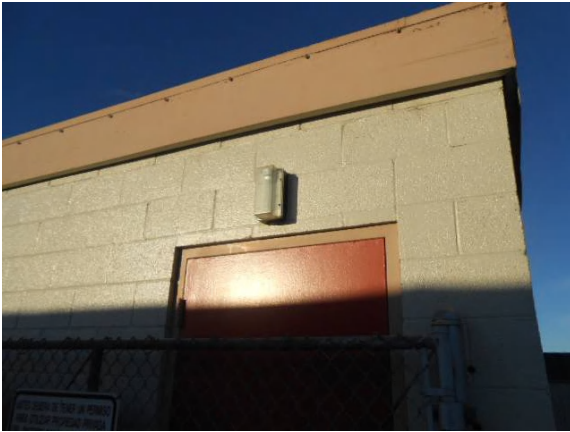
System: D5020 - Lighting

Location: Exterior Ticket Booth & Audio/Visual Entry

Material: HP Sodium Fixture, 250 W

Notes: Exterior Wall pack lighting was previously replaced in 2006 but this one.

Correction: Replace fixture H.P. sodium fixture, 250 W

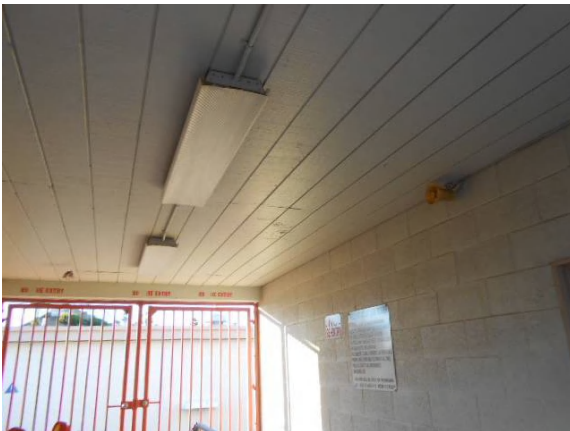
System: D5020 - Lighting

Location: General Admission, Storage, Carts Bay & Ticket Booths

Material: Fluorescent Lighting Fixture, 80 W

Notes: T8 fluorescent lamps and ballasts were updated in 2006; however light fixtures, switches and wiring are original to building age and it is recommended to be replaced during next remodel or renovation.

Correction: Replace fixture fluorescent lighting fixture, 80 W

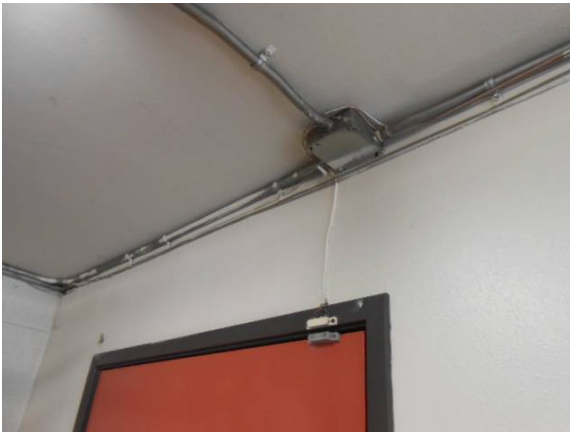
System: D5030910 - Security System, Camers, Access Control

Location: Typical for entire building
Material: System
Distress: Beyond Expected Life
Category: Capital Renewal
Priority: 4 - Recommended (Years 6-10)
Correction: Renew System
Qty: 1-Ea.
Estimate: \$1,313.28
Assessor Name: Eduardo Lopez
Date Created: 01/29/2013

Notes: Security system is needing upgrades. Recommend replacing and enhancing during the next building renovation.

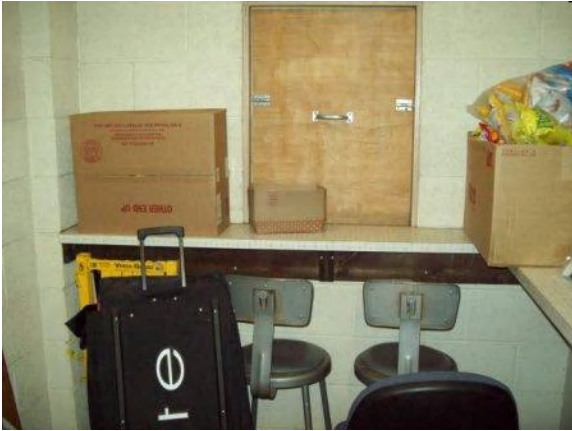
System: E2010 - Fixed Furnishings

Location: Ticket counters.

Notes: Interior counters are original to the building. System renewal is recommended at the next renovation.

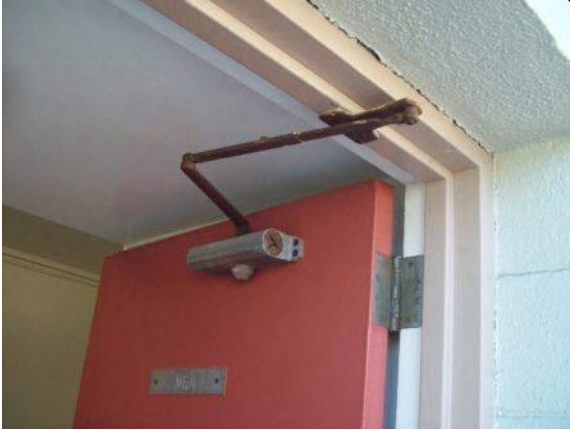
System: B2030 - Exterior Doors

Location: Exterior doors
Material: System
Distress: Beyond Expected Life
Category: Capital Renewal
Priority: 4 - Recommended (Years 6-10)
Correction: Renew System
Qty: 1-Ea.
Estimate: \$44,352.00
Assessor Name: Eduardo Lopez
Date Created: 01/29/2013

Notes: Exterior doors, frames, and hardware are original and in fair to poor condition. Some frames are particularly degraded. System replacement is recommended.

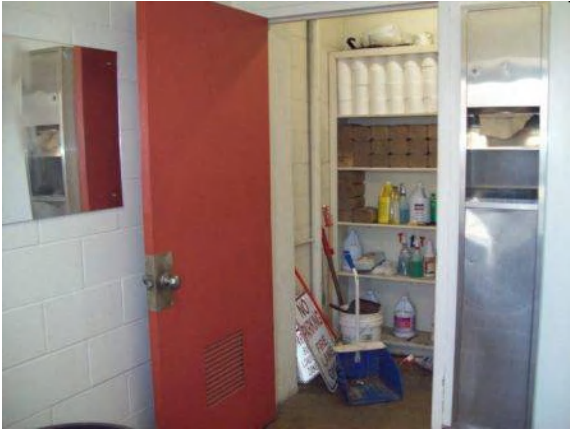
System: C1020 - Interior Doors

Location: Janitor closet door.
Material: System
Distress: Beyond Expected Life
Category: Capital Renewal
Priority: 3 - Necessary/Not Yet Critical (Years 2-5)
Correction: Renew System
Qty: 1-Ea.
Estimate: \$1,828.22
Assessor Name: Eduardo Lopez
Date Created: 01/29/2013

Notes: System is beyond its expected life. System renewal is recommended.

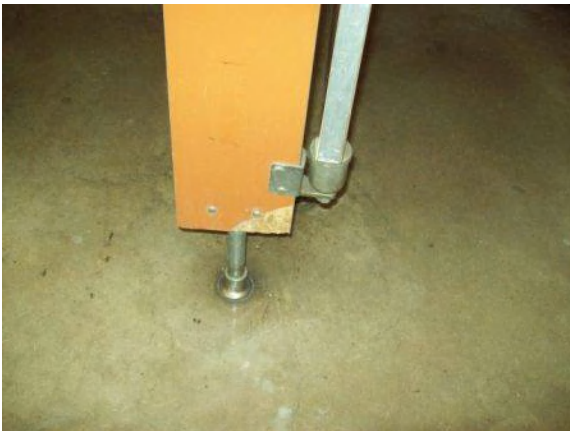
System: C1030 - Fittings

Location: Building wide.
Material: System
Distress: Beyond Expected Life
Category: Capital Renewal
Priority: 3 - Necessary/Not Yet Critical (Years 2-5)
Correction: Renew System
Qty: 1-Ea.
Estimate: \$27,878.40
Assessor Name: Eduardo Lopez
Date Created: 01/29/2013

Notes: Fittings system includes toilet partitons and accessories, signage, and storage shelving. These systems are generally well maintained in fair condition, with some damaged areas. Main restrooms do have ADA accessible stalls. The toilet at the the first aid station is not accessible. System renewal to full ADA compliance at the next major renovation is recommended.

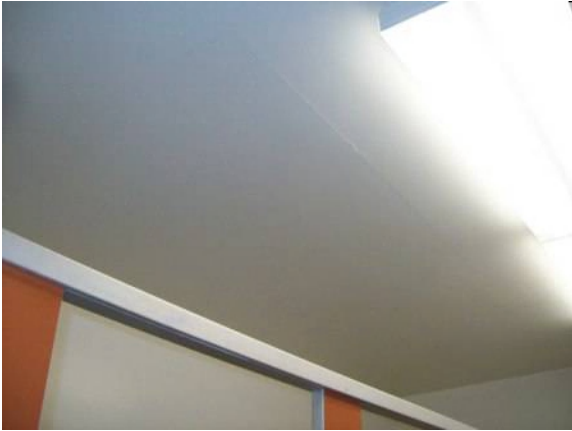
System: C3030 - Ceiling Finishes

Location: Interior ceilings.

Notes: Ceilings are well maintained with paint in fair condition. However there is underlying cracking in the plaster/drywall that is recommended to be replaced at the next building renovation.

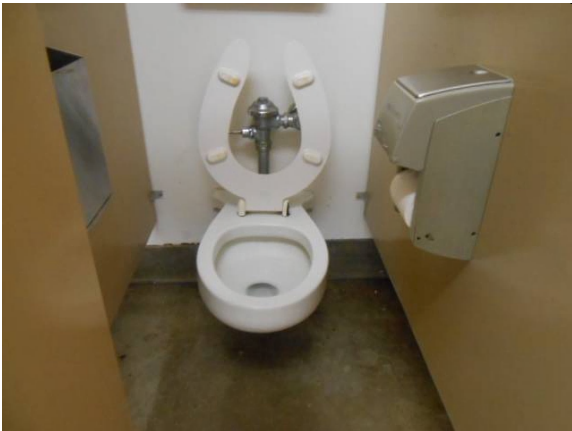
System: D2010 - Plumbing Fixtures

Location: Women, Men & First Aid restrooms

Material: Tankless Water Closet

Correction: Replace tankless water closet

Notes: Replace during next remodel or renovation.

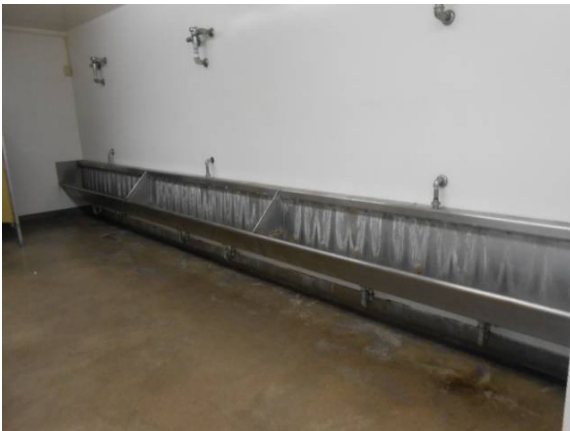
System: D2010 - Plumbing Fixtures

Location: Men restroom
Material: Urinal
Distress: Beyond Expected Life
Category: Capital Renewal
Priority: 4 - Recommended (Years 6-10)
Correction: Replace wall-hung urinal
Qty: 1-Ea.
Estimate: \$13,179.20
Assessor Name: Eduardo Lopez
Date Created: 01/22/2013

Notes: Replace during next remodel or renovation.

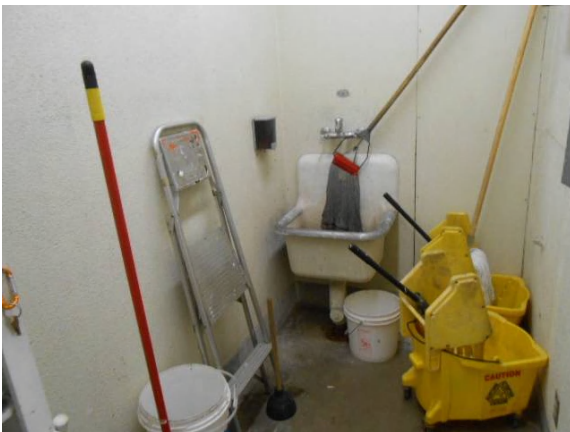
System: D2010 - Plumbing Fixtures

Location: Custodial Closet
Material: Service/Utility Sink
Distress: Beyond Expected Life
Category: Capital Renewal
Priority: 4 - Recommended (Years 6-10)
Correction: Replace sink and fixtures
Qty: 1-Ea.
Estimate: \$3,297.64
Assessor Name: Eduardo Lopez
Date Created: 01/22/2013

Notes: Replace during next remodel or renovation.

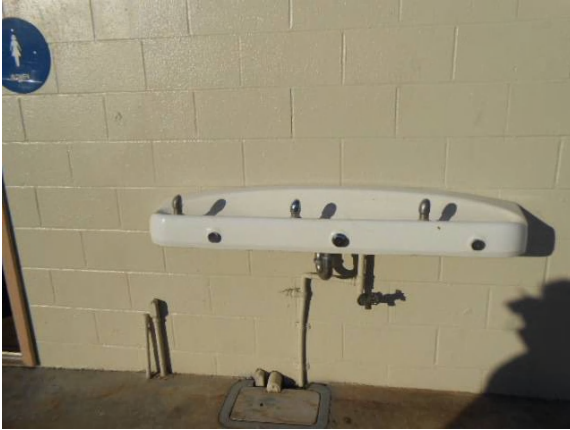
System: D2010 - Plumbing Fixtures

Location: North and East side of building
Material: Drinking Fountain
Distress: Missing
Category: Code Compliance
Priority: 4 - Recommended (Years 6-10)
Correction: Replace fountain drinking fountain
Qty: 6-Ea.
Estimate: \$11,929.98
Assessor Name: Eduardo Lopez
Date Created: 01/22/2013

Notes: The Drinking fountain is beyond its expected life and non-ADA. It is recommended to be replaced during next remodel or renovation.

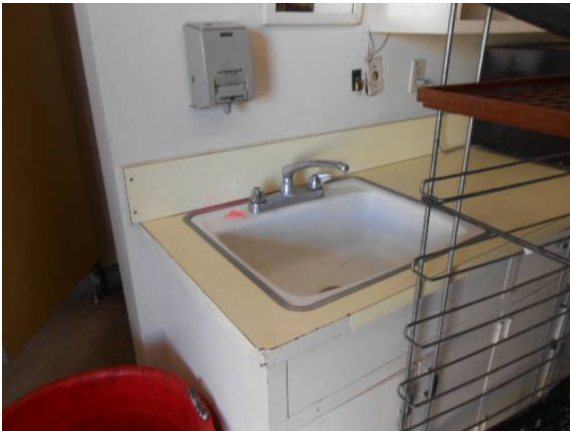
System: D2010 - Plumbing Fixtures

Location: First Aid Room
Material: Sink, Stainless Steel
Distress: Beyond Expected Life
Category: Capital Renewal
Priority: 4 - Recommended (Years 6-10)
Correction: Replace sink, stainless steel
Qty: 1-Ea.
Estimate: \$1,729.07
Assessor Name: Eduardo Lopez
Date Created: 01/24/2013

Notes: Sink is mostly original and beyond expected life and it is recommended to be replaced during next remodel or renovation.

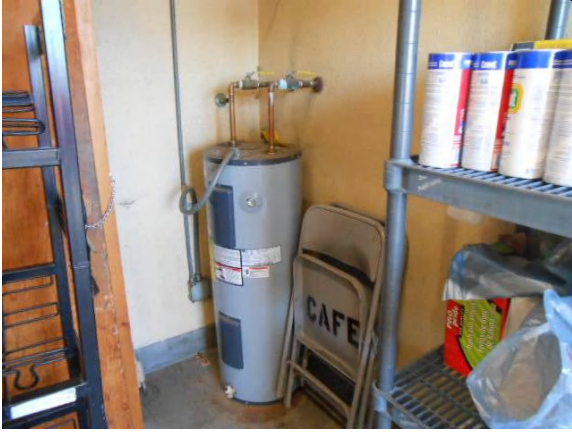
System: D2020 - Domestic Water Distribution

Location: Typical for entire building

Notes: Domestic hot water was replaced in 2002 and is currently furnished for custodial room only; however it is recommended to replace the domestic water distribution system during next remodel or renovation.

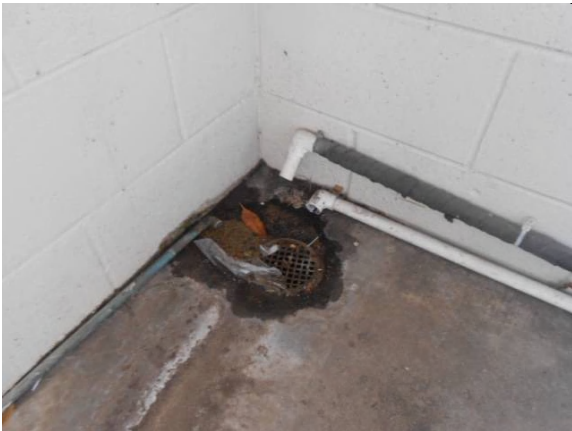
System: D2030 - Sanitary Waste

Location: Typical for entire building

Notes: Replace all above grade sanitary waste and vent piping during next remodel or renovation; below grade as needed.

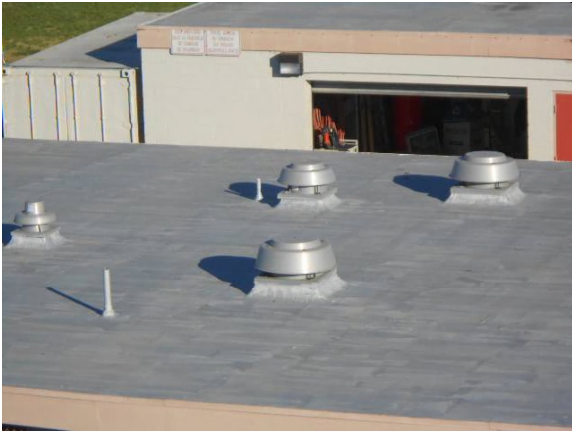
System: D3040 - Distribution Systems

Location: Typical for entire building

Notes: Recommend to be replaced during next remodel or renovation.

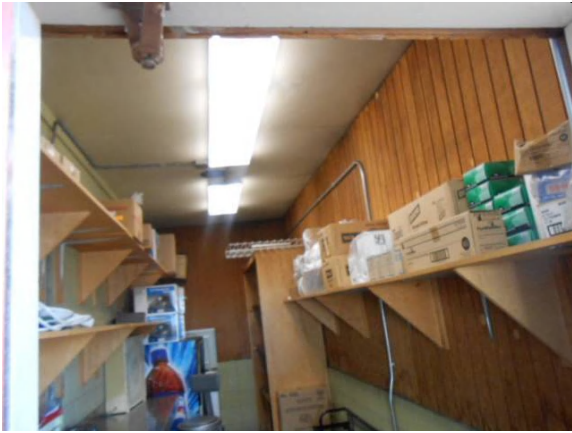
System: D3050 - Terminal & Package Units

Location: Typical for entire building

Distress: Missing

Notes: Building is missing a Terminal & Package Unit and it is recommended to be added for all enclosed areas during next major renovation.

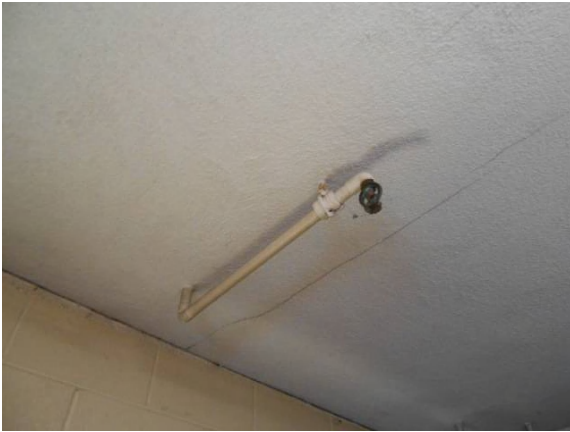
System: D4010 - Sprinklers

Location: Typical for entire building
Material: System
Distress: Inadequate
Category: Capital Renewal
Priority: 5 - Codes or Standards Compliance
Correction: Renew System
Qty: 1-Ea.
Estimate: \$17,319.46
Assessor Name: Eduardo Lopez
Date Created: 01/29/2013

Notes: Building is partially sprinklered, wet type fire sprinklers are currently located in the storage/electrical room and it's recommended to be added throughout building wide during next major renovation.

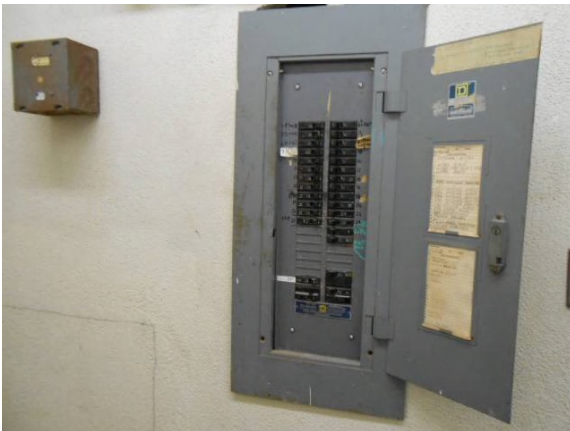
System: D5010 - Electrical Service/Distribution

Location: Typical for entire building
Material: System
Distress: Beyond Expected Life
Category: Capital Renewal
Priority: 4 - Recommended (Years 6-10)
Correction: Renew System
Qty: 1-Ea.
Estimate: \$19,096.70
Assessor Name: Eduardo Lopez
Date Created: 01/29/2013

Notes: The main electrical panels, distribution panel boards and feeders are mostly original to the building age. It is recommended to be replaced during the next major renovation.

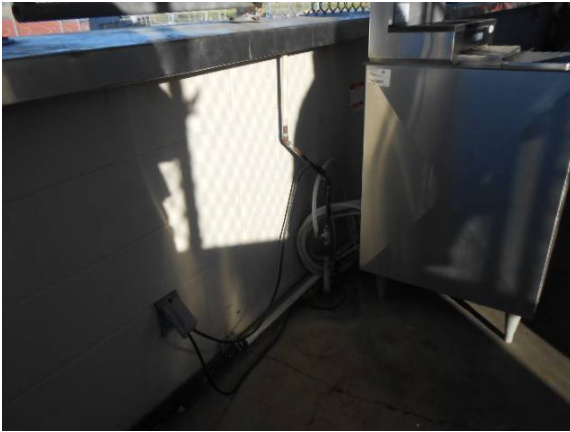
System: D5020 - Branch Wiring

Location: Typical for entire building
Material: System
Distress: Beyond Expected Life
Category: Capital Renewal
Priority: 4 - Recommended (Years 6-10)
Correction: Renew System
Qty: 1-Ea.
Estimate: \$52,376.54
Assessor Name: Eduardo Lopez
Date Created: 01/29/2013

Notes: The branch wiring, electrical panels and devices are mostly original to the building age. It is recommended to be replaced during the next major renovation.

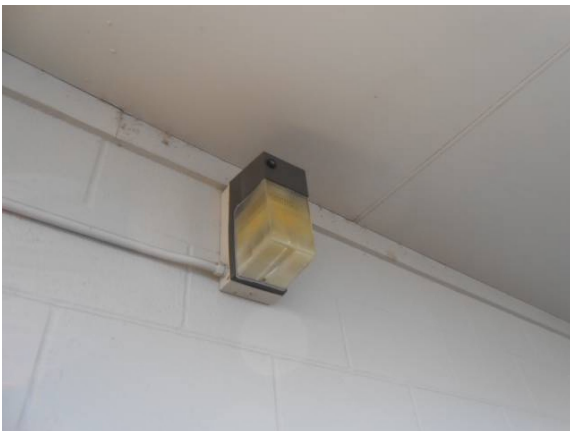
System: D5020 - Lighting

Location: Vending Area
Material: HP Sodium Fixture, 250 W
Distress: Beyond Expected Life
Category: Capital Renewal
Priority: 1 - Currently Critical (Immediate)
Correction: Replace fixture H.P. sodium fixture, 250 W
Qty: 2-Ea.
Estimate: \$1,506.27
Assessor Name: Eduardo Lopez
Date Created: 01/29/2013

Notes: Exterior Wall pack lighting was previously replaced in 2006 but these two. Replace during next remodel or renovation.

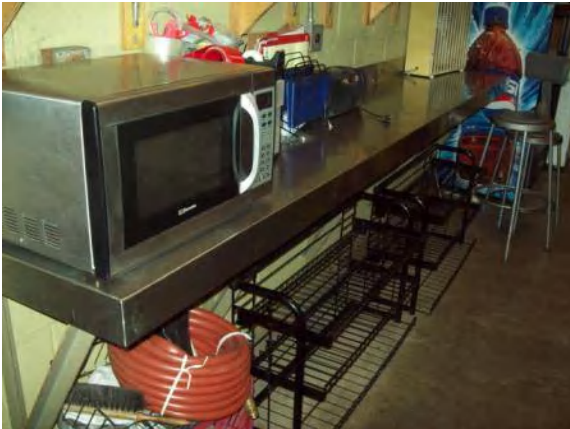
System: E1090 - Other Equipment

Location: Concessions prep and service areas.
Material: System
Distress: Inadequate
Category: Capital Renewal
Priority: 3 - Necessary/Not Yet Critical (Years 2-5)
Correction: Renew System
Qty: 1-Ea.
Estimate: \$10,454.40
Assessor Name: Eduardo Lopez
Date Created: 01/29/2013

Notes: Concessions equipment is very limited and original. Renew system at the next major renovation.

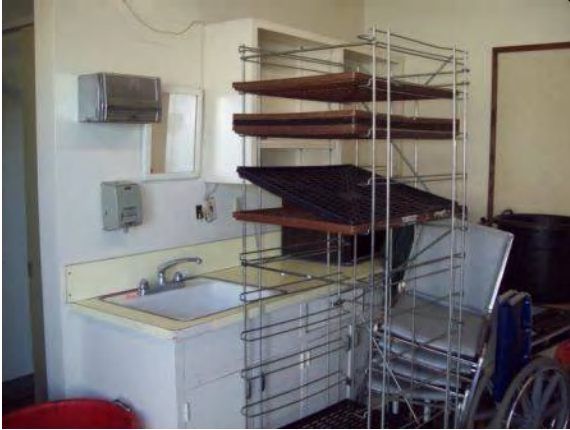
System: E2010 - Fixed Furnishings

Location: First aid station.

Notes: Cabinetry is original and beyond its expected life. System renewal is recommended.

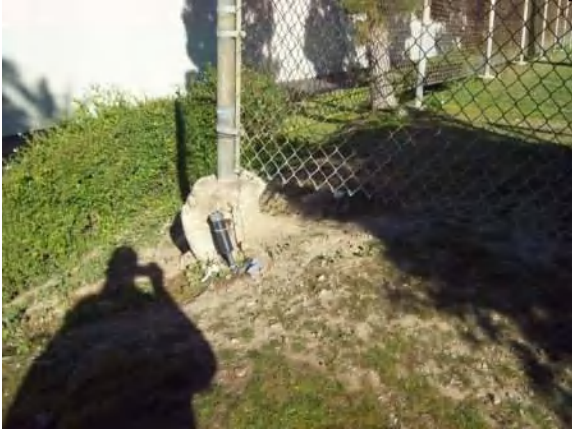
System: G2040105 - Fence & Guardrails

Location: Fences, particlaarly at grandstand.

Material: Chain Link Fence and Gate Repairs

Distress: Failing

Notes: Although many fencing sections were included in the 2004 refurbishment project, there are several intances of damaged or questional fencing and rails. Eroded foundations, rusted connections are found at various locations, particularly around the grandstands.

Correction: Minor chain link fence repairs (per 10 L.F.)

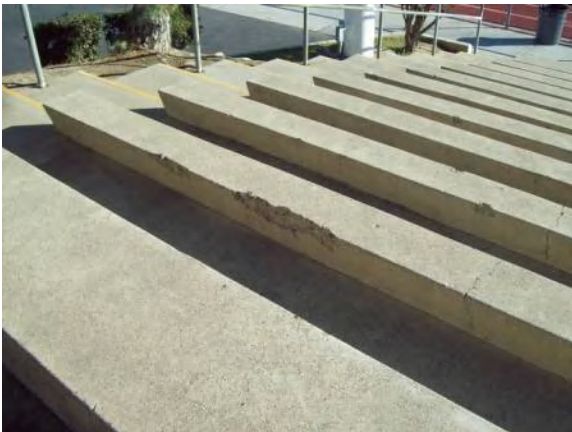
System: G2040950 - Grandstands

Location: Concrete grandstands

Distress: Damaged

Notes: Concrete risers and steps are in need of repairs at various points throughout the stadium.

Correction: Repair concrete steps

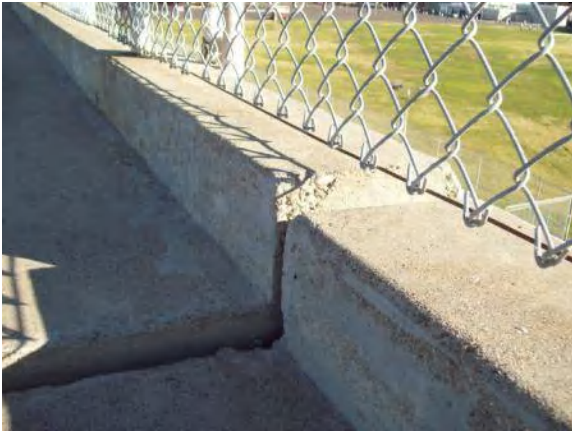
System: G2040950 - Grandstands

Location: East concrete grandstand.
Material: Professional Services Study
Distress: Damaged
Category: Deferred Maintenance
Priority: 3 - Necessary/Not Yet Critical (Years 2-5)
Correction: Professional Structural Engineer Analysis
Qty: 1-Each
Estimate: \$37,254.79
Assessor Name: Ann Buerger Linden
Date Created: 02/05/2013

Notes: Provide an engineering study of the east grandstand. Approximately one inch of offset is observed at a control joint. The back slope has cracking that may be allowing water intrusion/undermining of earth berming. An engineer's study for structural stabilization is recommended.

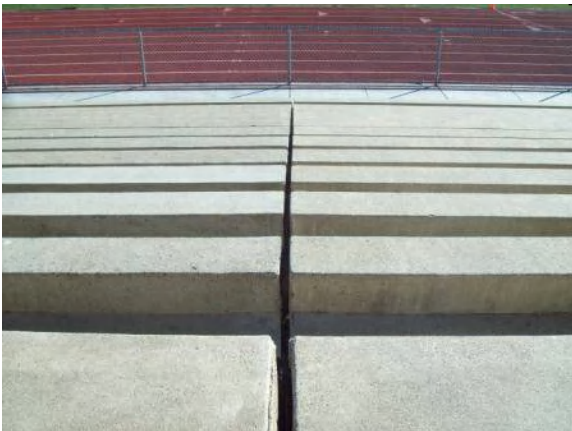
System: G2040950 - Grandstands

Location: Concrete grandstands
Material: Recaulk sidewalk expansion joints
Distress: Missing
Category: Deferred Maintenance
Priority: 3 - Necessary/Not Yet Critical (Years 2-5)
Correction: Recaulk sidewalk expansion joint
Qty: 2,000-L.F.
Estimate: \$76,118.40
Assessor Name: Ann Buerger Linden
Date Created: 02/05/2013

Notes: Joints in concrete grandstands are typically not caulked. Caulking is recommended to prevent water intrusion to the fill beneath the stands.

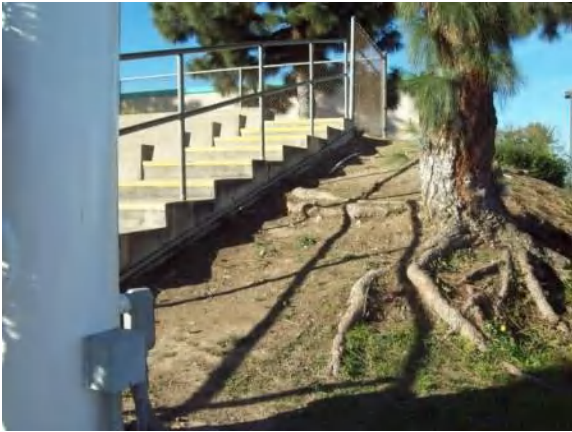
System: G2050 - Landscaping and Irrigation

Location: Site wide.

Notes: Landscape systems are in need of renewal. Erosion due to loss of ground cover, emerging roots, etc. is widespread on sloped areas. Irrigation systems are antiquated. System re-design and restoration is recommended.

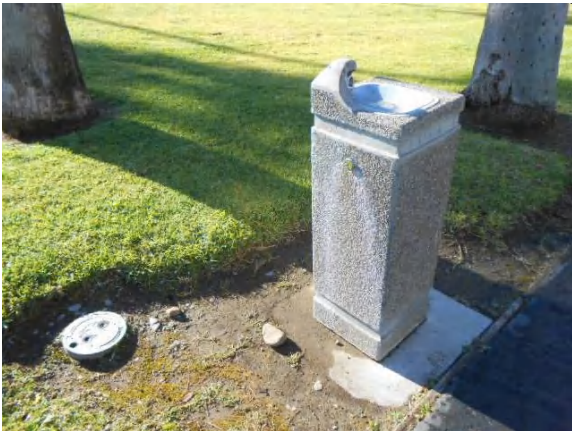
System: G3010 - Water Supply

Location: Site Drinking Fountains

Correction: Replace fountain drinking fountain

Notes: Replace Drinking Fountains during next remodel or renovation.

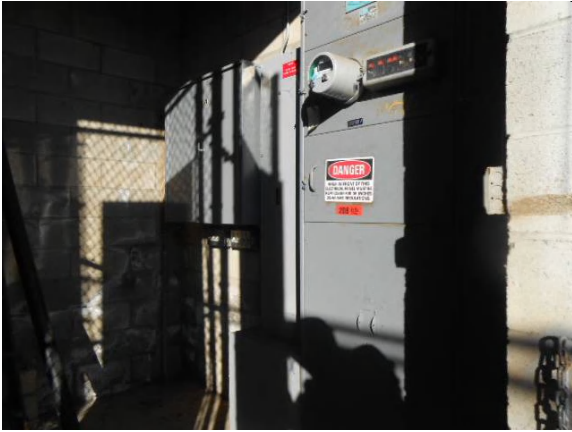
System: G4010 - Electrical Distribution

Location: Site Electrical Distribution

Notes: Transformer was replaced in 1996; However the main electrical panels, distribution panel boards and feeders are mostly original to the building age. It is recommended to be replaced during the next major renovation.

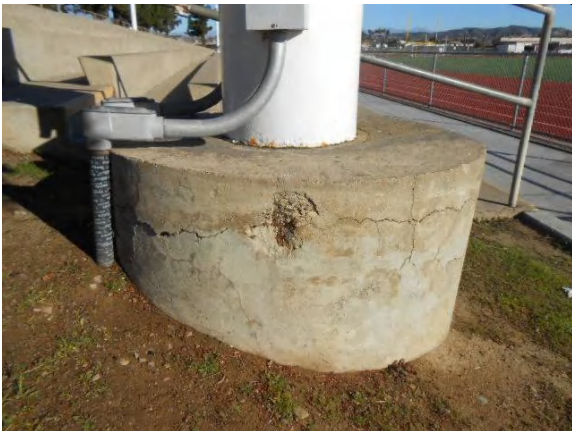
System: G4020 - Site Lighting

Location: Site Lighting

Notes: Some Exterior lighting and wiring was replaced during 2006 updates including repaint of light poles; however Stadium Light Fixtures and Light Poles remain original to building age and it is recommended to be replaced. A P.E. study is recommended for the SW Light Pole Base where are signs of failure are.
