Orange Unified School District

Facilities Condition Assessment for:

**Orange High School
525 N. Shaffer Street
Orange, CA 92867**

Report: Mar 11, 2013

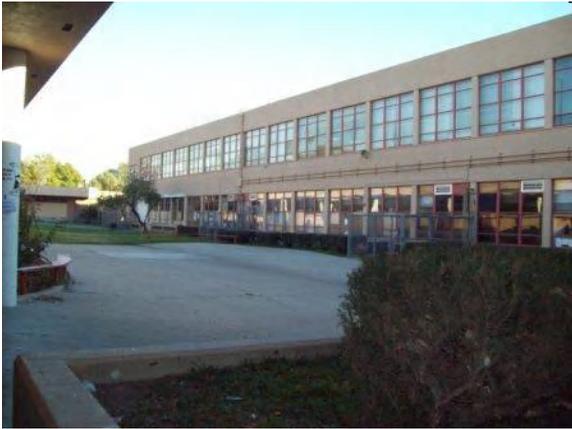
Location: Exterior windows.
Material: System
Distress: Beyond Expected Life
Category: Capital Renewal
Priority: 3 - Necessary/Not Yet Critical (Years 2-5)
Correction: Renew System
Qty: 1-Ea.
Estimate: \$1,118,845.09
Assessor Name: Eduardo Lopez
Date Created: 01/21/2013

Notes: Exterior windows are original and in poor condition. Latching/locking hardware functions poorly creating security and water infiltration problems. Many windows are located above suspended ceilings.

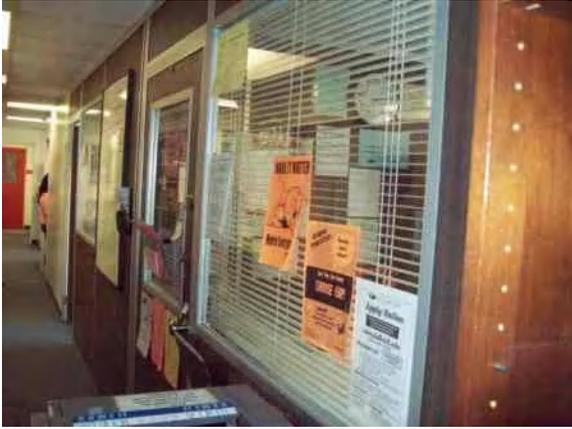
Location: Building wide
Material: Interior Partitions
Distress: Beyond Expected Life
Category: Capital Renewal
Priority: 3 - Necessary/Not Yet Critical (Years 2-5)
Correction: Allowance repair/remodel interior partitions
OUSD
Qty: 1-Job
Estimate: \$146,880.00
Assessor Name: Ann Buerger Linden
Date Created: 02/01/2013

Notes: Provide an allowance to repair and remodel interior partitions as needed to accommodate renovations to adjacent systems and update configurations for ADA compliance and operational efficiency. Modular wall systems in the office area do not provide sufficient sound control.

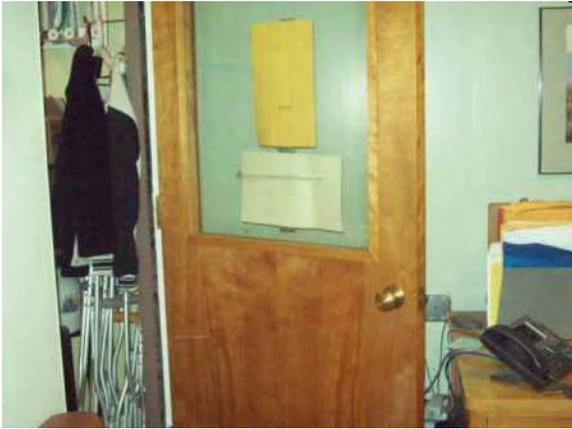
Location: All interior doors.
Material: System
Distress: Beyond Expected Life
Category: Capital Renewal
Priority: 3 - Necessary/Not Yet Critical (Years 2-5)
Correction: Renew System
Qty: 1-Ea.
Estimate: \$144,021.05
Assessor Name: Eduardo Lopez
Date Created: 01/21/2013

Notes: Replace all interior doors, frames, and hardware. Existing units are original and in fair to poor condition.

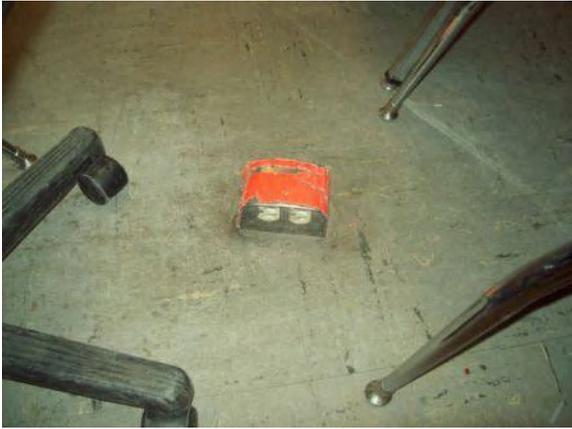
Location: Typical classrooms
Material: System
Distress: Beyond Expected Life
Category: Capital Renewal
Priority: 3 - Necessary/Not Yet Critical (Years 2-5)
Correction: Renew System
Qty: 1-Ea.
Estimate: \$140,041.44
Assessor Name: Eduardo Lopez
Date Created: 01/21/2013

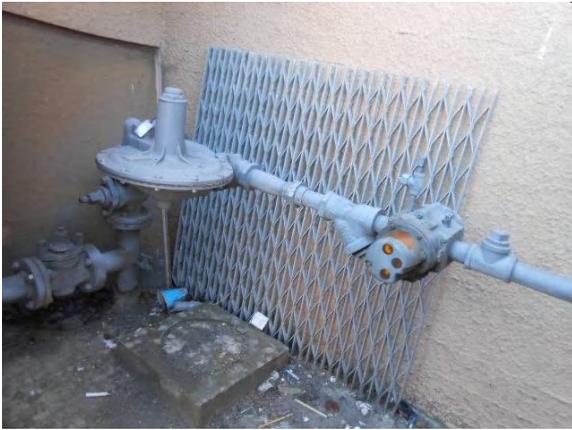
Location: Typical for entire building
Material: System
Distress: Beyond Expected Life
Category: Capital Renewal
Priority: 4 - Recommended (Years 6-10)
Correction: Renew System
Qty: 1-Ea.
Estimate: \$60,652.47
Assessor Name: Eduardo Lopez
Date Created: 01/29/2013

Notes: The Natural Gas distribution is original to the building age. It is recommended to be replaced during the next major renovation.

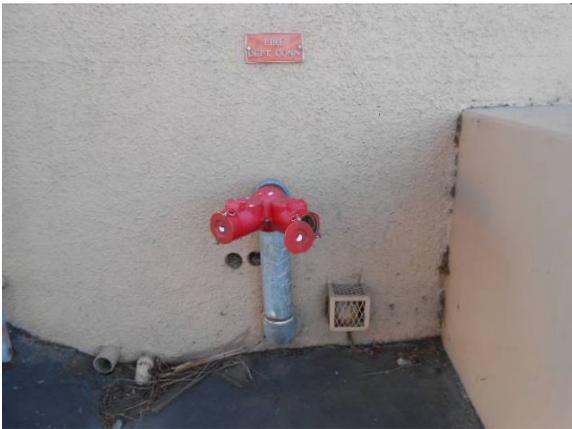
Location: Typical for entire building
Material: System
Distress: Beyond Expected Life
Category: Capital Renewal
Priority: 4 - Recommended (Years 6-10)
Correction: Renew System
Qty: 1-Ea.
Estimate: \$21,068.75
Assessor Name: Eduardo Lopez
Date Created: 01/28/2013

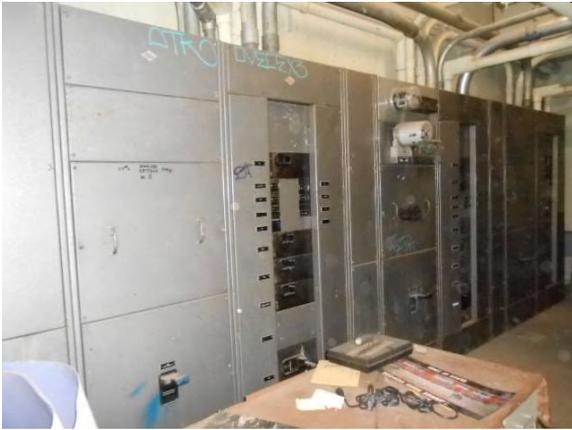
Location: Typical for entire building
Material: System
Distress: Beyond Expected Life
Category: Capital Renewal
Priority: 4 - Recommended (Years 6-10)
Correction: Renew System
Qty: 1-Ea.
Estimate: \$332,630.91
Assessor Name: Eduardo Lopez
Date Created: 01/28/2013

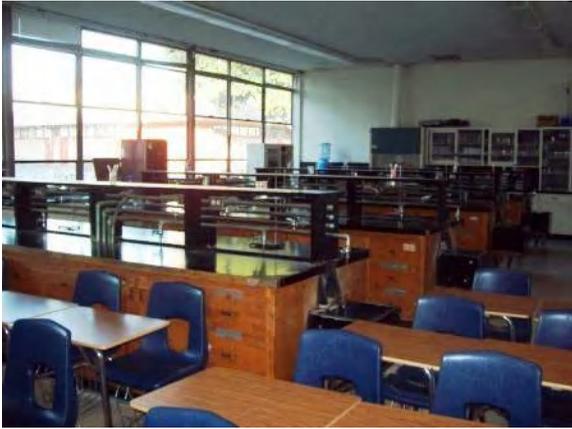
Location: Science classrooms 105, 110, 111, 112, 113 and adjacent work rooms.
Material: Laboratory Equipment OUSD
Distress: Beyond Expected Life
Category: Capital Renewal
Priority: 3 - Necessary/Not Yet Critical (Years 2-5)
Correction: Replace science laboratory fixed casework
Qty: 5,956-S.F.
Estimate: \$306,786.41
Assessor Name: Ann Buerger Linden
Date Created: 02/01/2013

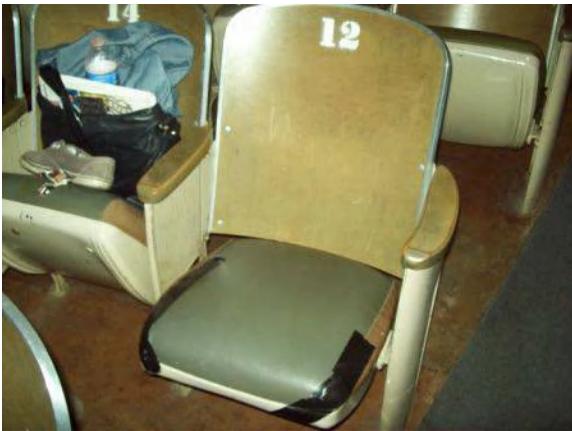
Location: Little theater
Material: System
Distress: Beyond Expected Life
Category: Capital Renewal
Priority: 3 - Necessary/Not Yet Critical (Years 2-5)
Correction: Renew System
Qty: 1-Ea.
Estimate: \$223,248.66
Assessor Name: Ann Buerger Linden
Date Created: 02/01/2013

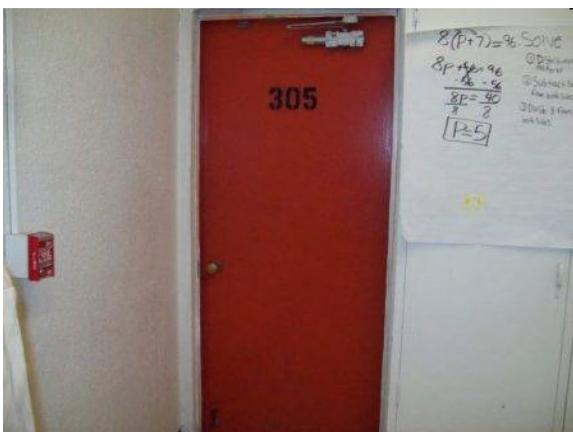
Location: All interior doors.
Material: System
Distress: Beyond Expected Life
Category: Capital Renewal
Priority: 3 - Necessary/Not Yet Critical (Years 2-5)
Correction: Renew System
Qty: 1-Ea.
Estimate: \$101,482.33
Assessor Name: Eduardo Lopez
Date Created: 01/21/2013

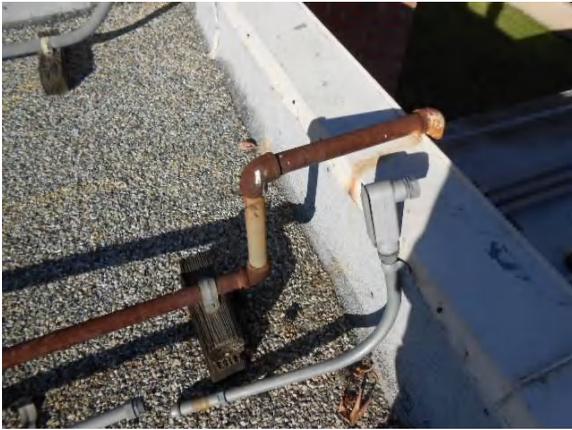
Location: Typical for entire building
Material: System
Distress: Beyond Expected Life
Category: Capital Renewal
Priority: 4 - Recommended (Years 6-10)
Correction: Renew System
Qty: 1-Ea.
Estimate: \$29,588.33
Assessor Name: Eduardo Lopez
Date Created: 01/28/2013

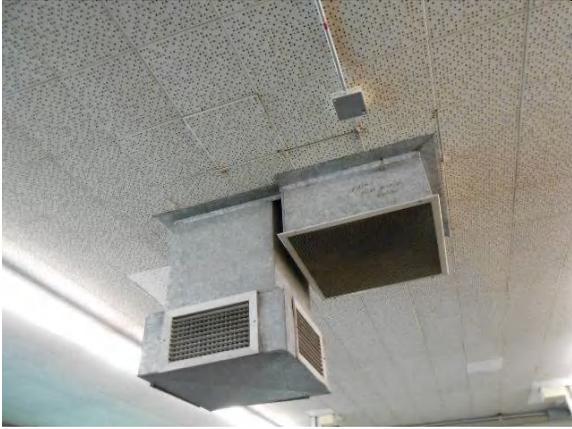
Location: Typical for entire building
Material: System
Distress: Beyond Expected Life
Category: Capital Renewal
Priority: 4 - Recommended (Years 6-10)
Correction: Renew System
Qty: 1-Ea.
Estimate: \$431,613.86
Assessor Name: Eduardo Lopez
Date Created: 01/28/2013

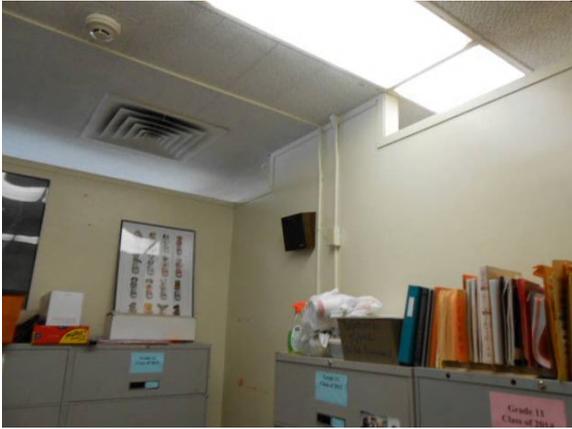
Location: Typical for entire building
Material: Smoke Detector
Distress: Inadequate
Category: Capital Renewal
Priority: 5 - Codes or Standards Compliance
Correction: Install Smoke Detectors
Qty: 32-Ea.
Estimate: \$81,243.88
Assessor Name: Eduardo Lopez
Date Created: 01/28/2013

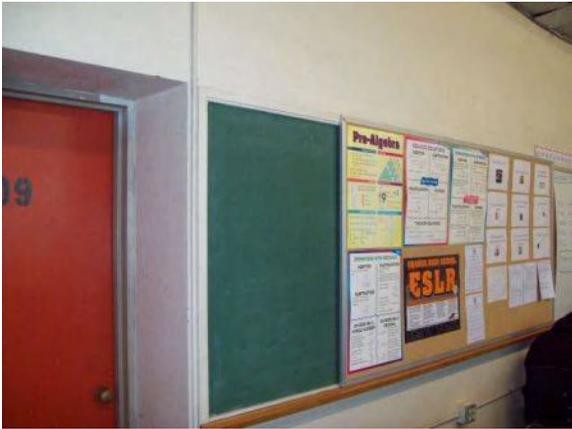
Location: All Classrooms
Material: Other Institutional Equipment
Distress: Inadequate
Category: Capital Renewal
Priority: 3 - Necessary/Not Yet Critical (Years 2-5)
Correction: Smartboards whiteboards tackboards
Qty: 11-Ea.
Estimate: \$122,761.43
Assessor Name: Ann Buerger Linden
Date Created: 01/30/2013

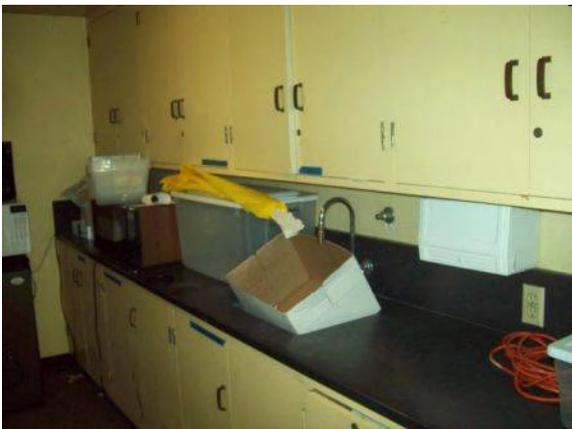
Location: Classrooms, storage/work rooms.
Material: Fixed Casework
Distress: Beyond Expected Life
Category: Capital Renewal
Priority: 3 - Necessary/Not Yet Critical (Years 2-5)
Correction: Replace Casework OUSD
Qty: 140-L.F.
Estimate: \$91,868.54
Assessor Name: Ann Buerger Linden
Date Created: 01/30/2013

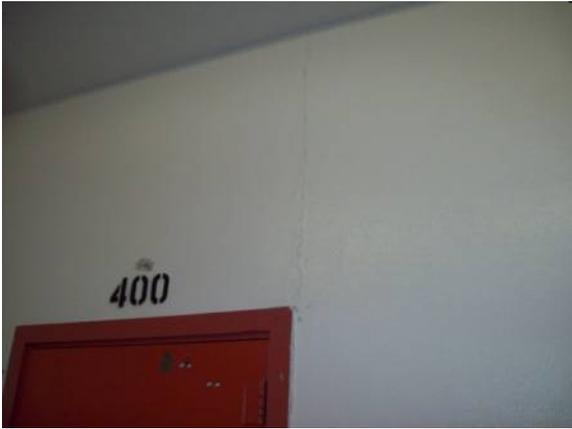
Location: Building interiors.
Material: System
Distress: Beyond Expected Life
Category: Capital Renewal
Priority: 3 - Necessary/Not Yet Critical (Years 2-5)
Correction: Renew System
Qty: 1-Ea.
Estimate: \$161,702.37
Assessor Name: Sonny Satterfield
Date Created: 01/30/2013

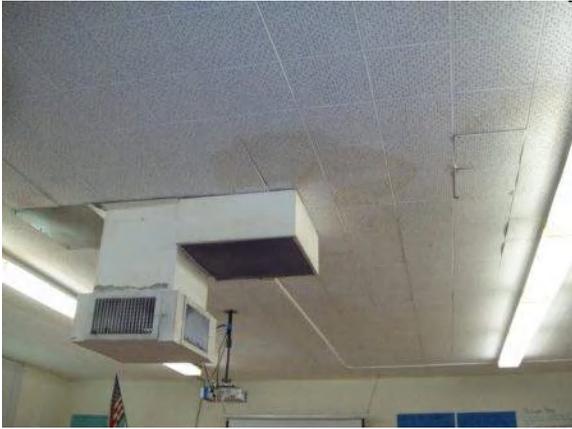
Location: Building wide.
Material: System
Distress: Beyond Expected Life
Category: Capital Renewal
Priority: 3 - Necessary/Not Yet Critical (Years 2-5)
Correction: Renew System
Qty: 1-Ea.
Estimate: \$287,308.83
Assessor Name: Ann Buerger Linden
Date Created: 01/30/2013

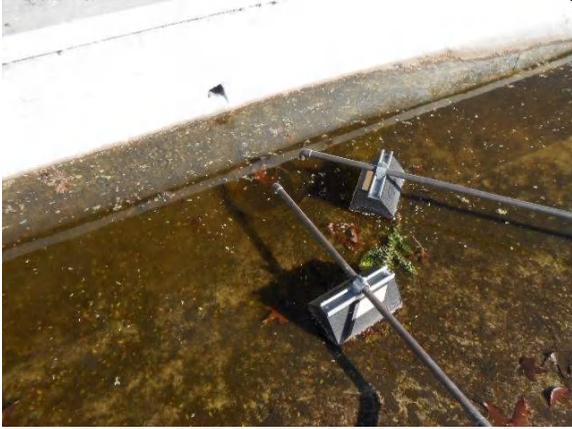
Location: Typical for entire building
Material: System
Distress: Beyond Expected Life
Category: Capital Renewal
Priority: 4 - Recommended (Years 6-10)
Correction: Renew System
Qty: 1-Ea.
Estimate: \$12,761.18
Assessor Name: Eduardo Lopez
Date Created: 01/28/2013

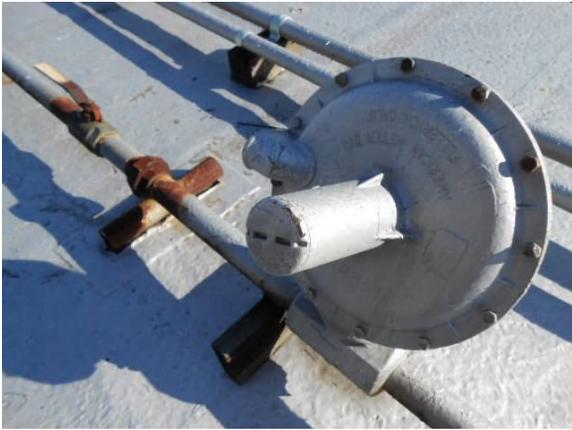
Location: Typical for entire building
Material: System
Distress: Beyond Expected Life
Category: Capital Renewal
Priority: 4 - Recommended (Years 6-10)
Correction: Renew System
Qty: 1-Ea.
Estimate: \$21,511.70
Assessor Name: Eduardo Lopez
Date Created: 01/28/2013

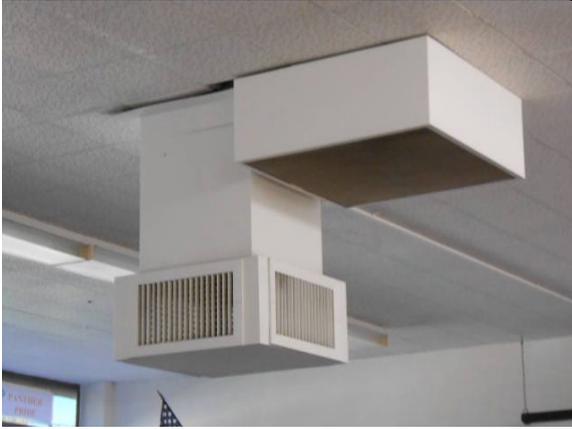
Location: Typical for entire building
Material: System
Distress: Beyond Expected Life
Category: Capital Renewal
Priority: 4 - Recommended (Years 6-10)
Correction: Renew System
Qty: 1-Ea.
Estimate: \$314,107.31
Assessor Name: Eduardo Lopez
Date Created: 01/28/2013

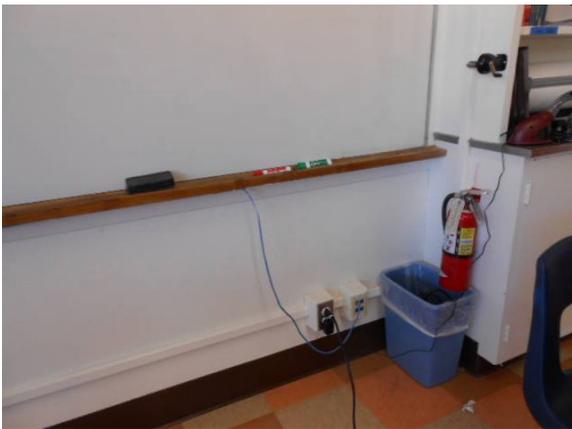
Location: Typical for entire building
Material: System
Distress: Beyond Expected Life
Category: Capital Renewal
Priority: 4 - Recommended (Years 6-10)
Correction: Renew System
Qty: 1-Ea.
Estimate: \$406,352.41
Assessor Name: Eduardo Lopez
Date Created: 01/28/2013

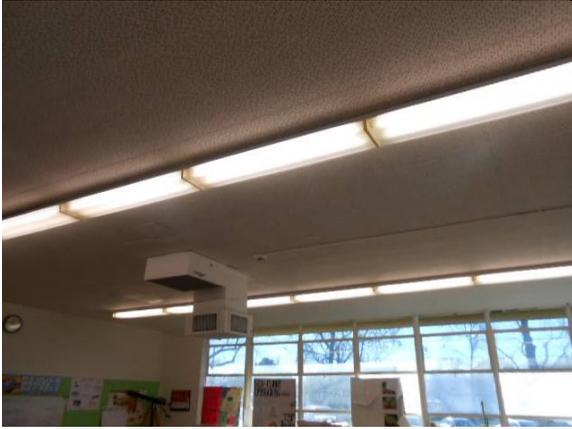
Location: Typical for entire building
Material: System
Distress: Beyond Expected Life
Category: Capital Renewal
Priority: 4 - Recommended (Years 6-10)
Correction: Renew System
Qty: 1-Ea.
Estimate: \$319,576.39
Assessor Name: Eduardo Lopez
Date Created: 01/28/2013

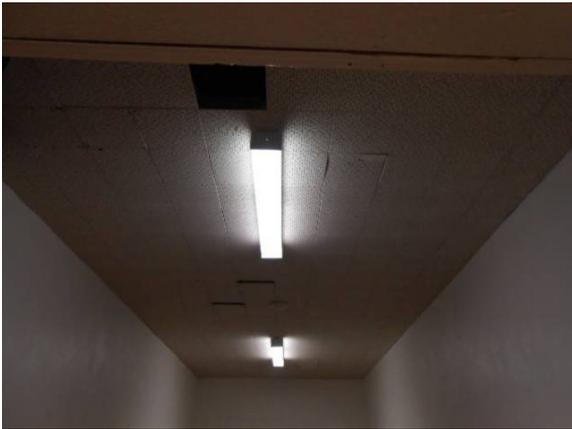
Location: Typical for entire building
Material: Smoke Detector
Distress: Inadequate
Category: Capital Renewal
Priority: 5 - Codes or Standards Compliance
Correction: Install Smoke Detectors
Qty: 26-Ea.
Estimate: \$66,010.65
Assessor Name: Eduardo Lopez
Date Created: 01/28/2013

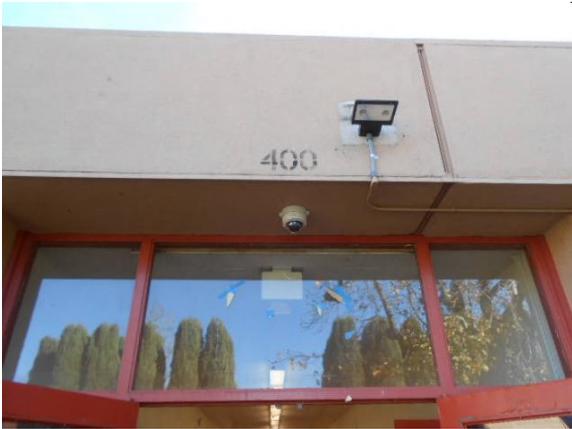
Location: Typical for entire building
Material: System
Distress: Missing
Category: Capital Renewal
Priority: 4 - Recommended (Years 6-10)
Correction: Renew System
Qty: 1-Ea.
Estimate: \$18,561.72
Assessor Name: Eduardo Lopez
Date Created: 01/28/2013

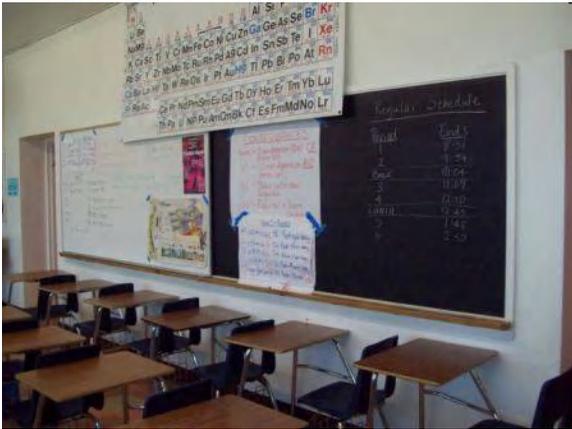
Location: Classrooms
Material: Other Institutional Equipment
Distress: Beyond Expected Life
Category: Capital Renewal
Priority: 3 - Necessary/Not Yet Critical (Years 2-5)
Correction: Smartboards whiteboards tackboards
Qty: 10-Ea.
Estimate: \$111,601.30
Assessor Name: Ann Buerger Linden
Date Created: 01/30/2013

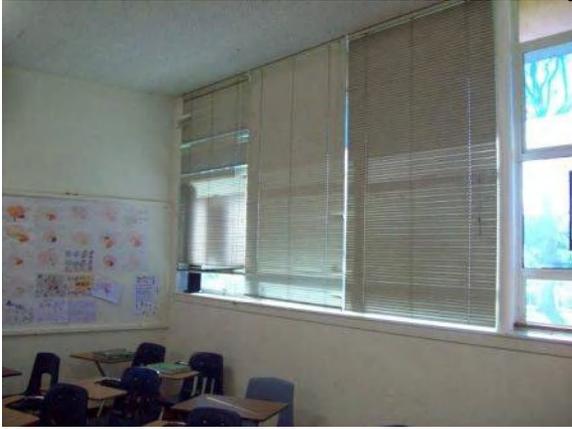
Location: Classroom windows.
Material: Blinds and Other Window Treatment
Distress: Inadequate
Category: Capital Renewal
Priority: 1 - Currently Critical (Immediate)
Correction: Replace window blinds
Qty: 1,440-S.F.
Estimate: \$15,614.21
Assessor Name: Ann Buerger Linden
Date Created: 01/30/2013

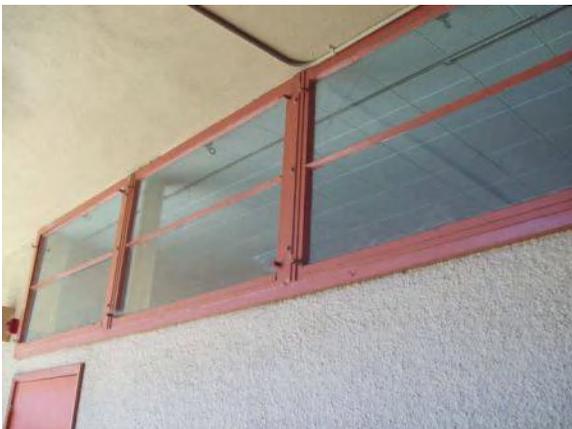
Location: Exterior walls
Material: System
Distress: Beyond Expected Life
Category: Capital Renewal
Priority: 3 - Necessary/Not Yet Critical (Years 2-5)
Correction: Renew System
Qty: 1-Ea.
Estimate: \$497,886.68
Assessor Name: Ann Buerger Linden
Date Created: 02/02/2013

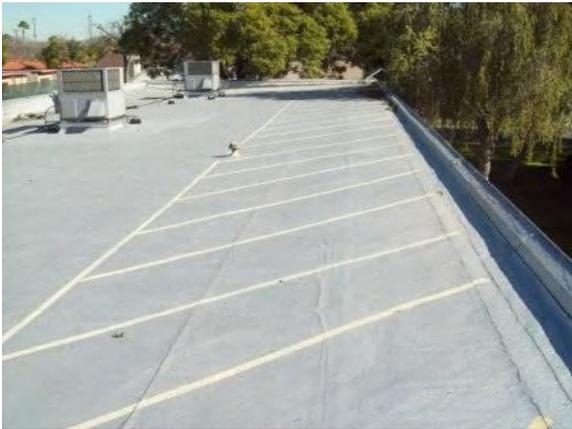
Location: Roofs
Material: System
Distress: Beyond Expected Life
Category: Capital Renewal
Priority: 3 - Necessary/Not Yet Critical (Years 2-5)
Correction: Renew System
Qty: 1-Ea.
Estimate: \$522,900.58
Assessor Name: Ann Buerger Linden
Date Created: 02/02/2013

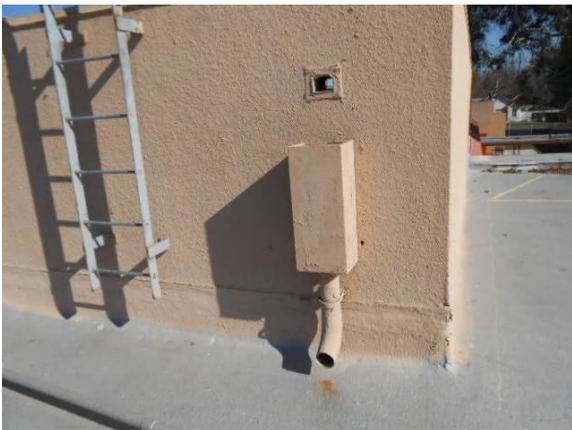
Location: Typical for entire building
Material: System
Distress: Beyond Expected Life
Category: Capital Renewal
Priority: 4 - Recommended (Years 6-10)
Correction: Renew System
Qty: 1-Ea.
Estimate: \$18,594.58
Assessor Name: Eduardo Lopez
Date Created: 01/28/2013

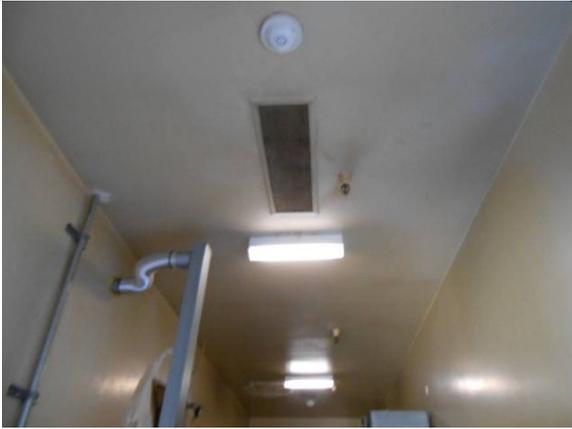
Location: Typical for entire building
Material: System
Distress: Beyond Expected Life
Category: Capital Renewal
Priority: 5 - Codes or Standards Compliance
Correction: Renew System
Qty: 1-Ea.
Estimate: \$155,336.23
Assessor Name: Eduardo Lopez
Date Created: 01/28/2013

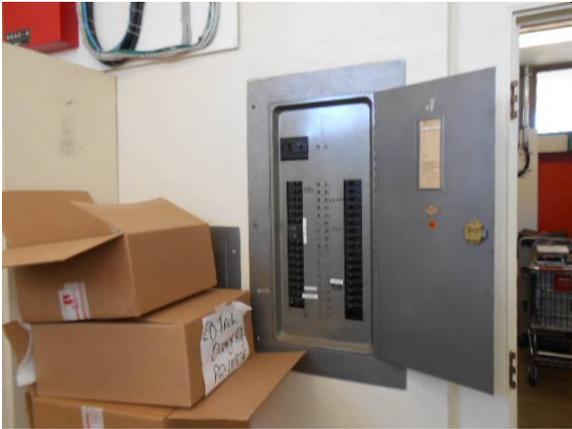
Location: Typical for entire building
Material: System
Distress: Beyond Expected Life
Category: Capital Renewal
Priority: 4 - Recommended (Years 6-10)
Correction: Renew System
Qty: 1-Ea.
Estimate: \$171,070.10
Assessor Name: Eduardo Lopez
Date Created: 01/28/2013

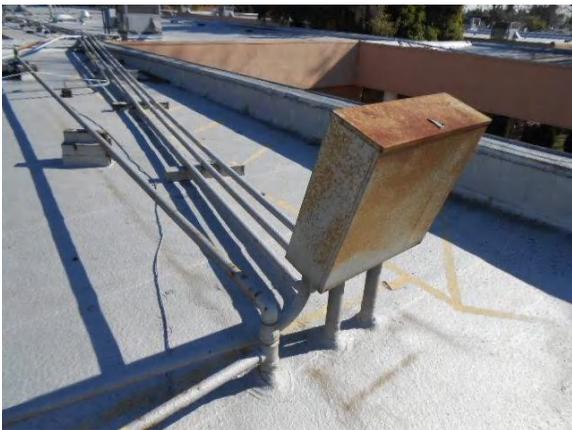
Location: Typical for entire building
Material: System
Distress: Beyond Expected Life
Category: Capital Renewal
Priority: 4 - Recommended (Years 6-10)
Correction: Renew System
Qty: 1-Ea.
Estimate: \$589,877.16
Assessor Name: Eduardo Lopez
Date Created: 01/28/2013

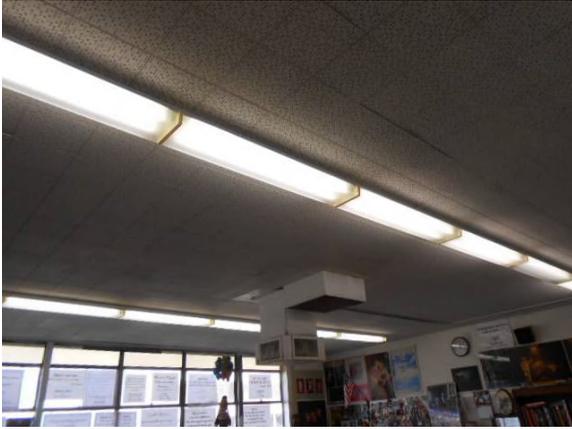
Location: Typical for entire building
Material: System
Distress: Beyond Expected Life
Category: Capital Renewal
Priority: 4 - Recommended (Years 6-10)
Correction: Renew System
Qty: 1-Ea.
Estimate: \$464,006.19
Assessor Name: Eduardo Lopez
Date Created: 01/28/2013

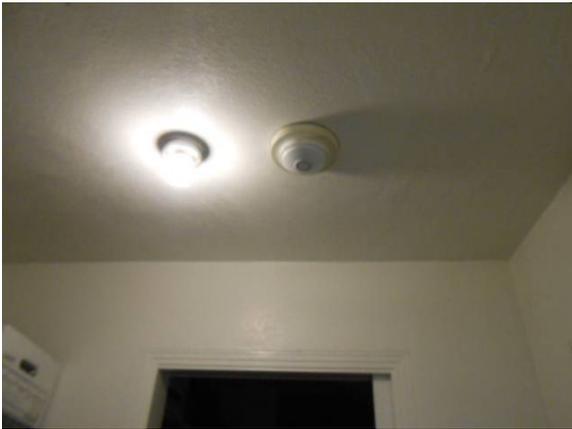
Location: Typical for entire building
Material: Smoke Detector
Distress: Inadequate
Category: Capital Renewal
Priority: 5 - Codes or Standards Compliance
Correction: Install Smoke Detectors
Qty: 40-Ea.
Estimate: \$101,554.85
Assessor Name: Eduardo Lopez
Date Created: 01/28/2013

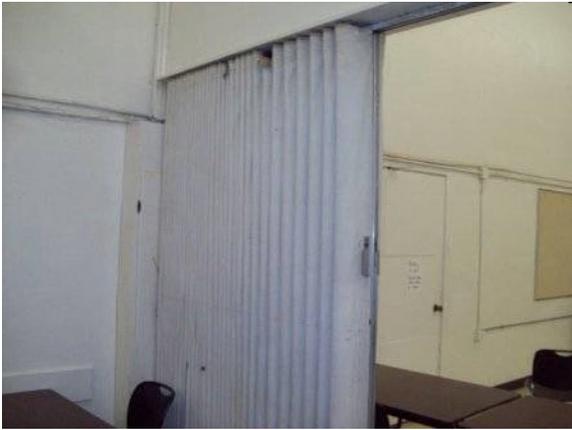
Location: Building interiors.
Material: Interior Partitions
Distress: Beyond Expected Life
Category: Capital Renewal
Priority: 3 - Necessary/Not Yet Critical (Years 2-5)
Correction: Allowance repair/remodel interior partitions
OUSD
Qty: 1-Job
Estimate: \$29,376.00
Assessor Name: Ann Buerger Linden
Date Created: 01/30/2013

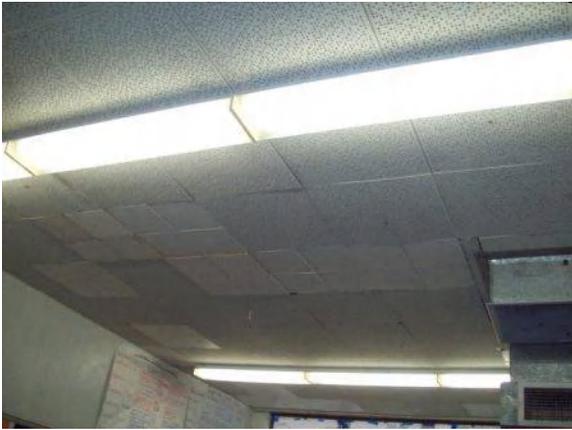
Location: Building wide.
Material: System
Distress: Beyond Expected Life
Category: Capital Renewal
Priority: 3 - Necessary/Not Yet Critical (Years 2-5)
Correction: Renew System
Qty: 1-Ea.
Estimate: \$192,842.50
Assessor Name: Eduardo Lopez
Date Created: 01/21/2013

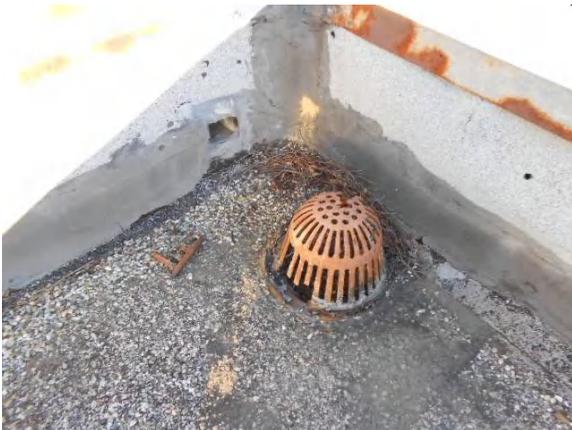
Location: Typical for entire building
Material: System
Distress: Beyond Expected Life
Category: Capital Renewal
Priority: 4 - Recommended (Years 6-10)
Correction: Renew System
Qty: 1-Ea.
Estimate: \$8,540.17
Assessor Name: Eduardo Lopez
Date Created: 01/28/2013

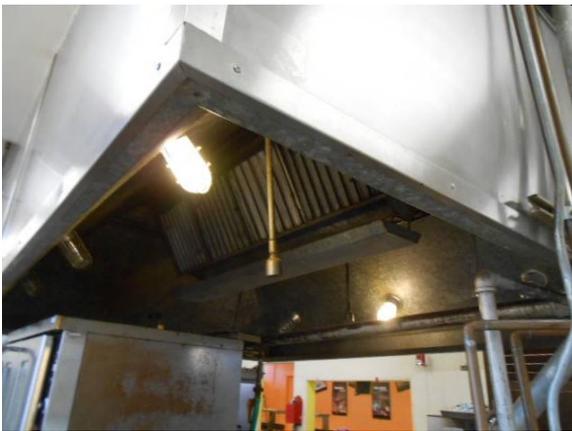
Location: Kitchen
Material: System
Distress: Beyond Expected Life
Category: Capital Renewal
Priority: 4 - Recommended (Years 6-10)
Correction: Renew System
Qty: 1-Ea.
Estimate: \$20,799.44
Assessor Name: Eduardo Lopez
Date Created: 01/28/2013

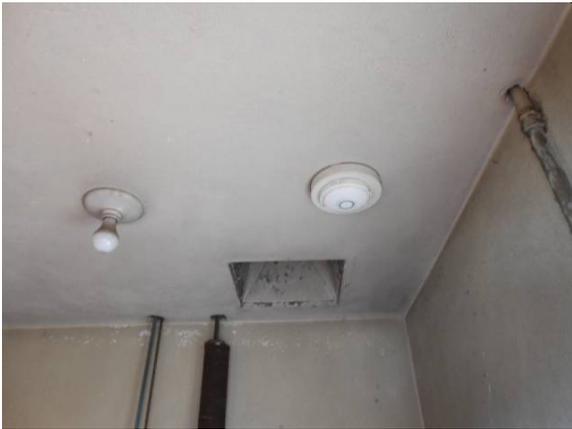
Location: Typical for entire building
Material: Smoke Detector
Distress: Inadequate
Category: Capital Renewal
Priority: 5 - Codes or Standards Compliance
Correction: Install Smoke Detectors
Qty: 40-Ea.
Estimate: \$101,554.85
Assessor Name: Eduardo Lopez
Date Created: 01/28/2013

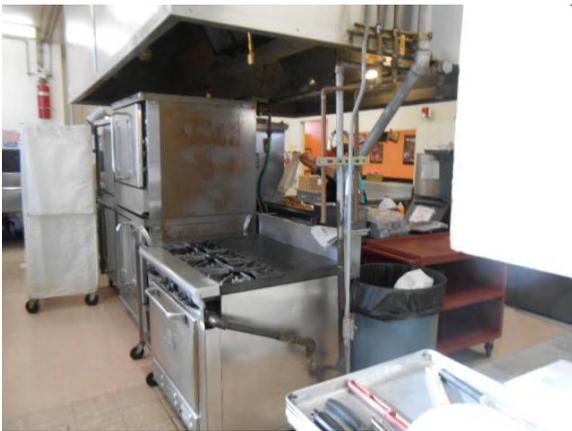
Location: Kitchen
Material: System
Distress: Beyond Expected Life
Category: Capital Renewal
Priority: 4 - Recommended (Years 6-10)
Correction: Renew System
Qty: 1-Ea.
Estimate: \$584,652.25
Assessor Name: Eduardo Lopez
Date Created: 01/28/2013

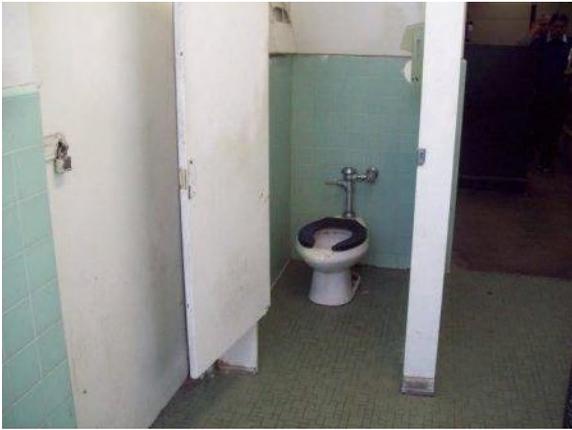
Location: Restrooms
Material: Toilet Partitions
Distress: Beyond Expected Life
Category: Capital Renewal
Priority: 3 - Necessary/Not Yet Critical (Years 2-5)
Correction: Replace toilet partitions and accessories
OUSD
Qty: 12-Ea.
Estimate: \$64,790.67
Assessor Name: Ann Buerger Linden
Date Created: 01/31/2013

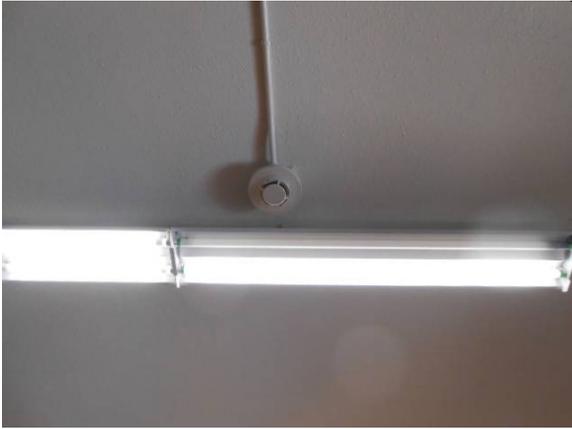
Location: Typical for entire building
Material: Smoke Detector
Distress: Inadequate
Category: Capital Renewal
Priority: 5 - Codes or Standards Compliance
Correction: Install Smoke Detectors
Qty: 40-Ea.
Estimate: \$101,554.85
Assessor Name: Eduardo Lopez
Date Created: 01/28/2013

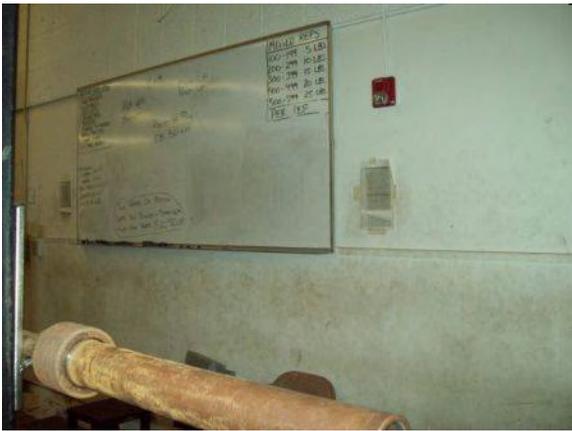
Location: Weight room. Training room. Offices.
Material: Other Institutional Equipment
Distress: Damaged
Category: Capital Renewal
Priority: 3 - Necessary/Not Yet Critical (Years 2-5)
Correction: Smartboards whiteboards tackboards
Qty: 4-Ea.
Estimate: \$30,571.26
Assessor Name: Ann Buerger Linden
Date Created: 01/31/2013

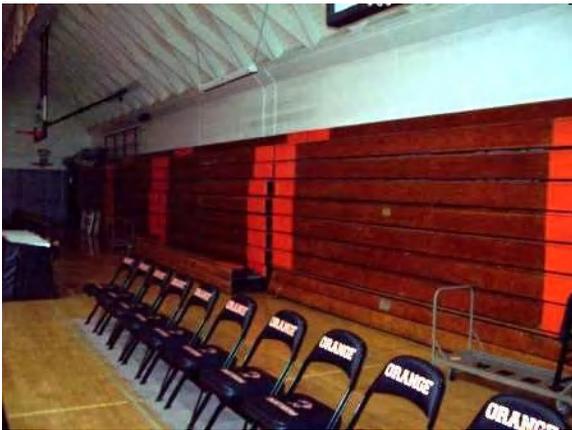
Location: Gymnasium
Material: Fixed Furnishings - Bleachers telescoping
Distress: Beyond Expected Life
Category: Capital Renewal
Priority: 3 - Necessary/Not Yet Critical (Years 2-5)
Correction: Gym bleachers telescoping minimum
Qty: 1,260-Seat
Estimate: \$469,330.85
Assessor Name: Ann Buerger Linden
Date Created: 01/31/2013
