Orange Unified School District

Facilities Condition Assessment for:

**Canyon High School
220 S. Imperial Highway
Anaheim, CA 92807**

Campus Report

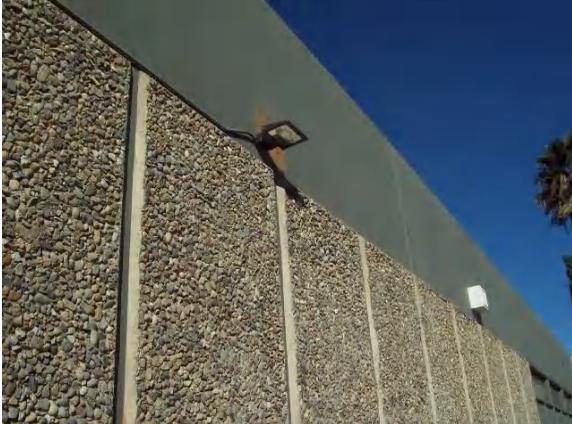
System: B2010 - Exterior Walls

Location: Typical for all exterior tilt wall construction type for ALL buildings on Campus

Distress: Inadequate

Notes: Recommend an Engineering Study to determine safe seismic bracing for all exterior walls with tilt wall construction type design; with recommendations and corrections to bring existing building construction to current guidelines and codes.

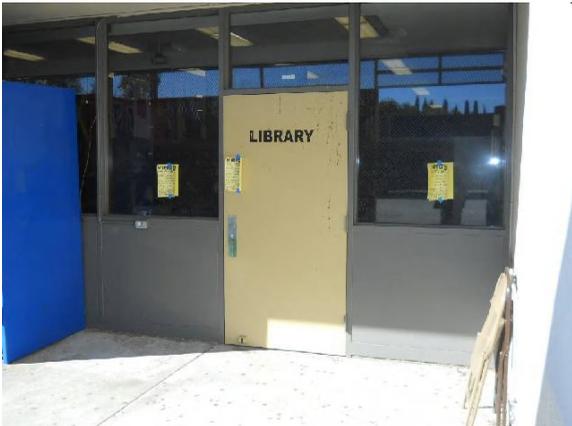
System: B2020 - Exterior Windows

Location: All exterior window systems

Material: Steel Frame, Fixed

Correction: Replace 2'-0" x 3'-0" steel frame window - 1st flr

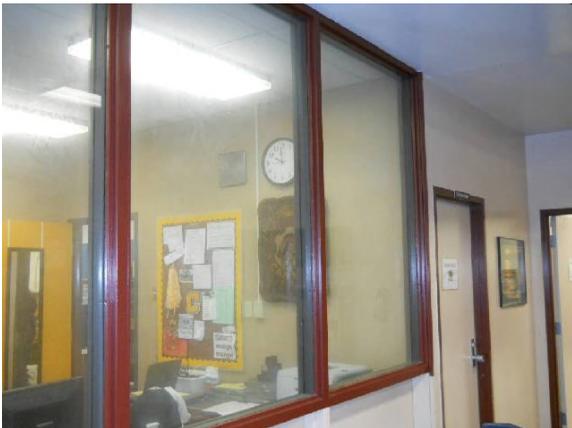
System: C1020 - Interior Doors

Location: All interior door systems
Material: Solid Core Interior Doors
Distress: Beyond Expected Life
Category: Deferred Maintenance
Priority: 3 - Necessary/Not Yet Critical (Years 2-5)
Correction: Replace 3'-0" x 7'-0" solid core wood door interior
Qty: 23-Ea.
Estimate: \$52,555.48
Assessor Name: Dave Cunningham
Date Created: 01/21/2013

Notes: All doors and door hardware are beyond expected useful service life

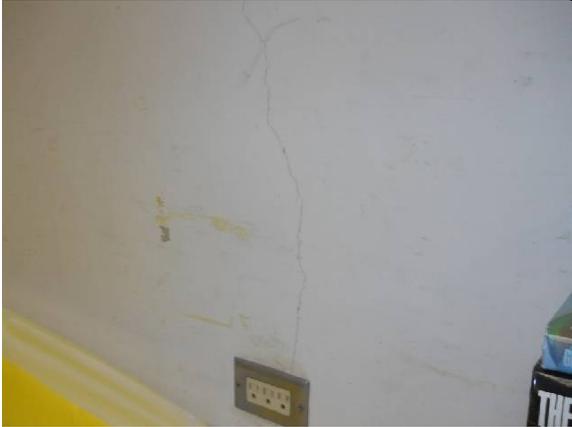
System: C3010 - Wall Finishes

Location: All interior walls
Material: Vinyl Wall Covering
Distress: Beyond Expected Life
Category: Deferred Maintenance
Priority: 3 - Necessary/Not Yet Critical (Years 2-5)
Correction: Replace medium weight vinyl wall covering
Qty: 140-C.S.F.
Estimate: \$67,939.20
Assessor Name: Dave Cunningham
Date Created: 01/21/2013

Notes: All interior wall surfaces; primarily vinyl covered walls and painted drywall. Walls are beyond expected useful service life.

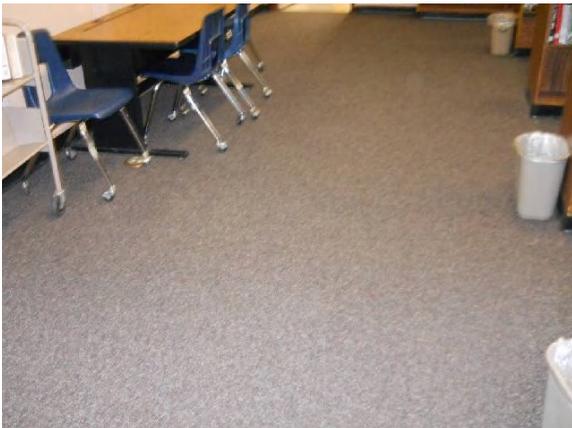
System: C3020210 - Carpet

Location: Rooms; Media Center, Librarian 7, Listening Center, Conf Room 12
Material: Carpet
Distress: Beyond Expected Life
Category: Deferred Maintenance
Priority: 3 - Necessary/Not Yet Critical (Years 2-5)
Correction: Replace carpet
Qty: 768-S.Y.
Estimate: \$74,457.45
Assessor Name: Dave Cunningham
Date Created: 01/21/2013

Notes: Carpet in these rooms is worn and beyond expected useful life.

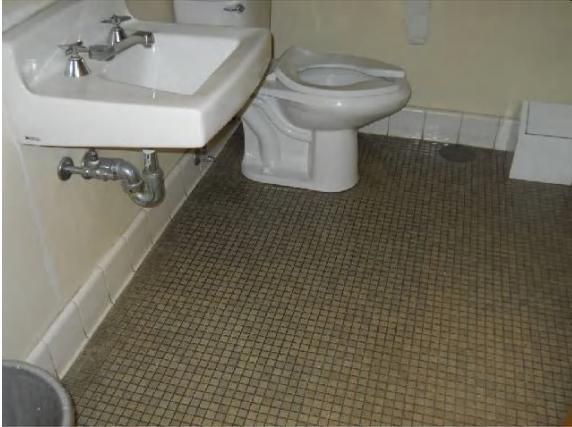
System: C3020210 - Ceramic Tile

Location: Toilet 5
Material: Ceramic Tile
Distress: Beyond Expected Life
Category: Deferred Maintenance
Priority: 3 - Necessary/Not Yet Critical (Years 2-5)
Correction: Replace 2" x 2" thin set ceramic tile floor
Qty: 1-C.S.F.
Estimate: \$2,511.36
Assessor Name: Dave Cunningham
Date Created: 01/21/2013

Notes: Ceramic floor tile is beyond expected useful life.

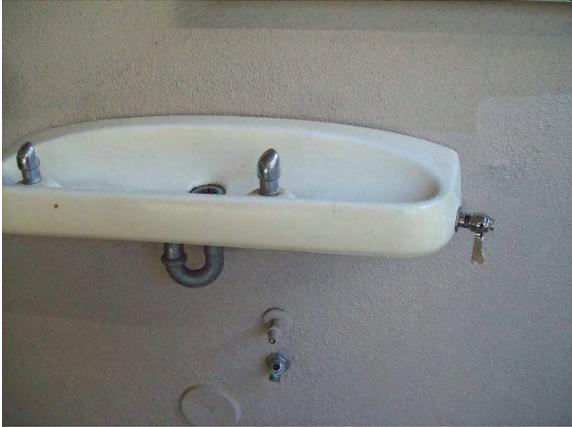
System: D2010 - Plumbing Fixtures

Location: System-Typical for all required building locations.
Material: System
Distress: Beyond Expected Life
Category: Capital Renewal
Priority: 4 - Recommended (Years 6-10)
Correction: Renew System
Qty: 1-Ea.
Estimate: \$83,925.07
Assessor Name: Sonny Satterfield
Date Created: 01/28/2013

Notes: Plumbing fixtures are mostly original to building construction date of 1972 and therefore are beyond expected life. Recommend replacing system during next remodel or renovation.

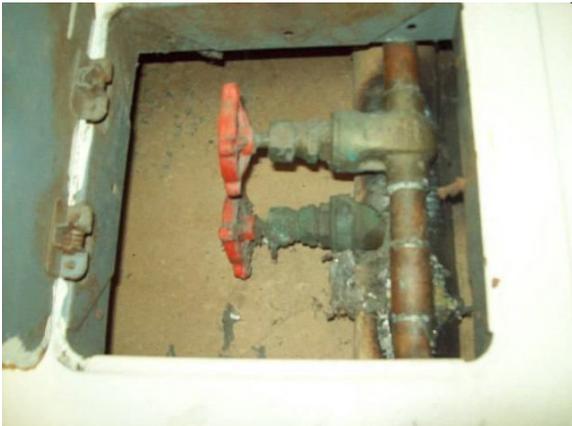
System: D2020 - Domestic Water Distribution

Location: System-Typical for all building locations
Material: System
Distress: Beyond Expected Life
Category: Capital Renewal
Priority: 4 - Recommended (Years 6-10)
Correction: Renew System
Qty: 1-Ea.
Estimate: \$25,737.02
Assessor Name: Sonny Satterfield
Date Created: 01/28/2013

Notes: Recommend replacing system during next remodel or renovation, domestic hot water heater was replaced in 2009; however most piping was installed during the 1972 original construction.

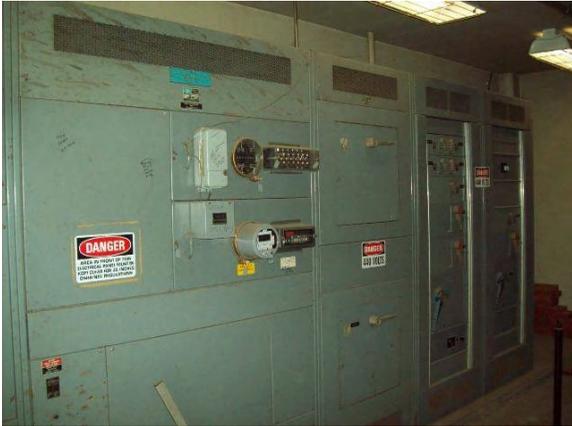
System: D5010 - Electrical Service/Distribution - Campus

Location: System-Typical for all building locations
Material: System
Distress: Beyond Expected Life
Category: Capital Renewal
Priority: 4 - Recommended (Years 6-10)
Correction: Renew System
Qty: 1-Ea.
Estimate: \$743,203.14
Assessor Name: Sonny Satterfield
Date Created: 01/28/2013

Notes: The Main Electrical Service for the entire school campus serving all buildings is housed within the A1-Library Bldg. Electrical Room. The main electrical switchgear, transformers, distribution panel boards and feeders are mostly original to the building construction date of 1972 and therefore beyond expected life. The system is recommended to be replaced during the next major renovation.

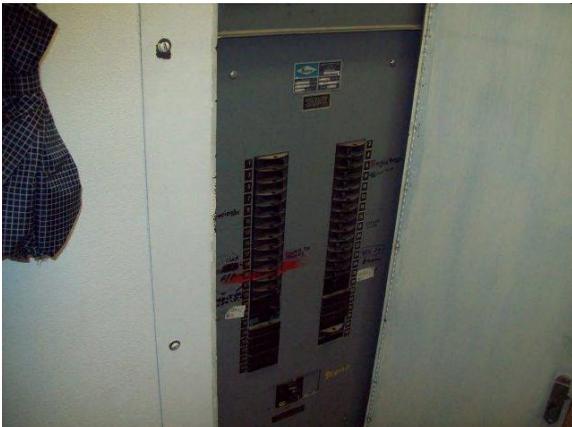
System: D5020 - Branch Wiring

Location: System-Typical for all required building locations.
Material: System
Distress: Beyond Expected Life
Category: Capital Renewal
Priority: 4 - Recommended (Years 6-10)
Correction: Renew System
Qty: 1-Ea.
Estimate: \$398,737.34
Assessor Name: Sonny Satterfield
Date Created: 01/28/2013

Notes: The branch wiring, electrical panels and devices are mostly original to the building construction date of 1972 and therefore beyond expected life. The system is recommended to be replaced during the next major renovation.

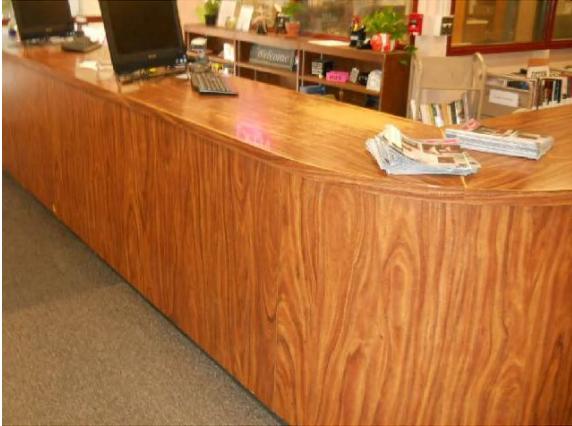
System: E2010 - Fixed Furnishings

Location: Throughout the building; Media Room, work room 2, work room 4, text book room
Material: Fixed Casework
Distress: Beyond Expected Life
Category: Deferred Maintenance
Priority: 3 - Necessary/Not Yet Critical (Years 2-5)
Correction: Replace Casework OUSD
Qty: 88-L.F.
Estimate: \$52,832.68
Assessor Name: Dave Cunningham
Date Created: 01/21/2013

Notes: All fixed casework is original construction. System is beyond expected useful service life. Approx 68 l.f.

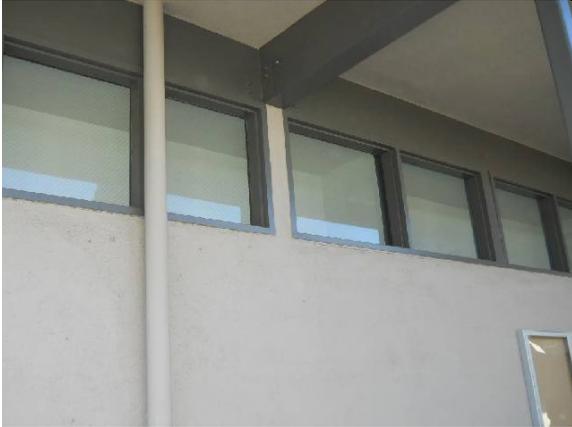
System: B2020 - Exterior Windows

Location: All exterior windows
Material: Steel Frame, Fixed
Distress: Beyond Expected Life
Category: Deferred Maintenance
Priority: 3 - Necessary/Not Yet Critical (Years 2-5)
Correction: Replace 2'-0" x 3'-0" steel frame window - 1st flr
Qty: 18-Ea.
Estimate: \$16,072.21
Assessor Name: Dave Cunningham
Date Created: 01/21/2013

Notes: Exterior window system is original construction, beyond expected service life.

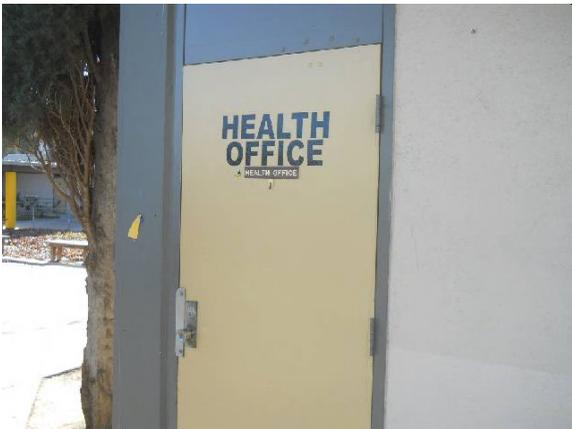
System: B2030 - Exterior Doors

Location: All Exterior Doors
Material: Steel, Unpainted
Distress: Beyond Expected Life
Category: Deferred Maintenance
Priority: 3 - Necessary/Not Yet Critical (Years 2-5)
Correction: Repl. 3'-0" x 7'-0" steel, insul. core, unptd. dr.
Qty: 5-Ea.
Estimate: \$19,676.59
Assessor Name: Dave Cunningham
Date Created: 01/21/2013

Notes: All exterior doors beyond expected service life

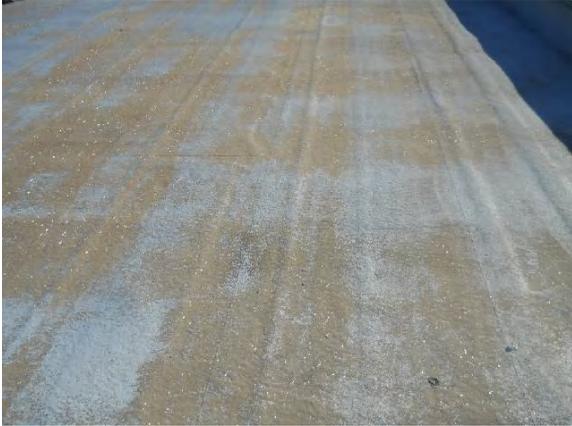
System: B3010105 - Built-Up

Location: Roof
Material: Built-Up Roofing
Distress: Failing
Category: Deferred Maintenance
Priority: 2 - Potentially Critical (Year 1)
Correction: Minor membrane repairs - (2% of roof area) built-u
Qty: 61-Sq.
Estimate: \$3,684.01
Assessor Name: Dave Cunningham
Date Created: 01/21/2013

Notes: Minor Roof Repairs, Reflective roof coating has failed, re-coat the roof. Roof Area 5342 sq ft plus 15% for overhangs and walkways = approx 6100 sq ft

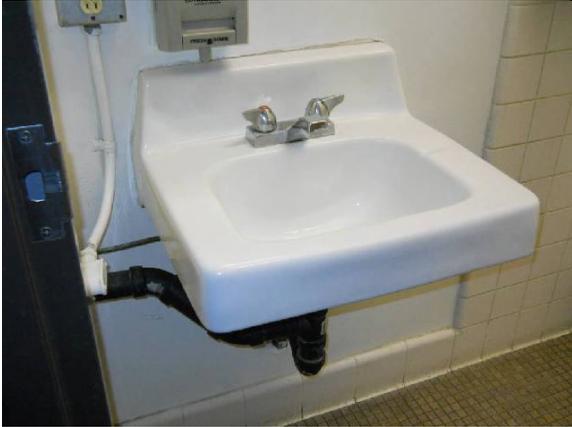
System: C3010 - Wall Finishes

Location: Toilets 7, 8, 20
Material: Wall Finishes
Distress: Beyond Expected Life
Category: Deferred Maintenance
Priority: 3 - Necessary/Not Yet Critical (Years 2-5)
Correction: Refinish/Repaint
Qty: 200-S.F.
Estimate: \$118.08
Assessor Name: Dave Cunningham
Date Created: 01/21/2013

Notes: Cerramic wall tiles beyond expected useful life

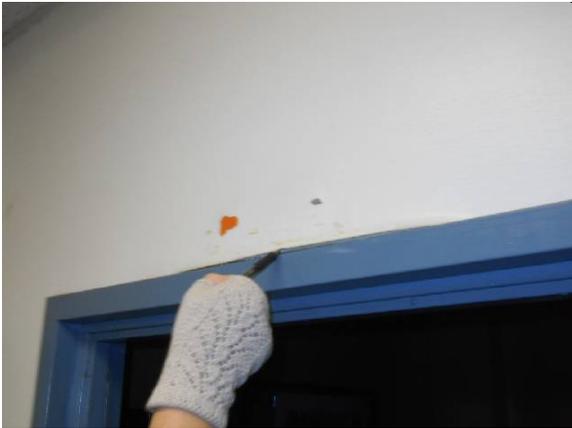
System: C3010 - Wall Finishes

Location: All offices, hallways, common areas in A-2
Material: Vinyl Wall Covering
Distress: Beyond Expected Life
Category: Deferred Maintenance
Priority: 3 - Necessary/Not Yet Critical (Years 2-5)
Correction: Replace medium weight vinyl wall covering
Qty: 117-C.S.F.
Estimate: \$56,876.50
Assessor Name: Dave Cunningham
Date Created: 01/21/2013

Notes: Vinyl wall coverings are beyond expected useful life. Walls are damaged, vinyl is peeling away from base.
Repair/replace all interior walls finishes

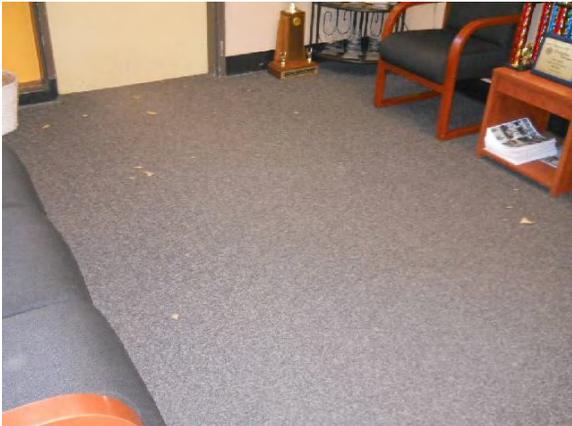
System: C3020210 - Carpet

Location: Bld A-2 all carpeted rooms. Approx 83% of floor covering in this building is carpeted.
 $5342 \text{ sq ft} \times 83\% = 4434 \text{ sq ft of carpet}$
Material: Carpet
Distress: Beyond Expected Life
Category: Deferred Maintenance
Priority: 3 - Necessary/Not Yet Critical (Years 2-5)
Correction: Replace carpet
Qty: 493-S.Y.
Estimate: \$43,361.91
Assessor Name: Dave Cunningham
Date Created: 01/21/2013

Notes: All carpet is worn and beyond expected service life

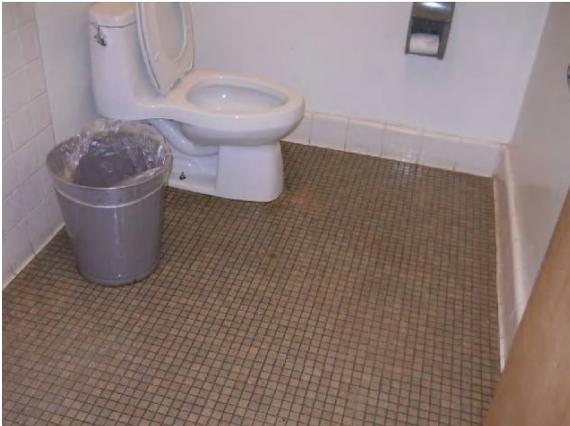
System: C3020210 - Ceramic Tile

Location: Ceramic Floor tile, Restrooms. Toilet 7, Toilet 8, Toilet 20. Approx 116 sq ft of ceramic floor tile in the building

Material: Ceramic Tile

Notes: Ceramic floor tile is beyond expected useful life

Correction: Replace 2" x 2" thin set ceramic tile floor

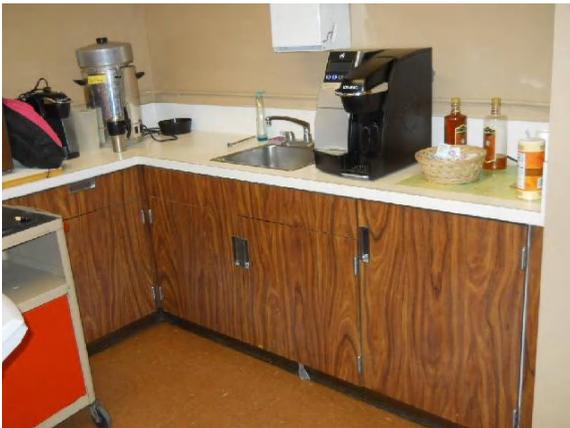
System: C3020410 - VCT

Location: Bld A-2 VCT floor covering, all rooms with VCT

Material: Vinyl

Notes: All VCT is worn and beyond expected useful service life

Correction: Replace VCT Flooring and Resilient Base

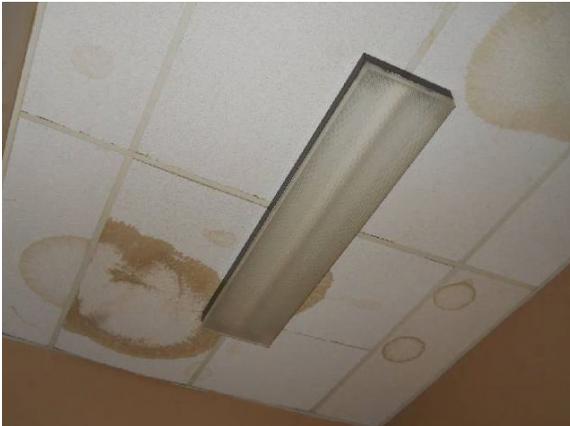
System: C3030 - Ceiling Finishes

Location: All ceiling finishes; approx. 97% are ceiling grid and acoustical tiles

Material: Acoustic Tile

Notes: All ceiling grid and tile systems are beyond expected service. Ceiling systems show damage and need to be replaced

Correction: Replace acoustic tile ceiling, non fire-rated

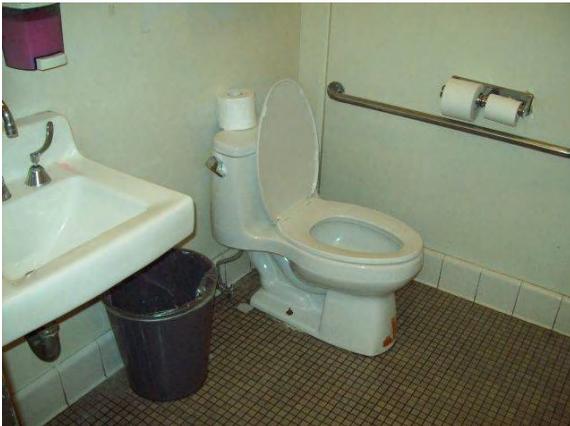
System: D2010 - Plumbing Fixtures

Location: System-Typical for all building locations.

Priority: 4 - Recommended (Years 6-10)

Notes: Plumbing fixtures are mostly original to building construction date of 1964 and therefore are beyond expected life. Recommend replacing system during next remodel or renovation.

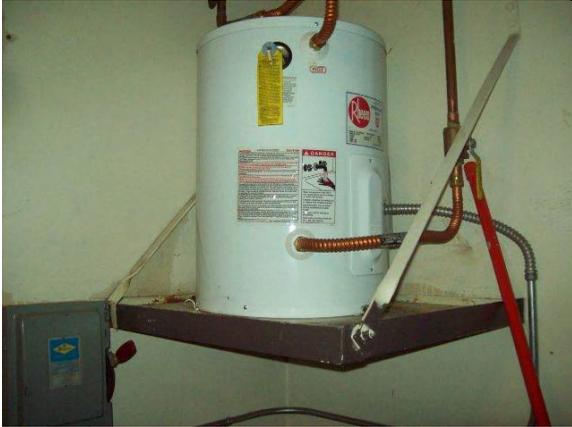
System: D2020 - Domestic Water Distribution

Location: System-Typical for all building locations.
Material: System
Distress: Beyond Expected Life
Category: Capital Renewal
Priority: 4 - Recommended (Years 6-10)
Correction: Renew System
Qty: 1-Ea.
Estimate: \$11,254.10
Assessor Name: Sonny Satterfield
Date Created: 01/26/2013

Notes: Recommend replacing system during next remodel or renovation, domestic hot water heater was replaced in 2009; however most piping was installed during the 1972 original construction.

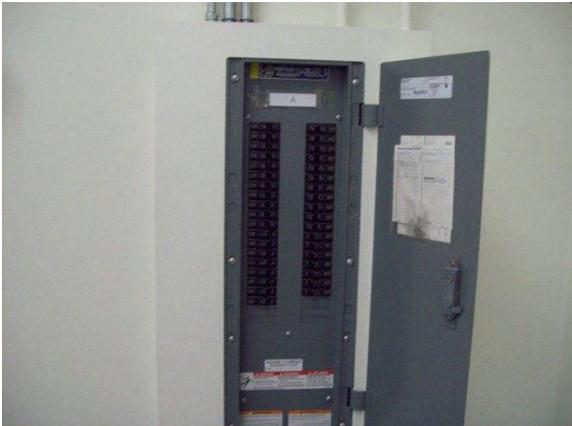
System: D5010 - Electrical Service/Distribution

Location: System-Typical for all building locations.
Material: System
Distress: Beyond Expected Life
Category: Capital Renewal
Priority: 4 - Recommended (Years 6-10)
Correction: Renew System
Qty: 1-Ea.
Estimate: \$56,947.43
Assessor Name: Sonny Satterfield
Date Created: 01/26/2013

Notes: The main electrical switchgear, distribution panel boards and feeders are mostly original to the building construction date of 1964 and therefore beyond expected life. The system is recommended to be replaced during the next major renovation.

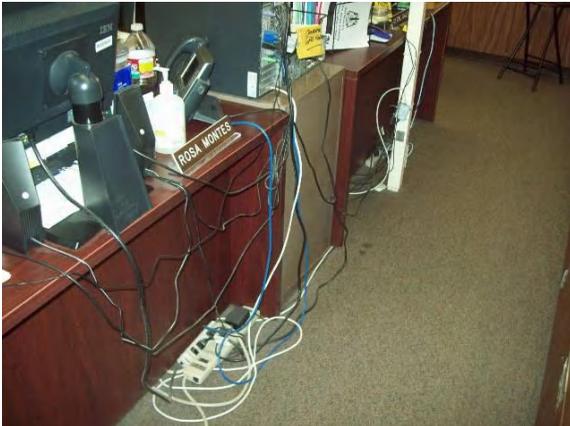
System: D5020 - Branch Wiring

Location: Typical for all building locations.
Material: System
Distress: Beyond Expected Life
Category: Capital Renewal
Priority: 4 - Recommended (Years 6-10)
Correction: Renew System
Qty: 1-Ea.
Estimate: \$169,742.26
Assessor Name: Sonny Satterfield
Date Created: 01/26/2013

Notes: The branch wiring, electrical panels and devices are mostly original to the building construction date of 1964 and therefore beyond expected life. The system is recommended to be replaced during the next major renovation.

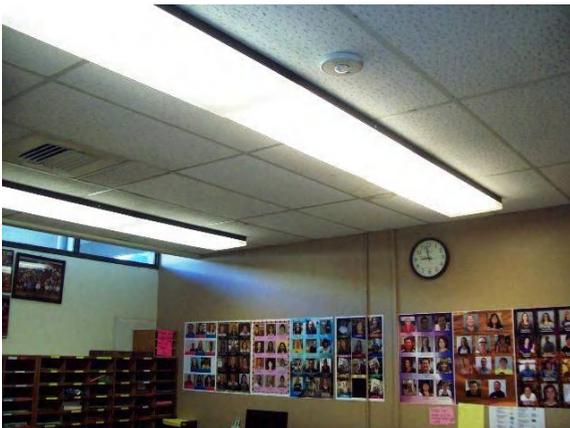
System: D5020 - Lighting

Location: System-Typical for all building locations.
Material: System
Distress: Beyond Expected Life
Category: Capital Renewal
Priority: 4 - Recommended (Years 6-10)
Correction: Renew System
Qty: 1-Ea.
Estimate: \$111,102.49
Assessor Name: Sonny Satterfield
Date Created: 01/26/2013

Notes: The building light fixtures, lamps and ballast were upgraded to T8 fluorescent type in 2008 in most classrooms; however we recommend replacing all lighting in the building during next remodel or renovation.

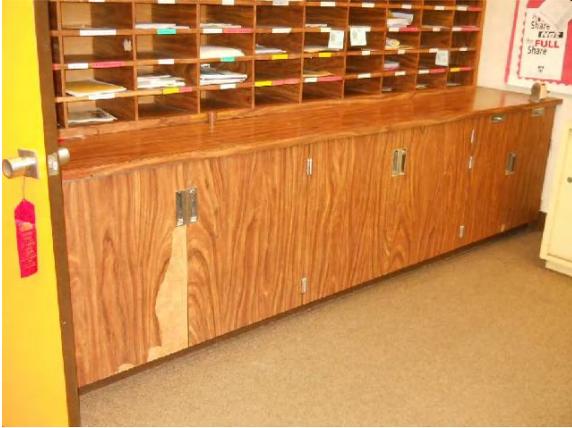
System: E2010 - Fixed Furnishings

Location: Health, Work Room, Copy Room, Reception, Consulting, Break Room
Material: Fixed Casework
Distress: Beyond Expected Life
Category: Deferred Maintenance
Priority: 3 - Necessary/Not Yet Critical (Years 2-5)
Correction: Replace Casework OUSD
Qty: 80-L.F.
Estimate: \$46,446.74
Assessor Name: Dave Cunningham
Date Created: 01/21/2013

Notes: Fixed Furnishings, built-in cabinets, reception desk, are showing damage, and are beyond their expected useful service life

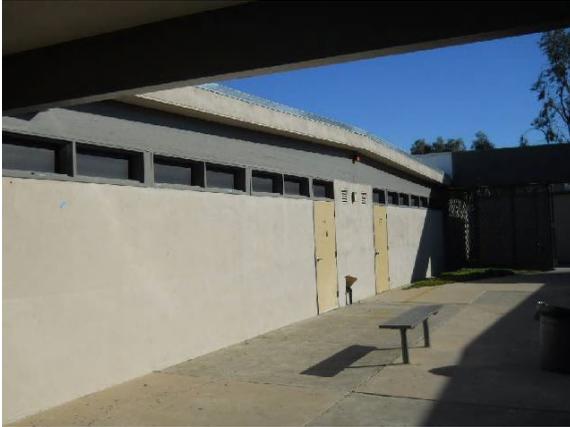
System: B2020 - Exterior Windows

Location: All exterior windows
Material: Steel Frame, Fixed
Distress: Beyond Expected Life
Category: Deferred Maintenance
Priority: 3 - Necessary/Not Yet Critical (Years 2-5)
Correction: Replace 2'-0" x 3'-0" steel frame window - 1st flr
Qty: 154-Ea.
Estimate: \$137,506.72
Assessor Name: Dave Cunningham
Date Created: 01/22/2013

Notes: All exterior window systems are beyond expected service life

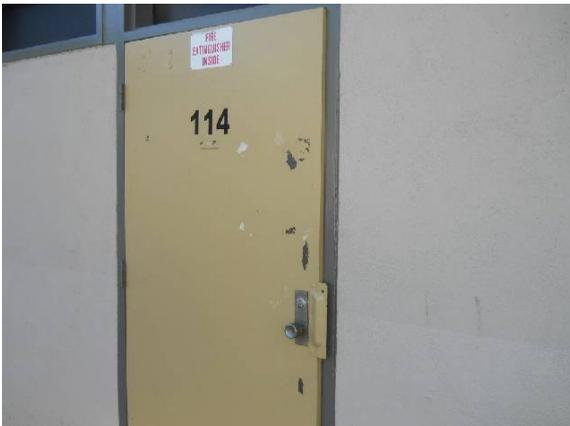
System: B2030 - Exterior Doors

Location: All exterior doors
Material: Steel, Unpainted
Distress: Beyond Expected Life
Category: Deferred Maintenance
Priority: 1 - Currently Critical (Immediate)
Correction: Repl. 3'-0" x 7'-0" steel, w/ safety glass, unptd.
Qty: 39-Ea.
Estimate: \$143,166.44
Assessor Name: Dave Cunningham
Date Created: 01/22/2013

Notes: All exterior door systems are original construction, beyond expected service life. Provide interior locking hardware at all classroom doors for security.

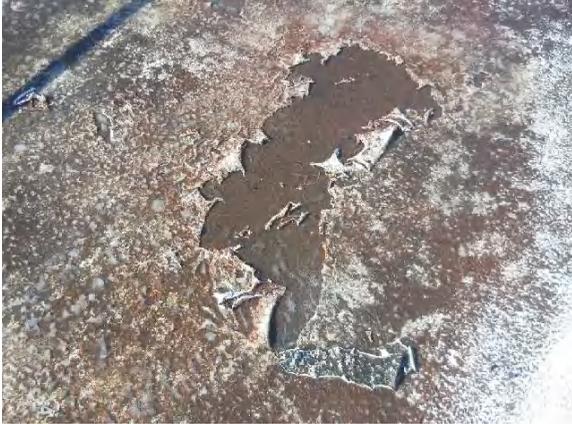
System: B3010105 - Built-Up

Location: Roof, several locations
Material: Built-Up Roofing
Distress: Damaged
Category: Deferred Maintenance
Priority: 2 - Potentially Critical (Year 1)
Correction: Minor membrane repairs - (2% of roof area) built-u
Qty: 10-Sq.
Estimate: \$1,472.26
Assessor Name: Dave Cunningham
Date Created: 01/22/2013

Notes: Roof reflective coating is not attached, water penetration under the coating

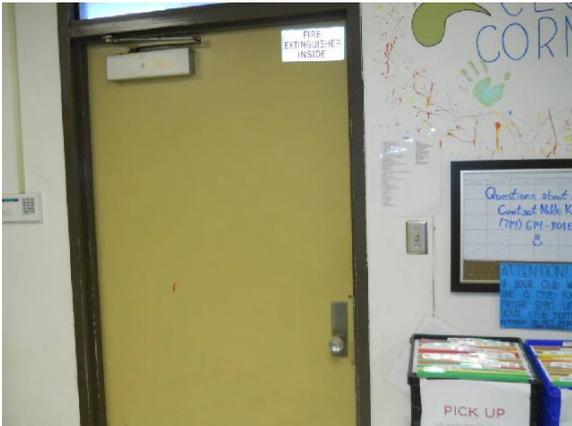
System: C1020 - Interior Doors

Location: All interior door systems
Material: Solid Core Interior Doors
Distress: Beyond Expected Life
Category: Deferred Maintenance
Priority: 1 - Currently Critical (Immediate)
Correction: Replace 3'-0" x 7'-0" solid core wood door interio
Qty: 13-Ea.
Estimate: \$29,705.27
Assessor Name: Dave Cunningham
Date Created: 01/22/2013

Notes: All interior door systems are original construction, beyond expected useful service life

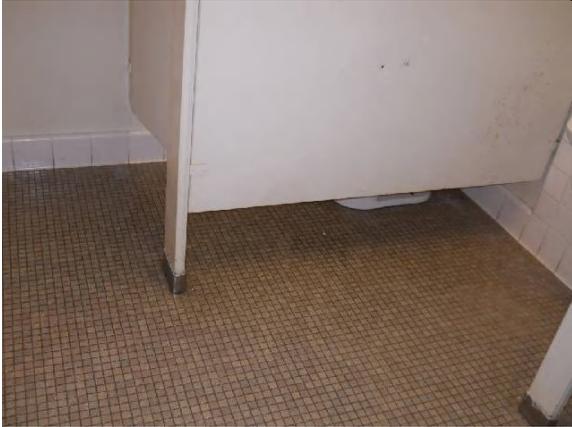
System: C1030 - Fittings

Location: Bld B-3 Restrooms
Material: Toilet Partitions
Distress: Beyond Expected Life
Category: Deferred Maintenance
Priority: 1 - Currently Critical (Immediate)
Correction: Toilet partitions,painted metal-overhead braced
Qty: 3-Ea.
Estimate: \$3,800.52
Assessor Name: Dave Cunningham
Date Created: 01/22/2013

Notes: Restroom partitions are beyond expected service life

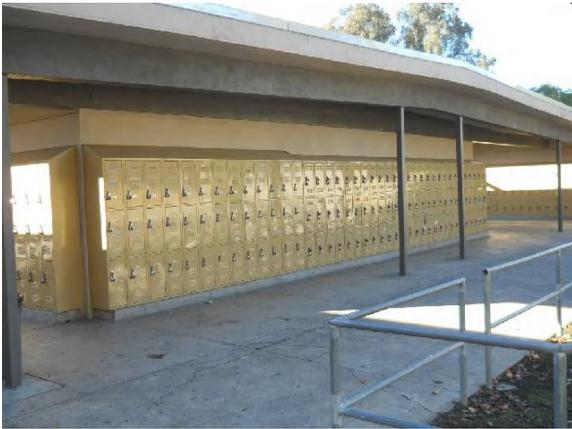
System: C1030 - Fittings

Location: Exterior hallways, circulation area
Material: Fixed Furnishings - Lockers
Distress: Beyond Expected Life
Category: Deferred Maintenance
Priority: 3 - Necessary/Not Yet Critical (Years 2-5)
Correction: Student lockers stacked 2-high
Qty: 800-Ea.
Estimate: \$265,340.16
Assessor Name: Dave Cunningham
Date Created: 01/22/2013

Notes: Most student lockers are original equipment, approx 800. Some 2-high and some 3-high locker units.

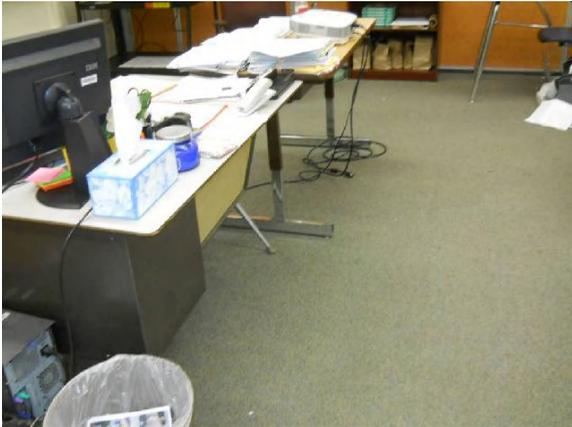
System: C3020210 - Carpet

Location: Rooms,
100.101,102A,102B,103,104,105A,105B,106,107,109,110,111,112,113,114,115,116,117,118,119,120,121,122,123
Material: Carpet
Distress: Beyond Expected Life
Category: Deferred Maintenance
Priority: 3 - Necessary/Not Yet Critical (Years 2-5)
Correction: Replace carpet
Qty: 2,575-S.Y.
Estimate: \$262,643.04
Assessor Name: Dave Cunningham
Date Created: 01/22/2013

Notes: All carpet is worn and beyond expected service life

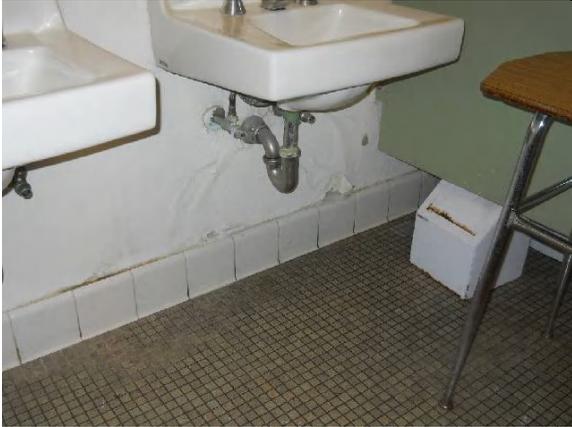
System: C3020210 - Ceramic Tile

Location: Bld B-3 Restrooms
Material: Ceramic Tile
Distress: Beyond Expected Life
Category: Deferred Maintenance
Priority: 1 - Currently Critical (Immediate)
Correction: Replace 2" x 2" thin set ceramic tile floor
Qty: 2-C.S.F.
Estimate: \$5,022.72
Assessor Name: Dave Cunningham
Date Created: 01/22/2013

Notes: Restroom ceramic floor tiles are beyond expected service life

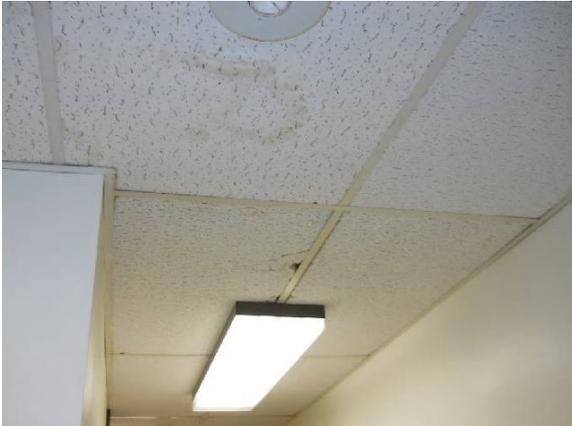
System: C3030 - Ceiling Finishes

Location: All rooms, except the Student Center Room in B-3.
Material: Acoustic Tile
Distress: Beyond Expected Life
Category: Deferred Maintenance
Priority: 1 - Currently Critical (Immediate)
Correction: Replace acoustic tile ceiling, non fire-rated
Qty: 284-C.S.F.
Estimate: \$189,348.48
Assessor Name: Dave Cunningham
Date Created: 01/22/2013

Notes: All ceiling grid and tile systems are beyond expected service life.

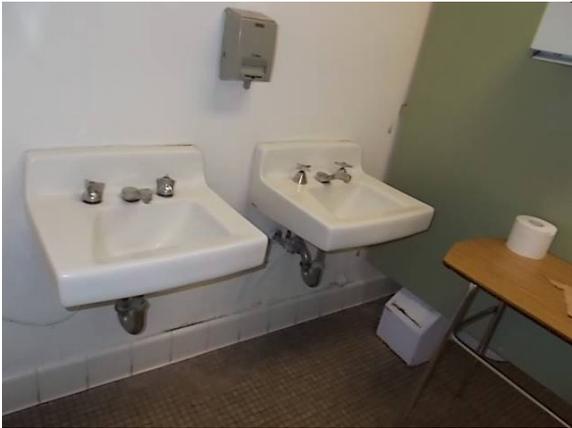
System: D2010 - Plumbing Fixtures

Location: System-Typical for all building locations, except student center.
Material: System
Distress: Beyond Expected Life
Category: Capital Renewal
Priority: 4 - Recommended (Years 6-10)
Correction: Renew System
Qty: 1-Ea.
Estimate: \$402,511.13
Assessor Name: Sonny Satterfield
Date Created: 01/29/2013

Notes: Plumbing fixtures are mostly original to building construction date of 1972, except Student Center, womwns staff restroom, the water closets were replaced in 2000. Recommend replacing entire system during next remodel or renovation.

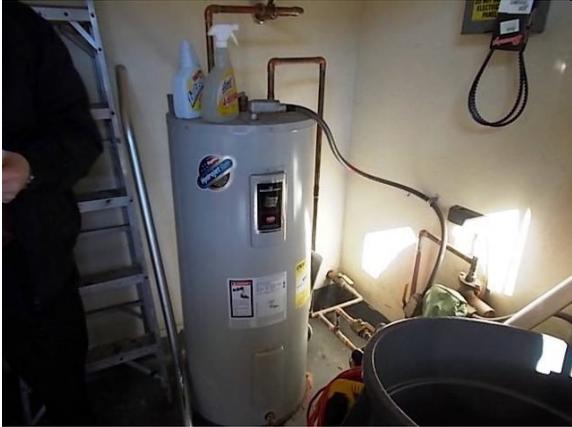
System: D2020 - Domestic Water Distribution

Location: System-Typical for all required building locations.
Material: System
Distress: Inadequate
Category: Capital Renewal
Priority: 4 - Recommended (Years 6-10)
Correction: Renew System
Qty: 1-Ea.
Estimate: \$352,985.15
Assessor Name: Sonny Satterfield
Date Created: 01/29/2013

Notes: Recommend replacing system during next remodel or renovation, domestic hot water was replaced in 2009, however hot water is currently furnished for custodial closets only.

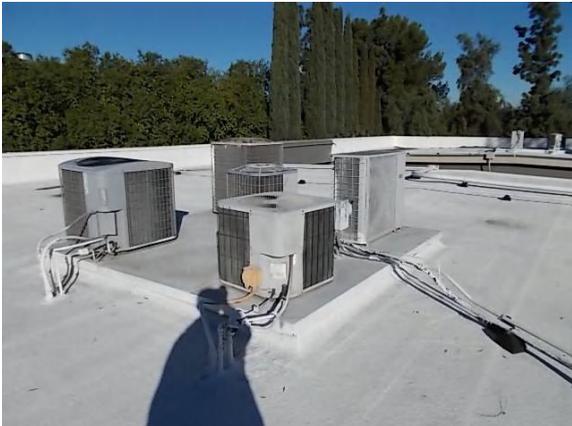
System: D3050 - Terminal & Package Units

Location: System-Typical for all building locations.
Material: System
Distress: Inadequate
Category: Capital Renewal
Priority: 4 - Recommended (Years 6-10)
Correction: Renew System
Qty: 1-Ea.
Estimate: \$995,021.91
Assessor Name: Sonny Satterfield
Date Created: 01/29/2013

Notes: The HVAC system was partially renewed in 2006 with (1) new rooftop package unit serving the Student Center; the classrooms have split systems A/C units with varying installation dates from 1995 to 2002; these units have a life expectancy of 15-years. Most of the air distribution duct and exhaust fans were installed in 1964 and beyond expected life. Fresh air supply to all areas and classrooms is inadequate. An engineering study by a PE is recommended for the HVAC System with recommendations for an integrated HVAC System, upgrades to fresh air intake and replacement of existing system, as required during the next major renovation.

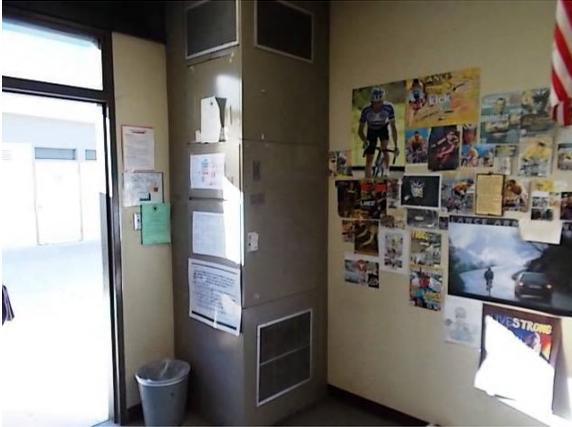
System: D3070 - Systems Testing & Balance

Location: Typical for all locations

Distress: Inadequate

Notes: The HVAC system was partially renewed in 2006 with (1) new rooftop package unit serving the Student Center; the classrooms have split systems A/C units with varying installation dates from 1995 to 2002; these units have a life expectancy of 15-years. Most of the air distribution duct and exhaust fans were installed in 1964 and beyond expected life. Fresh air supply to all areas and classrooms is inadequate. An engineering study by a PE is recommended for the HVAC System with recommendations for an integrated HVAC System, upgrades to fresh air intake and replacement of existing system, as required during the next major renovation.

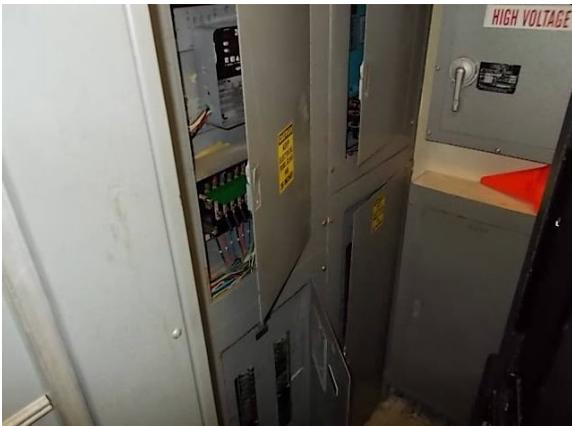
System: D5020 - Branch Wiring

Location: System-Typical for all building locations.
Material: System
Distress: Beyond Expected Life
Category: Capital Renewal
Priority: 4 - Recommended (Years 6-10)
Correction: Renew System
Qty: 1-Ea.
Estimate: \$922,533.89
Assessor Name: Sonny Satterfield
Date Created: 01/29/2013

Notes: The branch wiring, electrical panels and devices are mostly original to the building construction date of 1972 and therefore beyond expected life. The system is recommended to be replaced during the next major renovation.

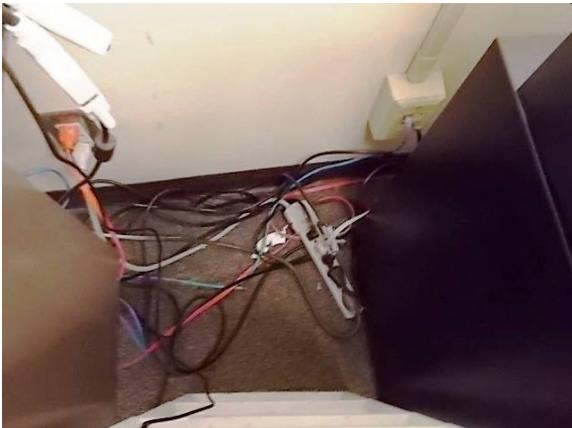
System: D5030920 - LAN System

Location: System-Typical for all building locations.
Material: Lan System
Distress: Inadequate
Category: Capital Renewal
Priority: 4 - Recommended (Years 6-10)
Correction: Replace LAN System Drop CAT6
Qty: 80-Ea.
Estimate: \$31,387.97
Assessor Name: Sonny Satterfield
Date Created: 01/29/2013

Notes: Most of the existing LAN/VOIP outlets will require new drops or relocation and enhancement during next building renovation.

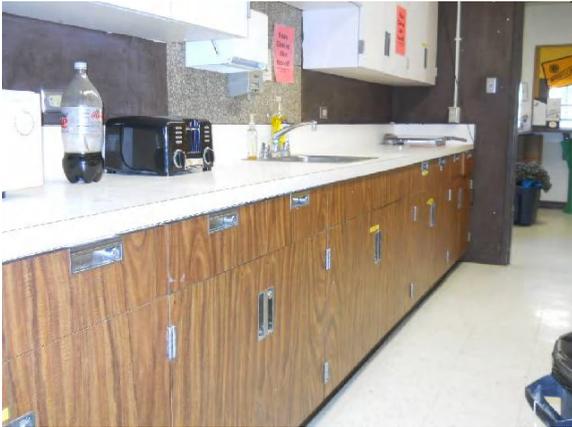
System: E2010 - Fixed Furnishings

Location: Bld B-3 Student Center, Work room, teacher lounge, Rm 122
Material: Fixed Casework
Distress: Beyond Expected Life
Category: Deferred Maintenance
Priority: 3 - Necessary/Not Yet Critical (Years 2-5)
Correction: Replace Casework OUSD
Qty: 60-L.F.
Estimate: \$32,073.41
Assessor Name: Dave Cunningham
Date Created: 01/22/2013

Notes: Built in Casework / cabinets are beyond expected service life. Approx 60 l.f.

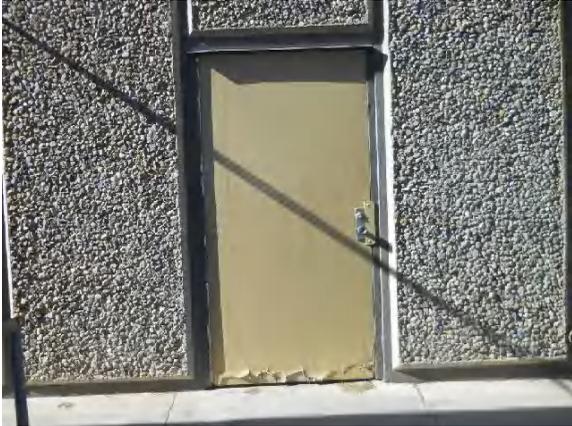
System: B2030 - Exterior Doors

Location: All exterior doors
Material: System
Distress: Beyond Expected Life
Category: Deferred Maintenance
Priority: 3 - Necessary/Not Yet Critical (Years 2-5)
Correction: Renew System
Qty: 1-Ea.
Estimate: \$136,690.23
Assessor Name: Dave Cunningham
Date Created: 01/23/2013

Notes: All exterior doors are original construction. Provide interior locking hardware at all classroom doors for security. Doors are beyond expected useful service life. 29 exterior doors.

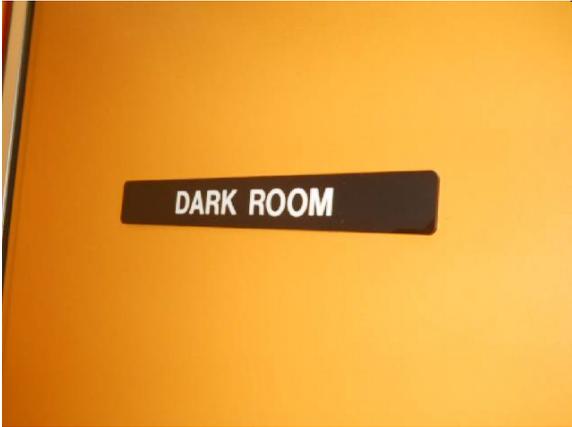
System: C1020 - Interior Doors

Location: All interior door systems
Material: System
Distress: Beyond Expected Life
Category: Deferred Maintenance
Priority: 3 - Necessary/Not Yet Critical (Years 2-5)
Correction: Renew System
Qty: 1-Ea.
Estimate: \$42,431.56
Assessor Name: Dave Cunningham
Date Created: 01/23/2013

Notes: All interior door systems are original construction and beyond expected service life. 15 interior door systems

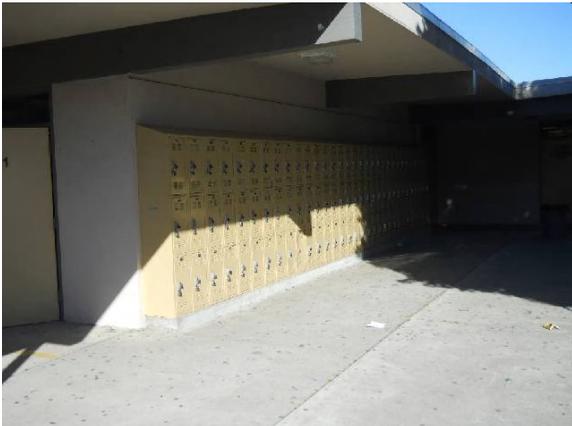
System: C1030 - Fittings

Location: Exterior hallways, circulation area
Material: Fixed Furnishings - Lockers
Distress: Beyond Service Life
Category: Deferred Maintenance
Priority: 3 - Necessary/Not Yet Critical (Years 2-5)
Correction: Student lockers stacked 2-high
Qty: 900-Ea.
Estimate: \$298,507.68
Assessor Name: Dave Cunningham
Date Created: 01/23/2013

Notes: Student lockers are original construction, beyond expected service life. Total of 900 lockers associated with this building.

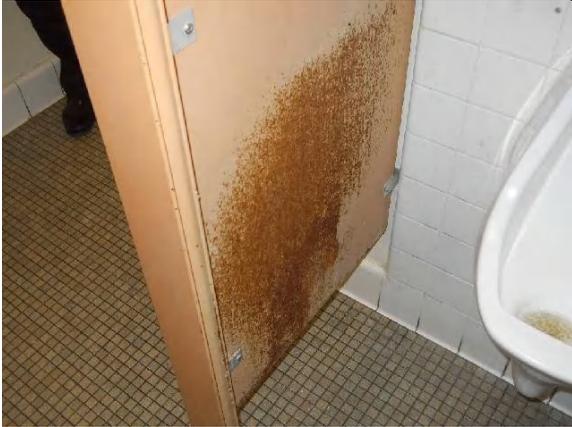
System: C1030 - Fittings

Location: Womens 15, Mens 16
Material: Toilet Partitions
Distress: Beyond Expected Life
Category: Deferred Maintenance
Priority: 4 - Recommended (Years 6-10)
Correction: Replace toilet partitions and accessories
OUSD
Qty: 11-Ea.
Estimate: \$9,372.96
Assessor Name: Dave Cunningham
Date Created: 01/25/2013

Notes: Restroom partitions and fittings are beyond expected service life. Recommend replacement during school renovation.

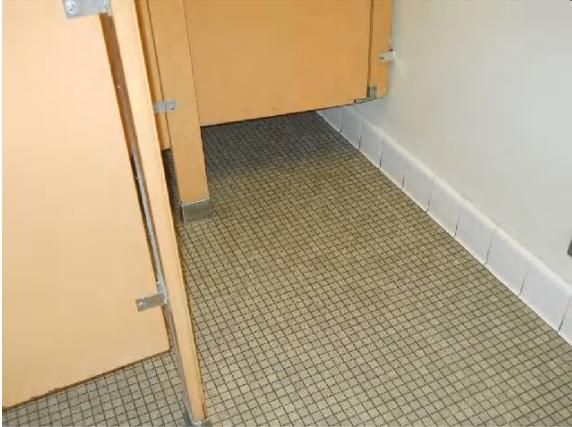
System: C3020210 - Ceramic Tile

Location: Restrooms; Boys 04, Girls 05, Girls 20, Boys 21, Men 16, Women 15

Notes: Ceramic tile floors are original construction, beyond expected service life. Recommend replacement during next school renovation.

Correction: Replace 2" x 2" thin set ceramic tile floor

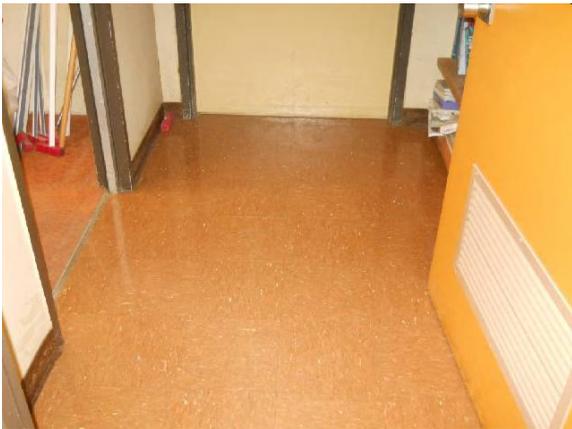
System: C3020410 - VCT

Location: Science Classrooms, storage rooms

Notes: VCT is original construction. Recommend replacement during school renovations

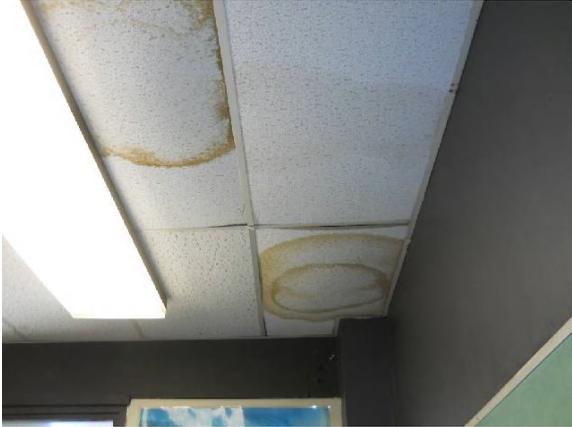
System: C3030 - Ceiling Finishes

Location: All rooms except Classroom 208 and Staff Lounge
Material: System
Distress: Beyond Service Life
Category: Capital Renewal
Priority: 3 - Necessary/Not Yet Critical (Years 2-5)
Correction: Renew System
Qty: 1-Ea.
Estimate: \$480,992.02
Assessor Name: Dave Cunningham
Date Created: 01/23/2013

Notes: All grid and acoustical tile ceiling systems are beyond expected useful service life. Painted hard-deck ceilings in restrooms need to be resurfaced and painted. Recommend replacement during next school renovation.

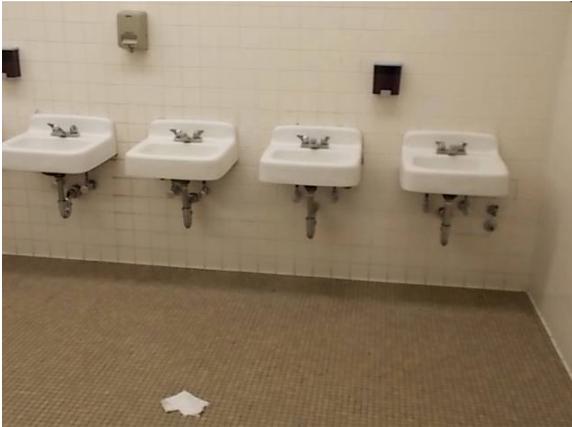
System: D2010 - Plumbing Fixtures

Location: System-Typical for all required building locations.
Material: System
Distress: Beyond Expected Life
Category: Capital Renewal
Priority: 4 - Recommended (Years 6-10)
Correction: Renew System
Qty: 1-Ea.
Estimate: \$236,101.31
Assessor Name: Sonny Satterfield
Date Created: 01/29/2013

Notes: Plumbing fixtures are mostly original to building construction date of 1972 except the water closets in the boys and girls toilets and urinals, which were replaced in 2005; the balance of the plumbing fixtures are beyond expected life. Recommend replacing system during next remodel or renovation. Also see science lab casework for additional plumbing fixture deficiencies; the sinks and faucets are included in the classroom casework costs but the rough-in and trim out costs are included here in this deficiency.

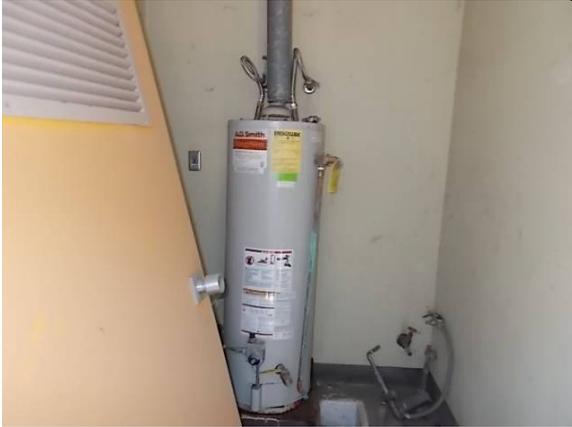
System: D2020 - Domestic Water Distribution

Location: Typical for all locations
Material: System
Distress: Beyond Expected Life
Category: Capital Renewal
Priority: 4 - Recommended (Years 6-10)
Correction: Renew System
Qty: 1-Ea.
Estimate: \$207,005.39
Assessor Name: Sonny Satterfield
Date Created: 01/29/2013

Notes: Recommend replacing system during next remodel or renovation, (2) domestic hot water heaters were replaced in 2007 and currently working properly; however most domestic water piping was installed during the 1972 original construction. New Science classroom case work will require new plumbing supply.

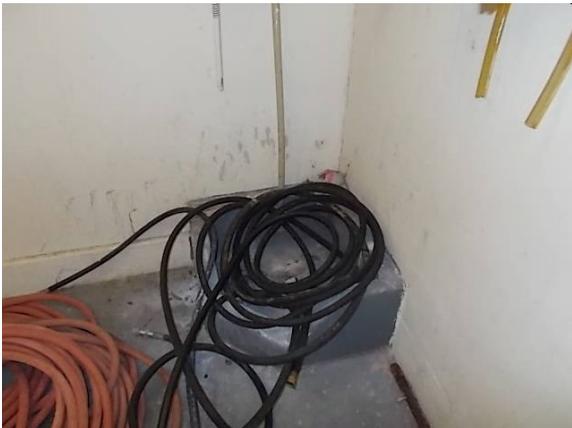
System: D2030 - Sanitary Waste

Location: System-Typical for all locations
Material: System
Distress: Beyond Expected Life
Category: Capital Renewal
Priority: 4 - Recommended (Years 6-10)
Correction: Renew System
Qty: 1-Ea.
Estimate: \$132,144.00
Assessor Name: Sonny Satterfield
Date Created: 01/29/2013

Notes: Recommend replacing all above grade sanitary waste and vent piping system during next remodel or renovation; below grade waste piping, recommend video inspection and replace as required.

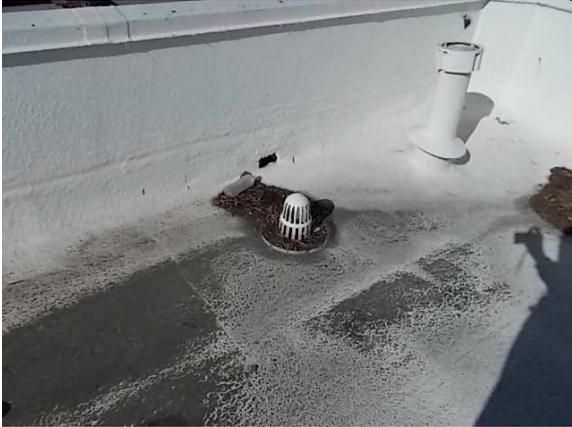
System: D2040 - Rain Water Drainage

Location: Typical for all locations
Material: System
Distress: Beyond Expected Life
Category: Capital Renewal
Priority: 4 - Recommended (Years 6-10)
Correction: Renew System
Qty: 1-Ea.
Estimate: \$21,518.86
Assessor Name: Sonny Satterfield
Date Created: 01/29/2013

Notes: Recommend replacing system during next remodel or renovation.

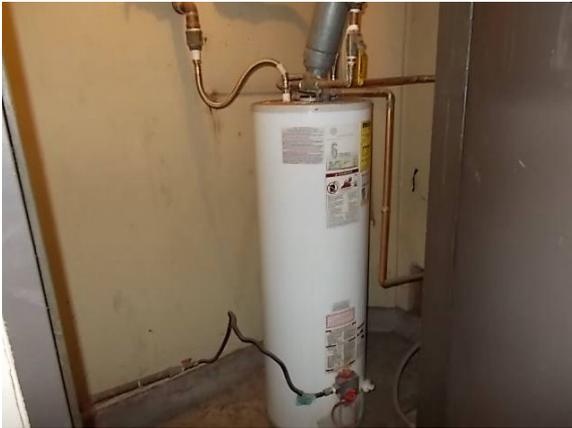
System: D2090 - Other Plumbing Systems-Nat Gas

Location: System-Typical for all required building locations.
Material: System
Distress: Beyond Expected Life
Category: Capital Renewal
Priority: 4 - Recommended (Years 6-10)
Correction: Renew System
Qty: 1-Ea.
Estimate: \$36,066.82
Assessor Name: Sonny Satterfield
Date Created: 01/29/2013

Notes: Recommend replacing system during next remodel or renovation.

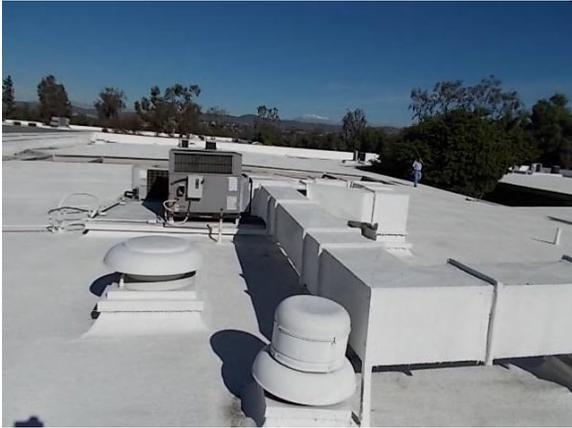
System: D3040 - Distribution Systems

Location: Typical for all locations
Material: System
Distress: Beyond Expected Life
Category: Capital Renewal
Priority: 4 - Recommended (Years 6-10)
Correction: Renew System
Qty: 1-Ea.
Estimate: \$526,151.32
Assessor Name: Sonny Satterfield
Date Created: 01/29/2013

Notes: A new HVAC distribution system with exhaust and fresh air intake supply will be required for proper indoor air quality to be maintained in classrooms. The HVAC system was partially renewed in 2006 with (1) new rooftop package unit serving the Student Center; the classrooms have split systems A/C units with varying installation dates from 1995 to 2002; these units have a life expectancy of 15-years. Most of the air distribution duct and exhaust fans were installed in 1964 and beyond expected life. Fresh air supply to all areas and classrooms is inadequate. An engineering study by a PE is recommended for the HVAC System with recommendations for an integrated HVAC System, upgrades to fresh air intake and replacement of existing system, as required during the next major renovation.

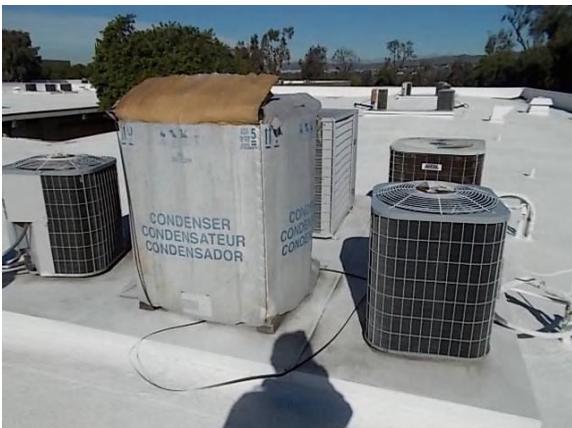
System: D3050 - Terminal & Package Units

Location: System-Typical for all building locations.
Material: System
Distress: Inadequate
Category: Capital Renewal
Priority: 4 - Recommended (Years 6-10)
Correction: Renew System
Qty: 1-Ea.
Estimate: \$583,130.85
Assessor Name: Sonny Satterfield
Date Created: 01/29/2013

Notes: The HVAC system is renewed when roof mounted condensers stop working. A rooftop package unit serving the Staff Lounge was replaced in 2000; the classrooms mostly have split systems A/C units with varying installation dates from 1998 to 2002; these units have a life expectancy of 15-years. Most of the air distribution duct and exhaust fans were installed in 1964 and beyond expected life. Fresh air supply to all areas and classrooms is inadequate. An engineering study by a PE is recommended for the HVAC System with recommendations for an integrated HVAC System, upgrades to fresh air intake and replacement of existing system, as required during the next major renovation.

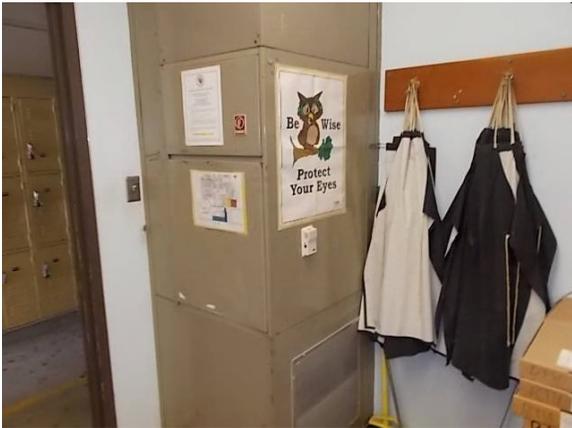
System: D3060 - Controls & Instrumentation

Location: Typical for all locations

Priority: 4 - Recommended (Years 6-10)

Notes: The HVAC System is recommended for new DDC controls during the next major renovation; the HVAC system is renewed when roof mounted condensers stop working. A rooftop package unit serving the Staff Lounge was replaced in 2000; the classrooms mostly have split systems A/C units with varying installation dates from 1998 to 2002; these units have a life expectancy of 15-years. Most of the air distribution duct and exhaust fans were installed in 1964 and beyond expected life. Fresh air supply to all areas and classrooms is inadequate. An engineering study by a PE is recommended for the HVAC System with recommendations for an integrated HVAC System, upgrades to fresh air intake and replacement of existing system, as required during the next major renovation.

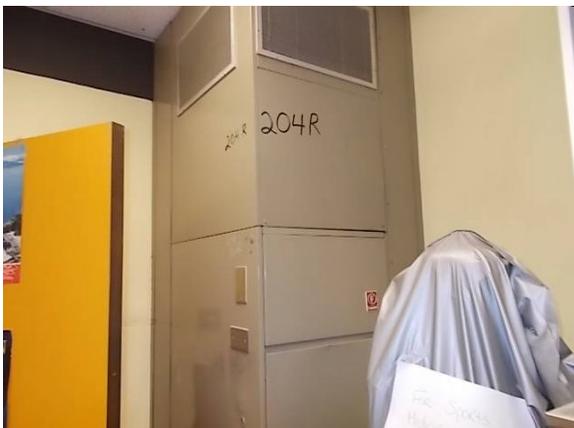
System: D3070 - Systems Testing & Balance

Location: Typical for all locations

Distress: Inadequate

Priority: 4 - Recommended (Years 6-10)

Notes: The HCAC System will require Systems Testing & Balance during the next major renovation; the HVAC system is renewed when roof mounted condensers stop working. A rooftop package unit serving the Staff Lounge was replaced in 2000; the classrooms mostly have split systems A/C units with varying installation dates from 1998 to 2002; these units have a life expectancy of 15-years. Most of the air distribution duct and exhaust fans were installed in 1964 and beyond expected life. Fresh air supply to all areas and classrooms is inadequate. An engineering study by a PE is recommended for the HVAC System with recommendations for an integrated HVAC System, upgrades to fresh air intake and replacement of existing system, as required during the next major renovation.
