Orange Unified School District

Facilities Condition Assessment for:

**Canyon High School
220 S. Imperial Highway
Anaheim, CA 92807**

Campus Report

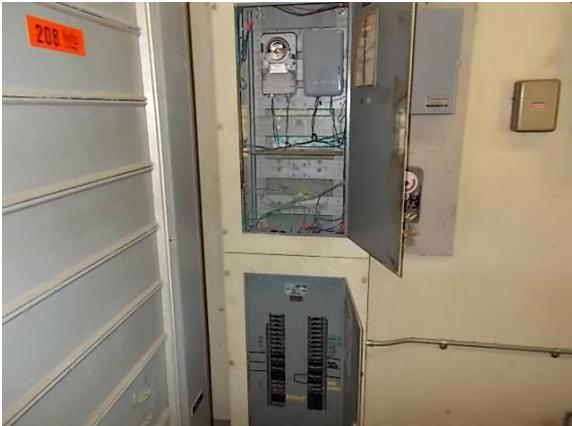
System: D5020 - Branch Wiring

Location: System-Typical for all building locations.
Material: System
Distress: Beyond Expected Life
Category: Capital Renewal
Priority: 4 - Recommended (Years 6-10)
Correction: Renew System
Qty: 1-Ea.
Estimate: \$540,699.29
Assessor Name: Sonny Satterfield
Date Created: 01/29/2013

Notes: The branch wiring, electrical panels and devices are mostly original to the building construction date of 1972 and therefore beyond expected life. The system is recommended to be replaced during the next major renovation.

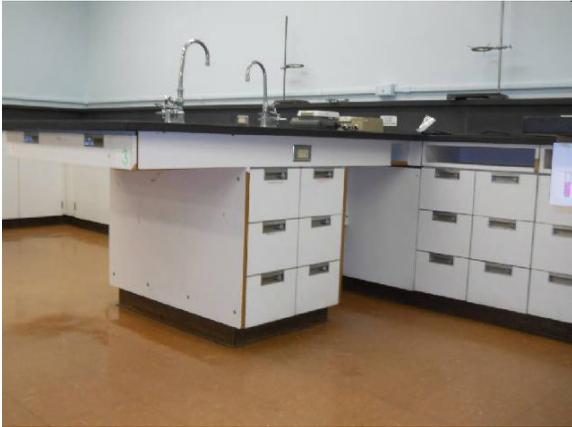
System: E1020 - Institutional Equipment

Location: Science Classrooms; 203, 204, 205, 206
Material: Laboratory Equipment OUSD
Distress: Beyond Expected Life
Category: Deferred Maintenance
Priority: 4 - Recommended (Years 6-10)
Correction: Replace science laboratory fixed casework
Qty: 6,050-S.F.
Estimate: \$311,628.24
Assessor Name: Dave Cunningham
Date Created: 01/24/2013

Notes: All science room lab equipment is original aged and beyond expected service life. Recommend replacement as part of school renovation.

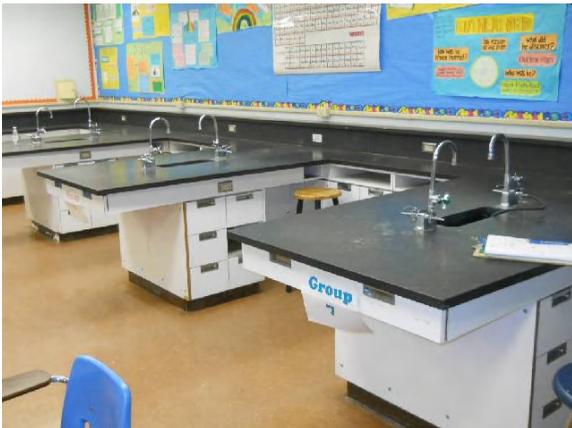
System: E1020 - Institutional Equipment

Location: Classrooms 203, 204, 205, 206
Material: Laboratory Equipment OUSD
Distress: Beyond Expected Life
Category: Deferred Maintenance
Priority: 4 - Recommended (Years 6-10)
Correction: Replace science laboratory fixed casework
Qty: 27-S.F.
Estimate: \$1,390.74
Assessor Name: Dave Cunningham
Date Created: 01/25/2013

Notes: Science lab benches are original equipment, beyond expected service life. Recommend replacement during school renovation.

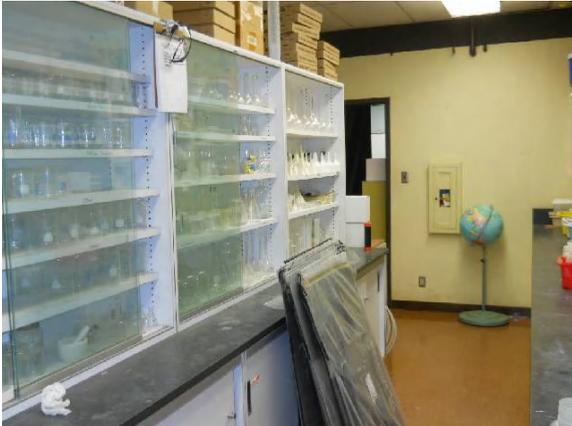
System: E2010 - Fixed Furnishings

Location: Lecture Room, Staff Lounge, Main Science Storage
Material: Fixed Casework
Distress: Beyond Expected Life
Category: Deferred Maintenance
Priority: 3 - Necessary/Not Yet Critical (Years 2-5)
Correction: Replace Casework OUSD
Qty: 118-L.F.
Estimate: \$99,854.99
Assessor Name: Dave Cunningham
Date Created: 01/23/2013

Notes: Built in storage systems are original construction. Systems are beyond expected service life. Recommend replacement during next school renovation.

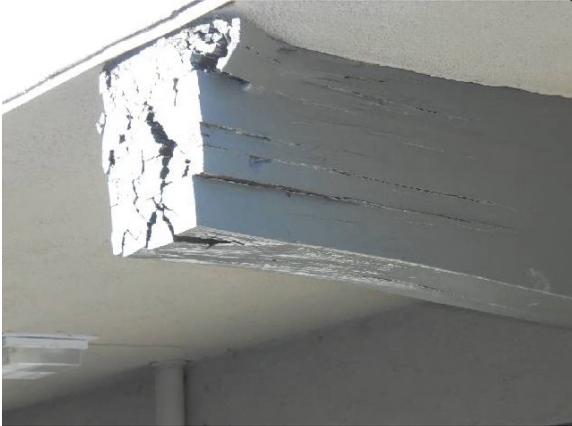
System: B1020 - Roof Construction

Location: Roof
Material: Professional Sevcies Study
Distress: Damaged
Category: Safety
Priority: 3 - Necessary/Not Yet Critical (Years 2-5)
Correction: Professional Structural Engineer Analysis
Qty: 1-Each
Estimate: \$37,254.79
Assessor Name: Dave Cunningham
Date Created: 01/23/2013

Notes: Wood roof beams have termite damage. Roof has partial collapse over one of the beams. Recommend a professional engineering study of the entire roof construction integrity

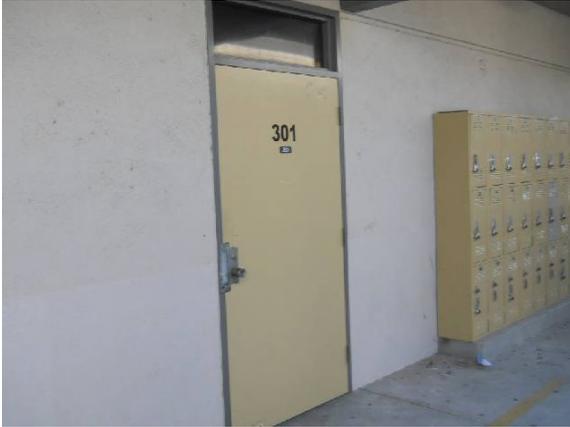
System: B2030 - Exterior Doors

Location: All exterior doors, 14 each
Material: System
Distress: Beyond Service Life
Category: Deferred Maintenance
Priority: 3 - Necessary/Not Yet Critical (Years 2-5)
Correction: Renew System
Qty: 1-Ea.
Estimate: \$74,783.02
Assessor Name: Dave Cunningham
Date Created: 01/23/2013

Notes: All exterior doors are original construction. Provide interior locking hardware at all classroom doors for security. Beyond expected useful service life. Recommend replacement during school renovation.

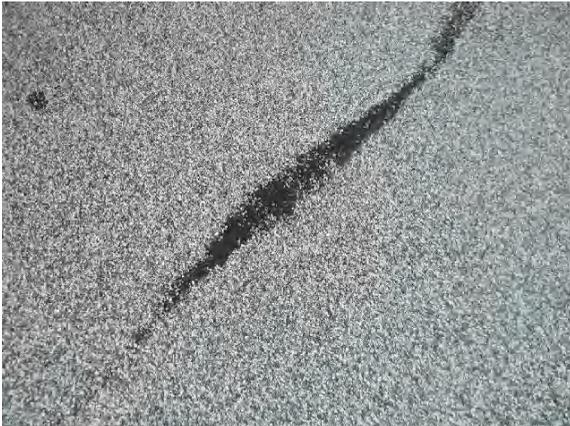
System: B3010105 - Built-Up

Location: Roof
Material: System
Distress: Beyond Service Life
Category: Deferred Maintenance
Priority: 3 - Necessary/Not Yet Critical (Years 2-5)
Correction: Renew System
Qty: 1-Ea.
Estimate: \$220,909.77
Assessor Name: Dave Cunningham
Date Created: 01/23/2013

Notes: Roof is 27 years old, beyond expected service life. Numerous roof leaks reported in this building.

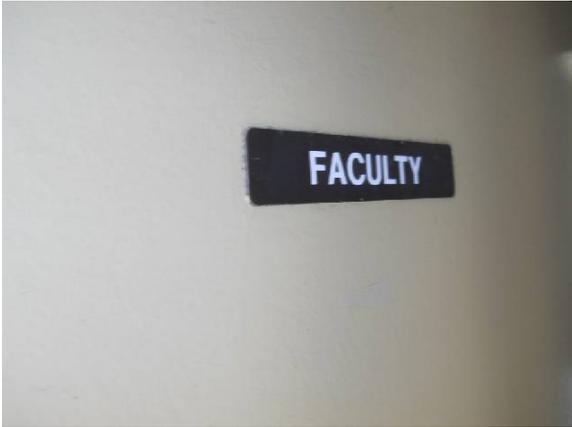
System: C1020 - Interior Doors

Location: All interior door systems, 9 each
Material: System
Distress: Beyond Service Life
Category: Deferred Maintenance
Priority: 3 - Necessary/Not Yet Critical (Years 2-5)
Correction: Renew System
Qty: 1-Ea.
Estimate: \$44,527.58
Assessor Name: Dave Cunningham
Date Created: 01/23/2013

Notes: All interior door systems are original construction, beyond expected service life. Recommend replacement during next school renovation

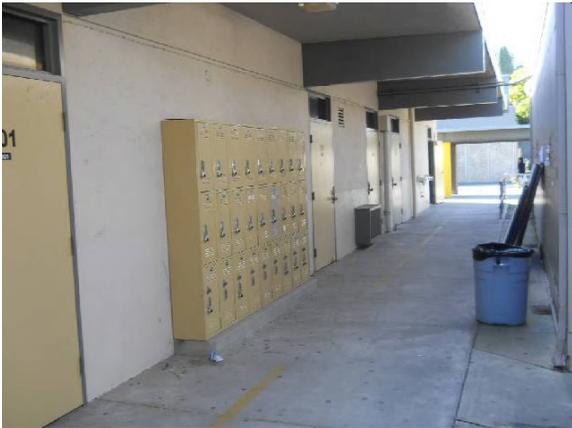
System: C1030 - Fittings

Location: Exterior hallways, circulation area
Material: Fixed Furnishings - Lockers
Distress: Beyond Service Life
Category: Deferred Maintenance
Priority: 3 - Necessary/Not Yet Critical (Years 2-5)
Correction: Student lockers stacked 2-high
Qty: 60-Ea.
Estimate: \$19,900.51
Assessor Name: Dave Cunningham
Date Created: 01/23/2013

Notes: Student lockers are original equipment, beyond expected service life

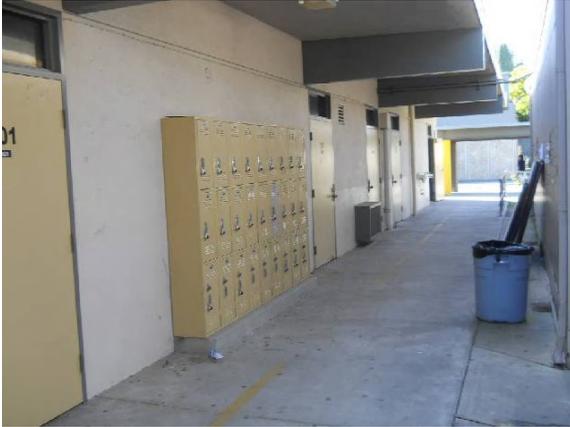
System: C1030 - Fittings

Location: Exterior hallways, circulation area
Material: System
Distress: Beyond Service Life
Category: Deferred Maintenance
Priority: 3 - Necessary/Not Yet Critical (Years 2-5)
Correction: Renew System
Qty: 1-Ea.
Estimate: \$64,707.29
Assessor Name: Dave Cunningham
Date Created: 01/23/2013

Notes: Student lockers are beyond expected useful life. Recommend replacement during the next school renovation. Approx 140 lockers associated with this building

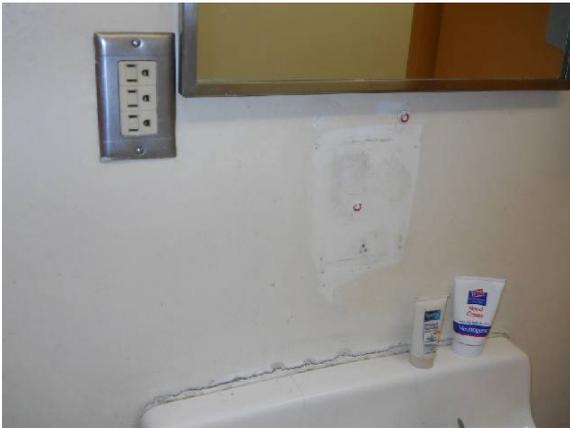
System: C3010 - Wall Finishes

Location: All rooms throughout the building
Material: System
Distress: Beyond Service Life
Category: Deferred Maintenance
Priority: 3 - Necessary/Not Yet Critical (Years 2-5)
Correction: Renew System
Qty: 1-Ea.
Estimate: \$135,154.74
Assessor Name: Dave Cunningham
Date Created: 01/23/2013

Notes: All wall surfaces need painted, patched as necessary. CMU painting, vinyl wall coverings, and ceramic tile in the restroom

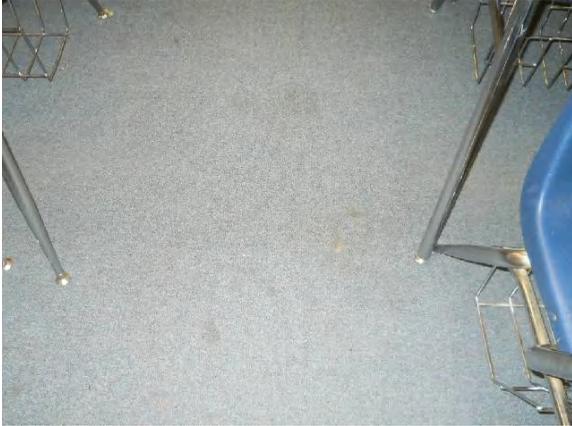
System: C3020210 - Carpet

Location: Classrooms 304, 305
Material: Carpet
Distress: Beyond Service Life
Category: Deferred Maintenance
Priority: 3 - Necessary/Not Yet Critical (Years 2-5)
Correction: Replace carpet
Qty: 266-S.Y.
Estimate: \$26,577.33
Assessor Name: Dave Cunningham
Date Created: 01/23/2013

Notes: Carpet is worn and beyond expected useful service life. Recommend replacement during the next school renovation.

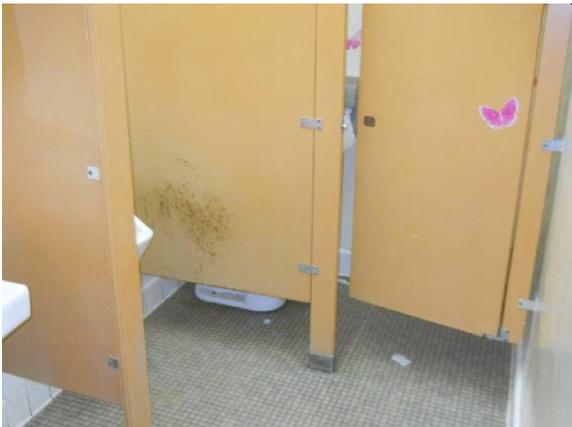
System: C3020210 - Ceramic Tile

Location: Toilet 10
Material: System
Distress: Beyond Service Life
Category: Deferred Maintenance
Priority: 3 - Necessary/Not Yet Critical (Years 2-5)
Correction: Renew System
Qty: 1-Ea.
Estimate: \$2,423.68
Assessor Name: Dave Cunningham
Date Created: 01/23/2013

Notes: Restroom floor tile is original construction, beyond expected service life. Approx 65 sq ft

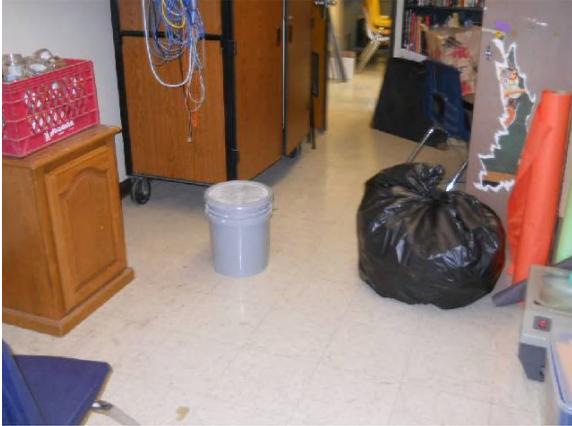
System: C3020410 - VCT

Location: Classroom 303, Teacher Lounge, office 12
all have original VCT. Classroom 302 VCT
replaced in 2006

Notes: VCT floor covering is beyond expected service life, recommend replacement during next school renovation.

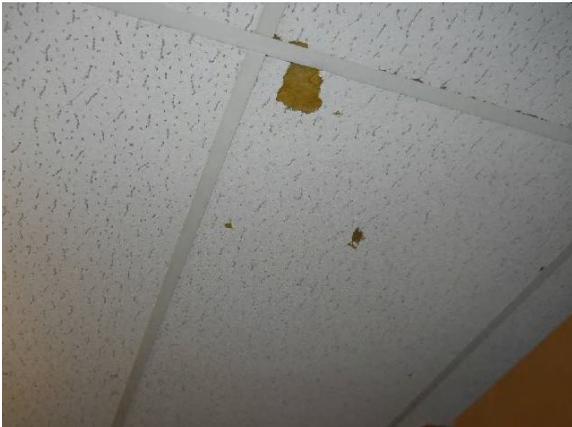
System: C3030 - Ceiling Finishes

Location: All rooms except classroom 302

Notes: Ceiling grid and accoustical tile system is beyond expected service life, recommend replacement during next school renovation

Correction: Replace acoustic tile ceiling, non fire-rated

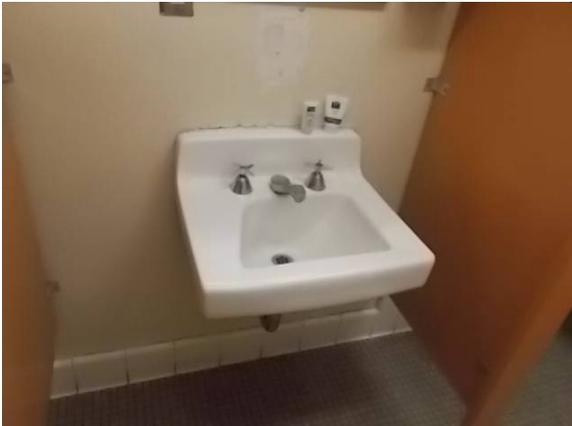
System: D2010 - Plumbing Fixtures

Location: System-Typical for all building locations.
Material: System
Distress: Beyond Expected Life
Category: Capital Renewal
Priority: 4 - Recommended (Years 6-10)
Correction: Renew System
Qty: 1-Ea.
Estimate: \$117,803.79
Assessor Name: Sonny Satterfield
Date Created: 01/29/2013

Notes: Plumbing fixtures are mostly original to building construction date of 1972 and therefore are beyond expected life. Recommend replacing system during next remodel or renovation.

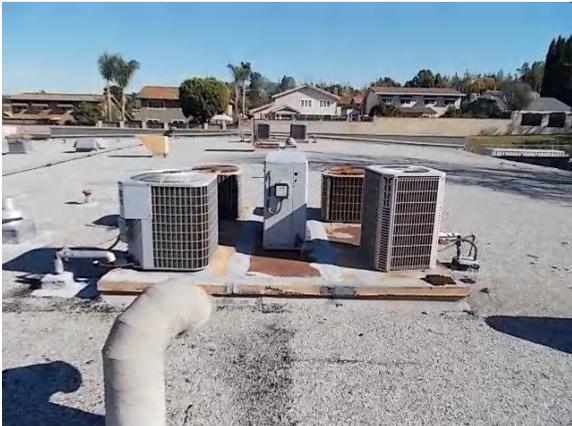
System: D3050 - Terminal & Package Units

Location: System-Typical for all building locations.
Material: System
Distress: Beyond Expected Life
Category: Capital Renewal
Priority: 4 - Recommended (Years 6-10)
Correction: Renew System
Qty: 1-Ea.
Estimate: \$291,052.33
Assessor Name: Sonny Satterfield
Date Created: 01/29/2013

Notes: The HVAC system is renewed when roof mounted condensers stop working; the classrooms mostly have split system A/C units with varying installation dates from 1998 to 2000; these units have a life expectancy of 15-years. Most of the air distribution duct and exhaust fans were installed in 1964 and beyond expected life. Fresh air supply to all areas and classrooms is inadequate. An engineering study by a PE is recommended for the HVAC System with recommendations for an integrated HVAC System, upgrades to fresh air intake and replacement of existing system, as required during the next major renovation.

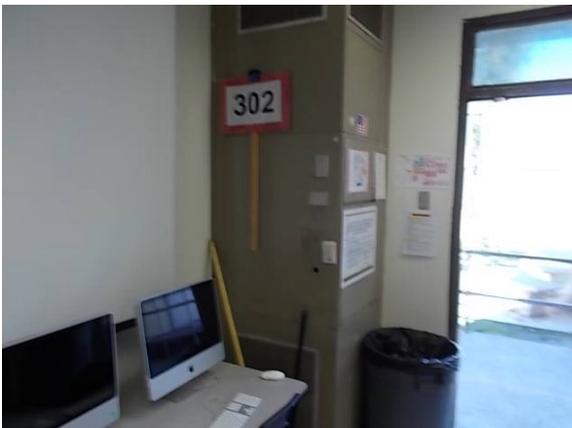
System: D3060 - Controls & Instrumentation

Location: System-Typical for all building locations.
Material: System
Distress: Beyond Expected Life
Category: Capital Renewal
Priority: 4 - Recommended (Years 6-10)
Correction: Renew System
Qty: 1-Ea.
Estimate: \$64,968.20
Assessor Name: Sonny Satterfield
Date Created: 01/29/2013

Notes: The HVAC System is recommended for new DDC controls with Testing & Balancing and IAQ tests during the next major renovation. Fresh air supply to all areas and classrooms is inadequate. An engineering study by a PE is recommended for the HVAC System with recommendations for an integrated HVAC System, upgrades to fresh air intake and replacement of existing system, as required during the next major renovation.

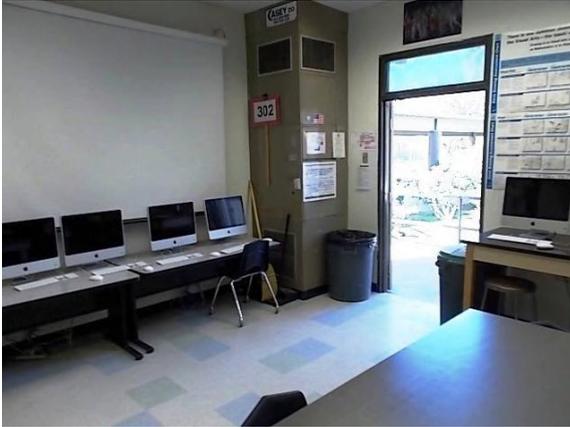
System: D3070 - Systems Testing & Balance

Location: System-Typical for all building locations.
Material: System
Distress: Beyond Expected Life
Category: Capital Renewal
Priority: 4 - Recommended (Years 6-10)
Correction: Renew System
Qty: 1-Ea.
Estimate: \$18,916.44
Assessor Name: Sonny Satterfield
Date Created: 01/29/2013

Notes: The HVAC System is recommended for new DDC controls with Testing & Balancing and IAQ tests during the next major renovation; the HVAC system is renewed when roof mounted condensers stop working. A rooftop package unit serving the Staff Lounge was replaced in 2000; the classrooms mostly have split systems A/C units with varying installation dates from 1998 to 2002; these units have a life expectancy of 15-years. Most of the air distribution duct and exhaust fans were installed in 1964 and beyond expected life. Fresh air supply to all areas and classrooms is inadequate. An engineering study by a PE is recommended for the HVAC System with recommendations for an integrated HVAC System, upgrades to fresh air intake and replacement of existing system, as required during the next major renovation.

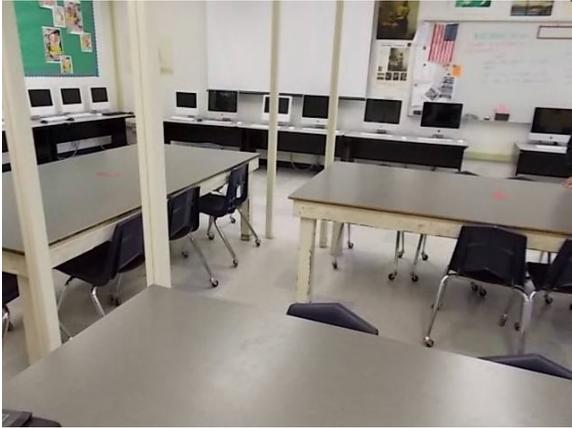
System: D5020 - Branch Wiring

Location: System-Typical for all building locations.
Material: System
Distress: Beyond Expected Life
Category: Capital Renewal
Priority: 4 - Recommended (Years 6-10)
Correction: Renew System
Qty: 1-Ea.
Estimate: \$269,918.10
Assessor Name: Sonny Satterfield
Date Created: 01/29/2013

Notes: The branch wiring, electrical panels and devices are mostly original to the building construction date of 1972, except the tele-power poles and computer outlets, all wiring and electrical outlets are recommended to be upgraded and replaced during the next major renovation.

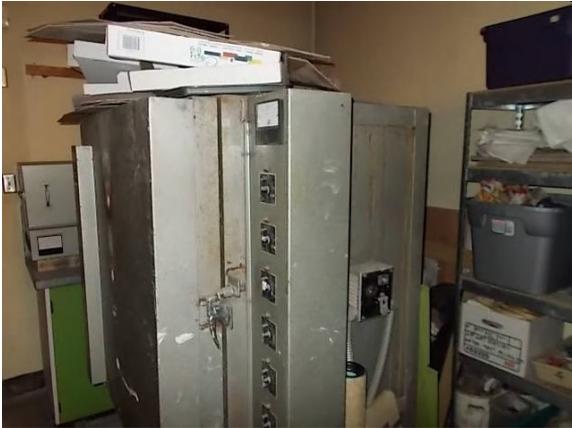
System: E1020 - Institutional Equipment

Location: Kiln Room-Adjacent to Room 300
Material: Building Interior Demolition
Distress: Beyond Service Life
Category: Deferred Maintenance
Priority: 4 - Recommended (Years 6-10)
Correction: Demo existing equipment/Specify details/quantity
Qty: 2-Job
Estimate: \$4,406.40
Assessor Name: Sonny Satterfield
Date Created: 01/29/2013

Notes: Demo and haul off (2) abandoned kilns. Not functional and not required to replace equipment.

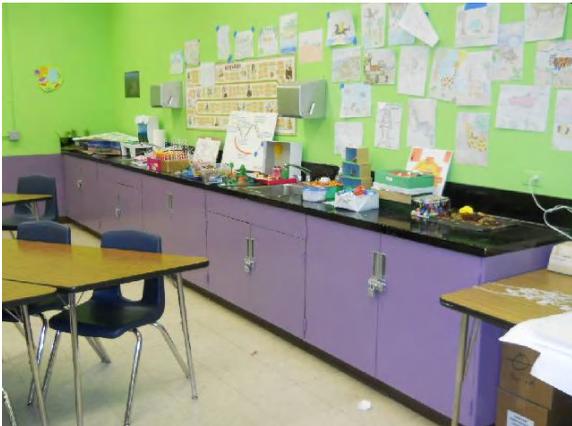
System: E2010 - Fixed Furnishings

Location: Classroom 300, 301, storage room
Material: Fixed Casework
Distress: Beyond Service Life
Category: Deferred Maintenance
Priority: 3 - Necessary/Not Yet Critical (Years 2-5)
Correction: Replace Casework OUSD
Qty: 96-L.F.
Estimate: \$43,654.81
Assessor Name: Dave Cunningham
Date Created: 01/23/2013

Notes: Fixed casework is beyond expected service life, recommend replacement during next school renovation

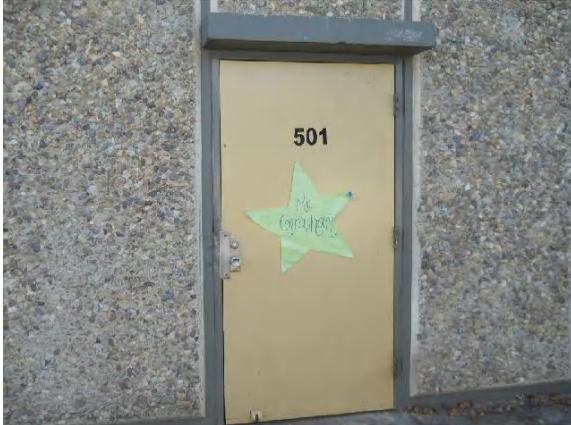
System: B2030 - Exterior Doors

Location: All exterior doors, including the overhead roll-up door. Total of 11 doors
Material: System
Distress: Beyond Service Life
Category: Capital Renewal
Priority: 3 - Necessary/Not Yet Critical (Years 2-5)
Correction: Renew System
Qty: 1-Ea.
Estimate: \$64,775.81
Assessor Name: Dave Cunningham
Date Created: 01/23/2013

Notes: All exterior doors are original construction. Provide interior locking hardware at all classroom doors for security. Door systems are beyond expected useful service life. Recommend replacement during the next school renovation

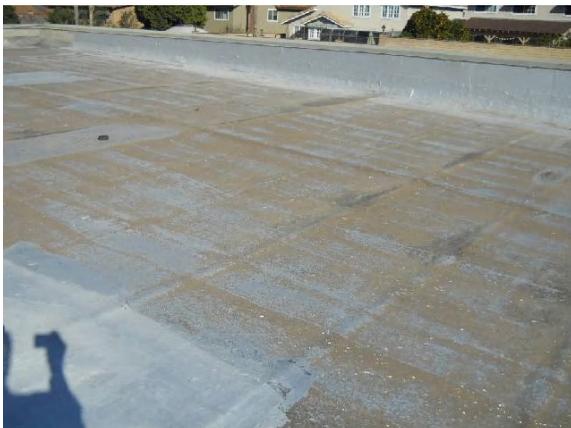
System: B3010105 - Built-Up

Location: Roof
Material: System
Distress: Beyond Service Life
Category: Deferred Maintenance
Priority: 3 - Necessary/Not Yet Critical (Years 2-5)
Correction: Renew System
Qty: 1-Ea.
Estimate: \$260,793.31
Assessor Name: Dave Cunningham
Date Created: 01/23/2013

Notes: Roof covering is 25 years old, beyond expected service life.

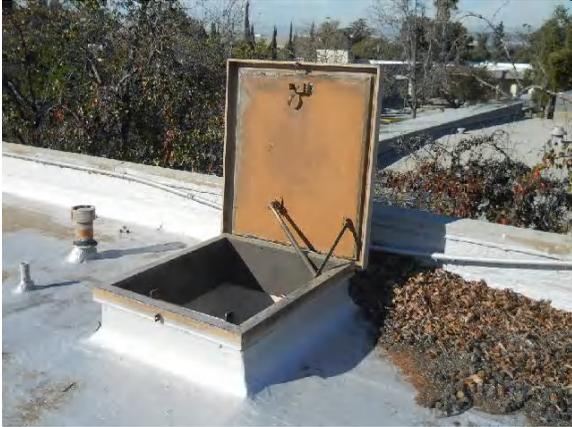
System: B3020 - Roof Openings

Location: Roof
Material: System
Distress: Beyond Service Life
Category: Deferred Maintenance
Priority: 3 - Necessary/Not Yet Critical (Years 2-5)
Correction: Renew System
Qty: 1-Ea.
Estimate: \$15,172.88
Assessor Name: Dave Cunningham
Date Created: 01/23/2013

Notes: Roof hatch is original construction, recommend replacement during next school renovation

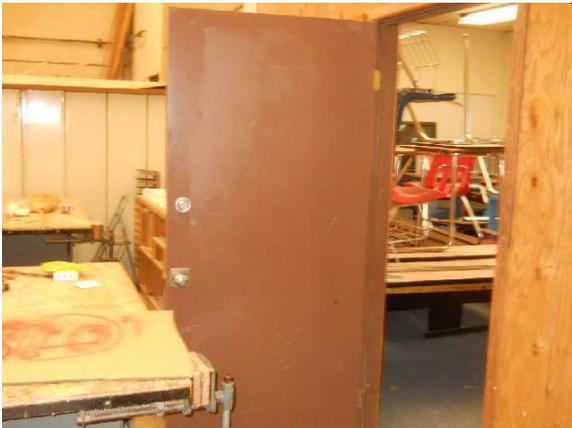
System: C1020 - Interior Doors

Location: All interior door systems, all rooms
Material: System
Distress: Beyond Service Life
Category: Deferred Maintenance
Priority: 3 - Necessary/Not Yet Critical (Years 2-5)
Correction: Renew System
Qty: 1-Ea.
Estimate: \$34,936.01
Assessor Name: Dave Cunningham
Date Created: 01/23/2013

Notes: All interior doors are original construction. Door systems are beyond expected service life. Recommend replacement during school renovation.

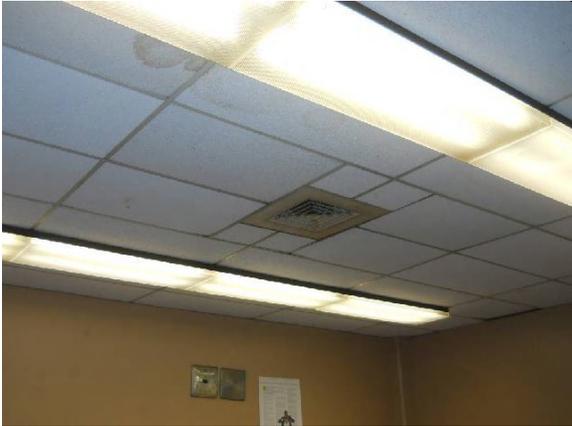
System: C3030 - Ceiling Finishes

Location: All rooms except the Video Production Classroom (open ceiling to roof deck).
Material: System
Distress: Beyond Service Life
Category: Deferred Maintenance
Priority: 3 - Necessary/Not Yet Critical (Years 2-5)
Correction: Renew System
Qty: 1-Ea.
Estimate: \$88,182.99
Assessor Name: Dave Cunningham
Date Created: 01/23/2013

Notes: All ceiling grid and accoustical tile systems are beyond expected service life. Ceiling tiles are damaged from previous roof leaks throughout the building.

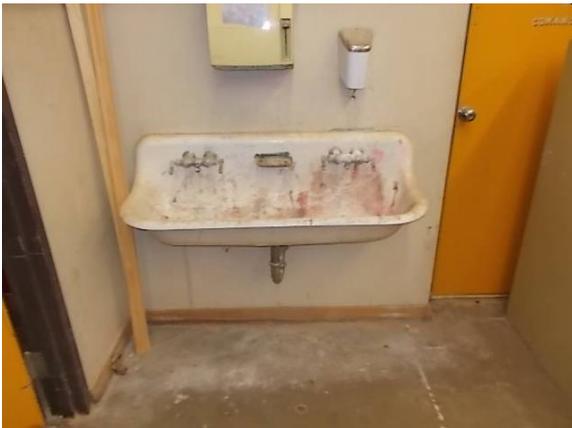
System: D2010 - Plumbing Fixtures

Location: System-Typical for all building locations.
Material: System
Distress: Beyond Service Life
Category: Capital Renewal
Priority: 4 - Recommended (Years 6-10)
Correction: Renew System
Qty: 1-Ea.
Estimate: \$125,589.40
Assessor Name: Dave Cunningham
Date Created: 01/23/2013

Notes: Plumbing fixtures are mostly original to building construction date of 1972 and therefore are beyond expected life. Recommend replacing system during next remodel or renovation.

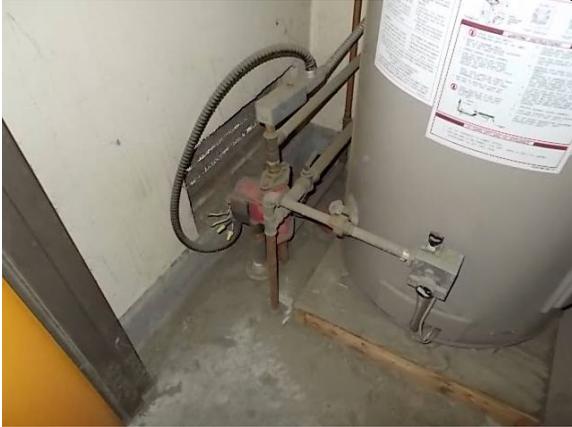
System: D2020 - Domestic Water Distribution

Location: System-Typical for all building locations.
Material: System
Distress: Beyond Service Life
Category: Capital Renewal
Priority: 4 - Recommended (Years 6-10)
Correction: Renew System
Qty: 1-Ea.
Estimate: \$110,116.07
Assessor Name: Dave Cunningham
Date Created: 01/23/2013

Notes: Recommend replacing system during next remodel or renovation, 80-gal domestic hot water heater was replaced in 2006 and currently working properly; however most domestic water piping was installed during the 1972 original construction.

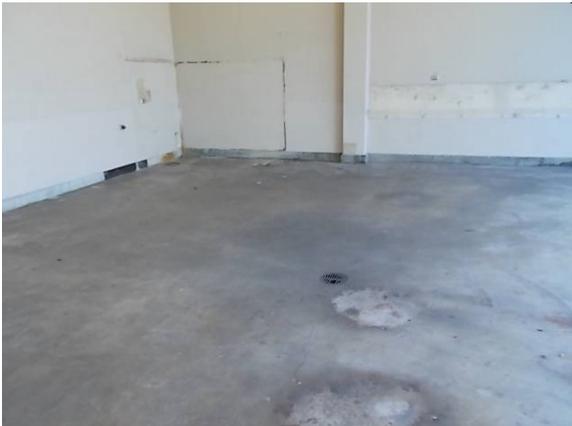
System: D2030 - Sanitary Waste

Location: System-Typical for all building locations.
Material: System
Distress: Beyond Service Life
Category: Capital Renewal
Priority: 4 - Recommended (Years 6-10)
Correction: Renew System
Qty: 1-Ea.
Estimate: \$70,306.03
Assessor Name: Dave Cunningham
Date Created: 01/23/2013

Notes: Recommend replacing all above grade sanitary waste and vent piping system during next remodel or renovation; below grade waste piping, recommend video inspection and replace as required.

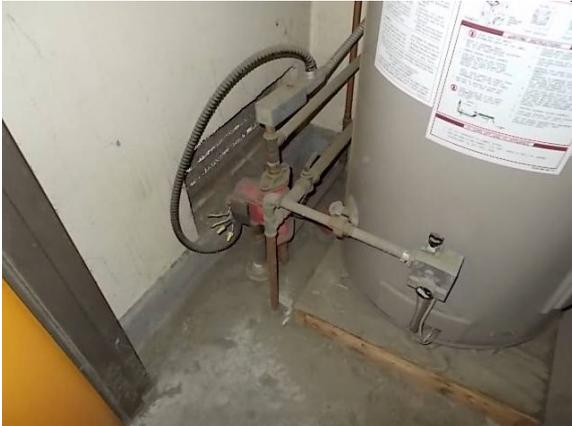
System: D2090 - Other Plumbing Systems-Nat Gas

Location: System-Typical for all building locations.
Material: System
Distress: Beyond Expected Life
Category: Capital Renewal
Priority: 4 - Recommended (Years 6-10)
Correction: Renew System
Qty: 1-Ea.
Estimate: \$19,078.77
Assessor Name: Dave Cunningham
Date Created: 01/23/2013

Notes: Recommend replacing system during next remodel or renovation.

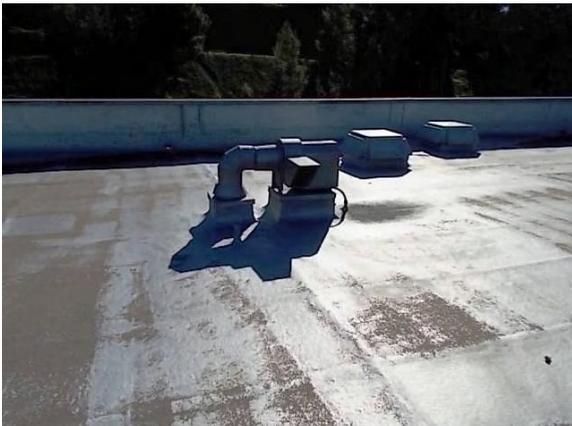
System: D3040 - Distribution Systems

Location: System-Typical for all required building locations.
Material: System
Distress: Inadequate
Category: Capital Renewal
Priority: 4 - Recommended (Years 6-10)
Correction: Renew System
Qty: 1-Ea.
Estimate: \$279,872.08
Assessor Name: Dave Cunningham
Date Created: 01/23/2013

Notes: The 500 Wing HVAC systems was partially renewed in 2006/2012, with new Heat Only-rooftop package units for Rooms 500/502, controls and duct work; Room 501 received a new Roof Top Package Unit in 2006 with A/C and Heat. It is uncertain, what the continued use and function of this building will be; so it is recommended to replace and/or upgrade the entire HVAC system with an integrated system. Most of the air distribution duct and exhaust fans were installed in 1972 and beyond expected life. Fresh air supply to all areas is inadequate. An engineering study and testing of the building IAQ by a PE is recommended for the HVAC System with engineered drawings for upgrades and replacement, as required during the next major renovation.

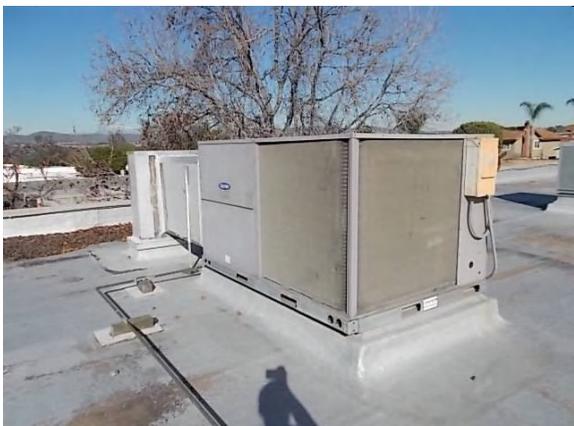
System: D3050 - Terminal & Package Units

Location: System-Typical for all required building locations.

Priority: 4 - Recommended (Years 6-10)

Notes: The 500 Wing HVAC systems was partially renewed in 2006/2012, with new Heat Only-rooftop package units for Rooms 500/502, controls and duct work; Room 501 received a new Roof Top Package Unit in 2006 with A/C and Heat. It is uncertain, what the continued use and function of this building will be; so it is recommended to replace and/or upgrade the entire HVAC system with an integrated system. Most of the air distribution duct and exhaust fans were installed in 1972 and beyond expected life. Fresh air supply to all areas is inadequate. An engineering study and testing of the building IAQ by a PE is recommended for the HVAC System with engineered drawings for upgrades and replacement, as required during the next major renovation.

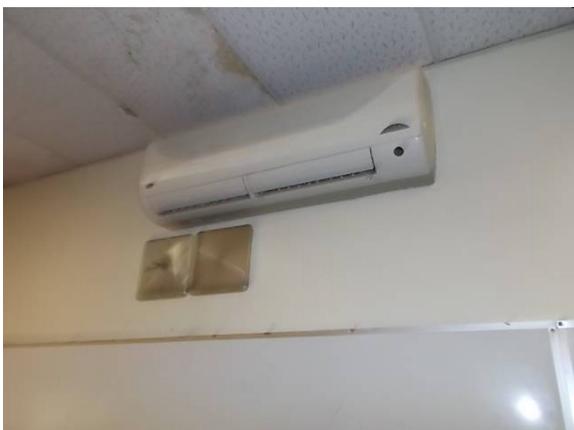
System: D3060 - Controls & Instrumentation

Location: System-Typical for all building locations.

Priority: 4 - Recommended (Years 6-10)

Notes: The HVAC System is recommended for new DDC controls with Testing & Balancing and IAQ tests during the next major renovation. The 500 Wing HVAC systems was partially renewed in 2006/2012, with new Heat Only-rooftop package units for Rooms 500/502, controls and duct work; Room 501 received a new Roof Top Package Unit in 2006 with A/C and Heat. It is uncertain, what the continued use and function of this building will be; so it is recommended to replace and/or upgrade the entire HVAC system with an integrated system. Most of the air distribution duct and exhaust fans were installed in 1972 and beyond expected life. Fresh air supply to all areas is inadequate. An engineering study and testing of the building IAQ by a PE is recommended for the HVAC System with engineered drawings for upgrades and replacement, as required during the next major renovation.

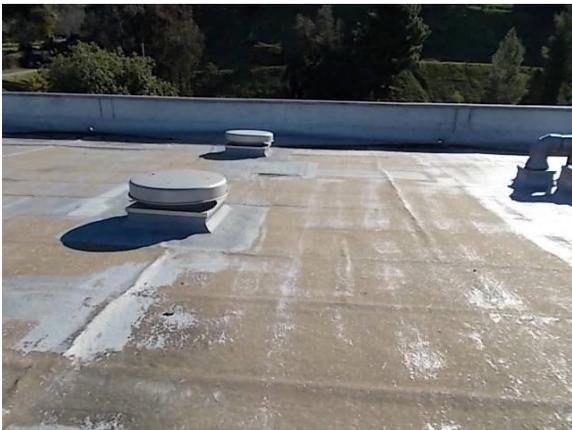
System: D3070 - Systems Testing & Balance

Location: System-Typical for all required building locations.

Priority: 4 - Recommended (Years 6-10)

Notes: The HVAC System is recommended for new DDC controls with Testing & Balancing and IAQ tests during the next major renovation. The 500 Wing HVAC systems was partially renewed in 2006/2012, with new Heat Only-rooftop package units for Rooms 500/502, controls and duct work; Room 501 received a new Roof Top Package Unit in 2006 with A/C and Heat. It is uncertain, what the continued use and function of this building will be; so it is recommended to replace and/or upgrade the entire HVAC system with an integrated system. Most of the air distribution duct and exhaust fans were installed in 1972 and beyond expected life. Fresh air supply to all areas is inadequate. An engineering study and testing of the building IAQ by a PE is recommended for the HVAC System with engineered drawings for upgrades and replacement, as required during the next major renovation.

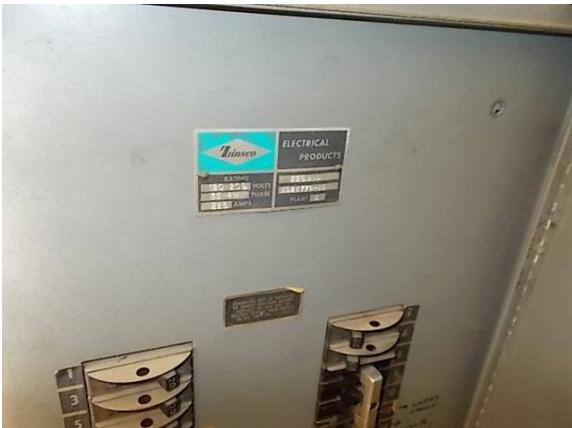
System: D5020 - Branch Wiring

Location: System-Typical for all building locations.
Material: System
Distress: Beyond Service Life
Category: Capital Renewal
Priority: 4 - Recommended (Years 6-10)
Correction: Renew System
Qty: 1-Ea.
Estimate: \$287,683.86
Assessor Name: Dave Cunningham
Date Created: 01/23/2013

Notes: The branch wiring, electrical panels and devices are mostly original to the building construction date of 1972 and therefore beyond expected life. The system is recommended to be replaced during the next major renovation.

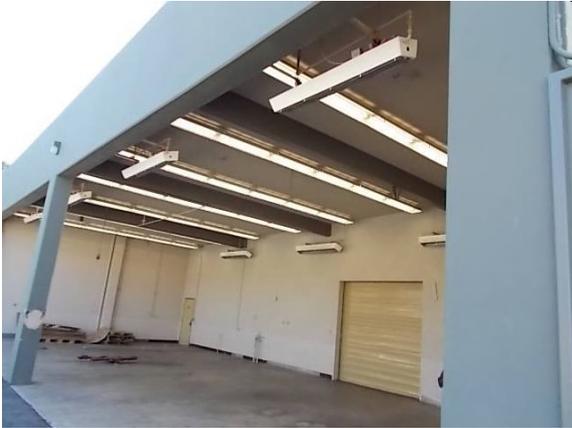
System: E1030 - Vehicular Equipment

Location: Rooms 500/502
Material: System
Distress: Beyond Expected Life
Category: Capital Renewal
Priority: 4 - Recommended (Years 6-10)
Correction: Renew System
Qty: 1-Ea.
Estimate: \$147,973.16
Assessor Name: Sonny Satterfield
Date Created: 01/30/2013

Notes: Vehicle service equipment, including lifts and air compressors are all beyond expected life. If the function of these classrooms continues as Vo-Tech/Automotive training, it is recommended to replace equipment.

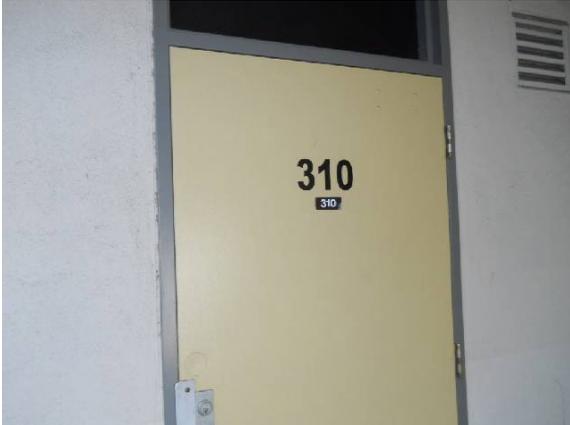
System: B2030 - Exterior Doors

Location: All exterior doors
Material: System
Distress: Beyond Service Life
Category: Deferred Maintenance
Priority: 3 - Necessary/Not Yet Critical (Years 2-5)
Correction: Renew System
Qty: 1-Ea.
Estimate: \$118,130.03
Assessor Name: Dave Cunningham
Date Created: 01/23/2013

Notes: All exterior doors are original construction. Provide interior locking hardware at all classroom doors for security. Door systems are beyond expected service life. Recommend replacement during next school renovation.

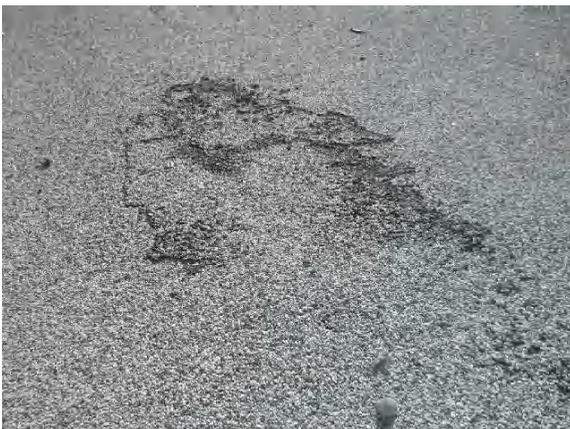
System: B3010105 - Built-Up

Location: Roof of classroom bld.
Material: System
Distress: Beyond Service Life
Category: Deferred Maintenance
Priority: 3 - Necessary/Not Yet Critical (Years 2-5)
Correction: Renew System
Qty: 1-Ea.
Estimate: \$255,787.99
Assessor Name: Dave Cunningham
Date Created: 01/23/2013

Notes: Built Up roof is 28 years old and beyond expected service life. Numerous leaks were reported in the classrooms. Recommend replacement of the roof covering. The roof area over the Custodial offices/storage was replaced in 2002 and is in good condition per reports from the staff.

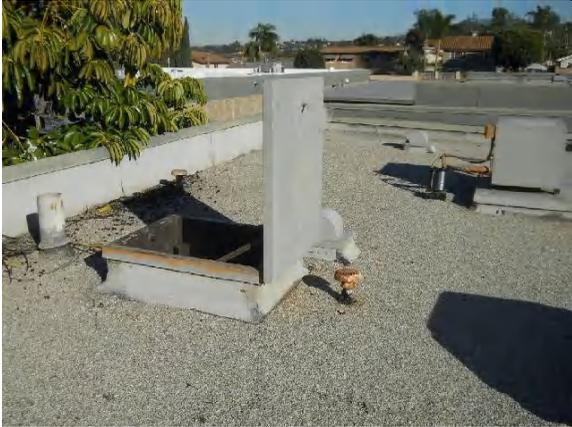
System: B3020 - Roof Openings

Location: Roof
Material: System
Distress: Beyond Service Life
Category: Deferred Maintenance
Priority: 4 - Recommended (Years 6-10)
Correction: Renew System
Qty: 1-Ea.
Estimate: \$17,540.11
Assessor Name: Dave Cunningham
Date Created: 01/23/2013

Notes: Roof hatch is original construction, beyond expected service life. Recommend replacement

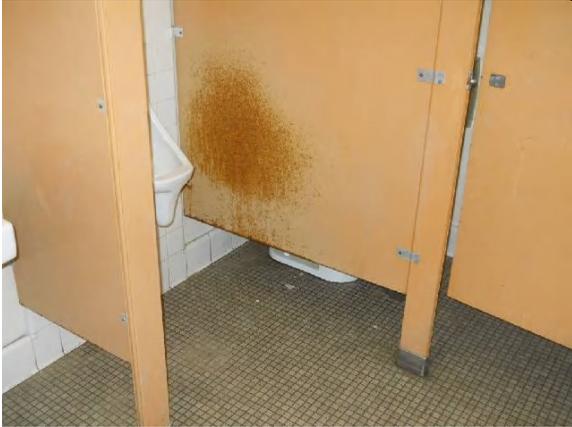
System: C1030 - Fittings

Location: Restrooms; Womens 09, Mens 15, Toilet 22
Material: Toilet Partitions
Distress: Beyond Service Life
Category: Deferred Maintenance
Priority: 2 - Potentially Critical (Year 1)
Correction: Toilet partitions,painted metal-overhead braced
Qty: 7-Ea.
Estimate: \$8,867.88
Assessor Name: Dave Cunningham
Date Created: 01/24/2013

Notes: Restroom partitions are damaged and beyond service life.

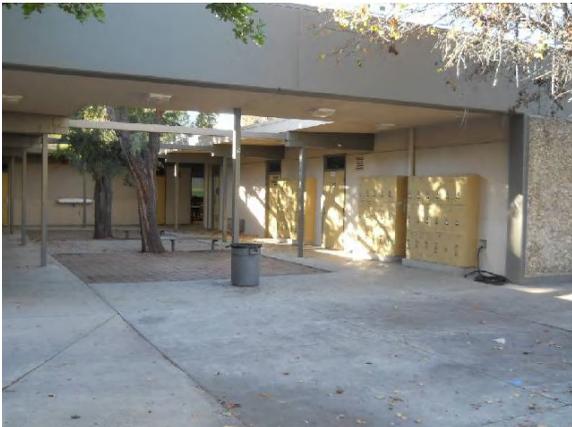
System: C1030 - Fittings

Location: Exterior hallways, circulation area
Material: Fixed Furnishings - Lockers
Distress: Beyond Service Life
Category: Deferred Maintenance
Priority: 3 - Necessary/Not Yet Critical (Years 2-5)
Correction: Student lockers stacked 2-high
Qty: 114-Ea.
Estimate: \$37,810.97
Assessor Name: Dave Cunningham
Date Created: 01/24/2013

Notes: Student lockers are original construction, beyond expected service life. Reecommend replacement during next school renovation.

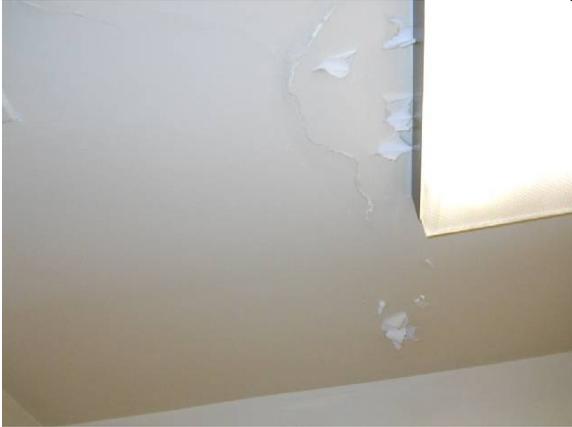
System: C3010 - Wall Finishes

Location: Throughout the building
Material: System
Distress: Beyond Service Life
Category: Deferred Maintenance
Priority: 3 - Necessary/Not Yet Critical (Years 2-5)
Correction: Renew System
Qty: 1-Ea.
Estimate: \$166,547.49
Assessor Name: Dave Cunningham
Date Created: 01/23/2013

Notes: Wall finishes; painted CMU and drywall, need painted and minor repairs as necessary.

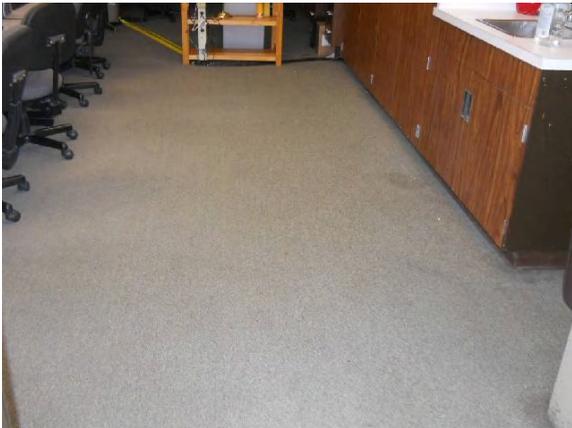
System: C3020210 - Carpet

Location: Classrooms 306, 308, 309, 311
Material: System
Distress: Beyond Service Life
Category: Capital Renewal
Priority: 3 - Necessary/Not Yet Critical (Years 2-5)
Correction: Renew System
Qty: 1-Ea.
Estimate: \$69,086.00
Assessor Name: Dave Cunningham
Date Created: 01/23/2013

Notes: Carpet is worn and out of date, beyond expected service life. Recommend replacement during next school renovation

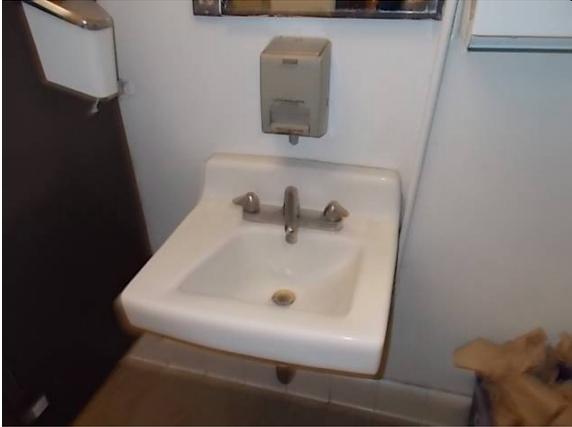
System: D2010 - Plumbing Fixtures

Location: System-Typical for all building locations
Material: System
Distress: Beyond Service Life
Category: Capital Renewal
Priority: 4 - Recommended (Years 6-10)
Correction: Renew System
Qty: 1-Ea.
Estimate: \$144,998.22
Assessor Name: Dave Cunningham
Date Created: 01/23/2013

Notes: Plumbing fixtures are mostly original to building construction date of 1972 and therefore are beyond expected life. Recommend replacing system during next remodel or renovation.

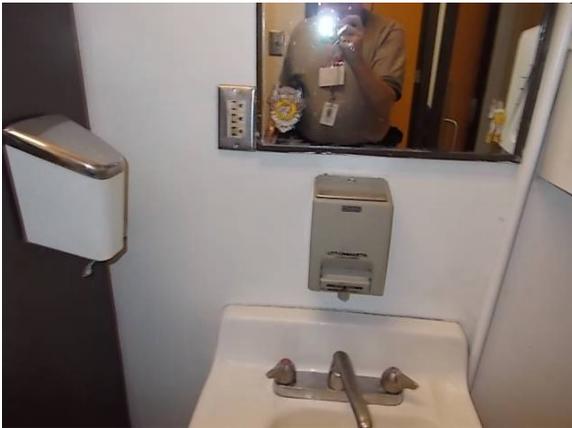
System: D2020 - Domestic Water Distribution

Location: Replace during next remodel or renovation
Material: System
Distress: Beyond Expected Life
Category: Capital Renewal
Priority: 4 - Recommended (Years 6-10)
Correction: Renew System
Qty: 1-Ea.
Estimate: \$127,124.02
Assessor Name: Dave Cunningham
Date Created: 01/23/2013

Notes: Recommend replacing system during next remodel or renovation, 80-gal domestic hot water heater was replaced in 2012 and currently working properly; however most domestic water piping was installed during the 1972 original construction.

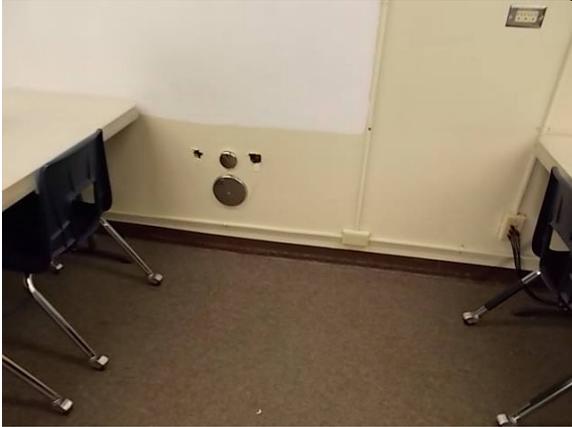
System: D2030 - Sanitary Waste

Location: System-Typical for all required building locations.

Priority: 4 - Recommended (Years 6-10)

Notes: Recommend replacing all above grade sanitary waste and vent piping system during next remodel or renovation; below grade waste piping, recommend video inspection and replace as required.

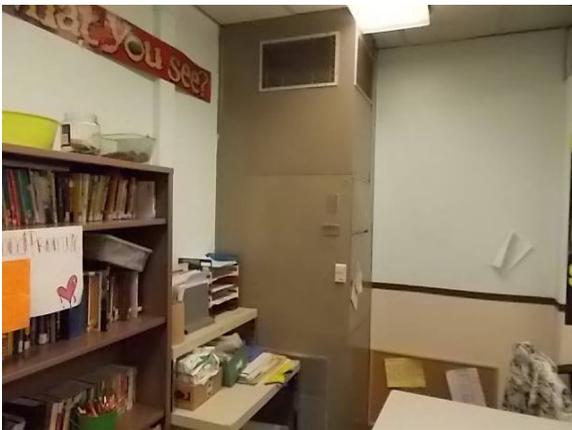
System: D3040 - Distribution Systems

Location: System-Typical for all building locations.

Distress: Inadequate

Priority: 4 - Recommended (Years 6-10)

Notes: A new HVAC distribution system with exhaust and fresh air intake supply will be required for proper indoor air quality to be maintained in classrooms. The classrooms have split systems A/C units with varying installation dates from 1995 to 2002; these units have a life expectancy of 15-years. Most of the air distribution duct and exhaust fans were installed in 1964 and beyond expected life. Fresh air supply to all areas and classrooms is inadequate. An engineering study by a PE is recommended for the HVAC System with recommendations for an integrated HVAC System, upgrades to fresh air intake and replacement of existing system, as required during the next major renovation.

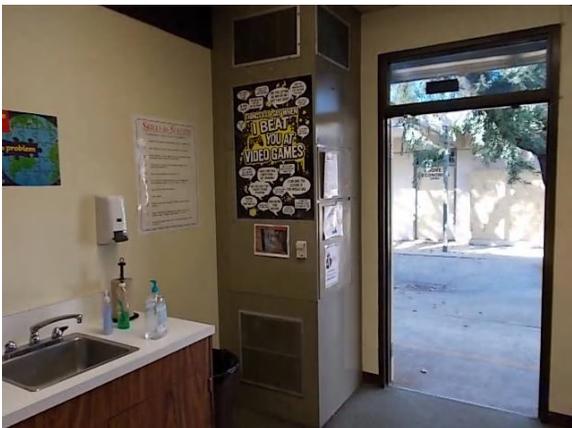
System: D3060 - Controls & Instrumentation

Location: System-Typical for all building locations.
Material: System
Distress: Inadequate
Category: Capital Renewal
Priority: 4 - Recommended (Years 6-10)
Correction: Renew System
Qty: 1-Ea.
Estimate: \$80,016.30
Assessor Name: Dave Cunningham
Date Created: 01/23/2013

Notes: The HVAC System is recommended for new DDC controls with Testing & Balancing and IAQ tests during the next major renovation; the HVAC system is renewed when roof mounted condensers stop working. The classrooms mostly have split systems A/C units with varying installation dates from 1995 to 1998; these units have a life expectancy of 15-years. Most of the air distribution duct and exhaust fans were installed in 1964 and beyond expected life. Fresh air supply to all areas and classrooms is inadequate. An engineering study by a PE is recommended for the HVAC System with recommendations for an integrated HVAC System, upgrades to fresh air intake and replacement of existing system, as required during the next major renovation.

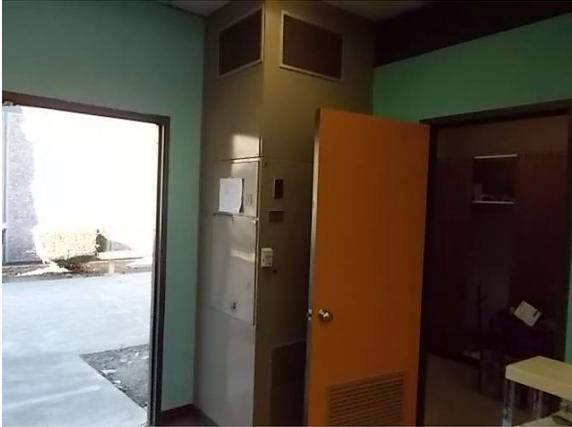
System: D3070 - Systems Testing & Balance

Location: System-Typical for all building locations.
Material: System
Distress: Inadequate
Category: Capital Renewal
Priority: 4 - Recommended (Years 6-10)
Correction: Renew System
Qty: 1-Ea.
Estimate: \$23,219.76
Assessor Name: Dave Cunningham
Date Created: 01/23/2013

Notes: The HVAC System is recommended for new DDC controls with Testing & Balancing and IAQ tests during the next major renovation; the HVAC system is renewed when roof mounted condensers stop working. The classrooms mostly have split systems A/C units with varying installation dates from 1995 to 1998; these units have a life expectancy of 15-years. Most of the air distribution duct and exhaust fans were installed in 1964 and beyond expected life. Fresh air supply to all areas and classrooms is inadequate. An engineering study by a PE is recommended for the HVAC System with recommendations for an integrated HVAC System, upgrades to fresh air intake and replacement of existing system, as required during the next major renovation.

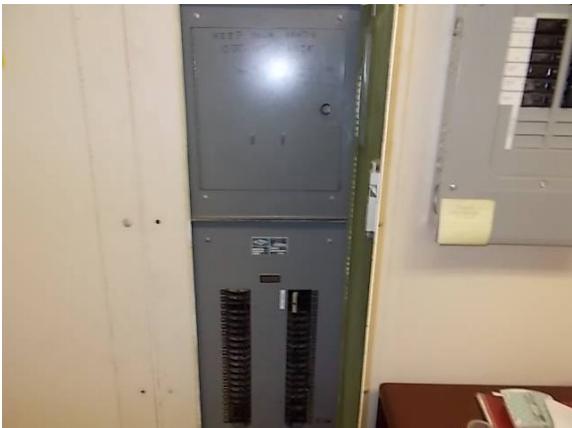
System: D5020 - Branch Wiring

Location: System-Typical for all building locations.
Material: System
Distress: Beyond Service Life
Category: Capital Renewal
Priority: 4 - Recommended (Years 6-10)
Correction: Renew System
Qty: 1-Ea.
Estimate: \$332,259.74
Assessor Name: Dave Cunningham
Date Created: 01/23/2013

Notes: The branch wiring, electrical panels and devices are mostly original to the building construction date of 1972 and therefore beyond expected life. The system is recommended to be replaced during the next major renovation.

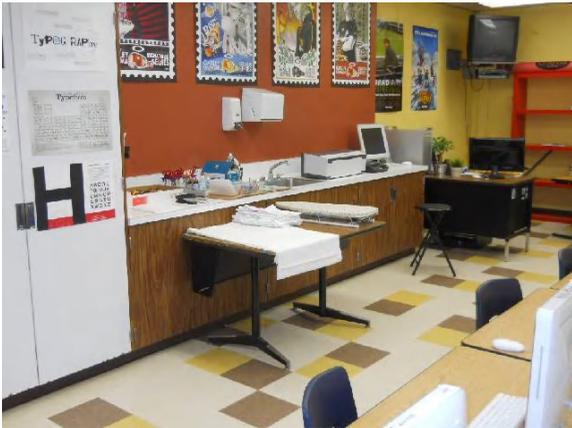
System: E2010 - Fixed Furnishings

Location: Computer Classrooms 309, 310
Material: Fixed Casework
Distress: Beyond Expected Life
Category: Deferred Maintenance
Priority: 3 - Necessary/Not Yet Critical (Years 2-5)
Correction: Replace Casework OUSD
Qty: 40-L.F.
Estimate: \$18,189.50
Assessor Name: Dave Cunningham
Date Created: 01/24/2013

Notes: Built in casework is beyond expected service life.

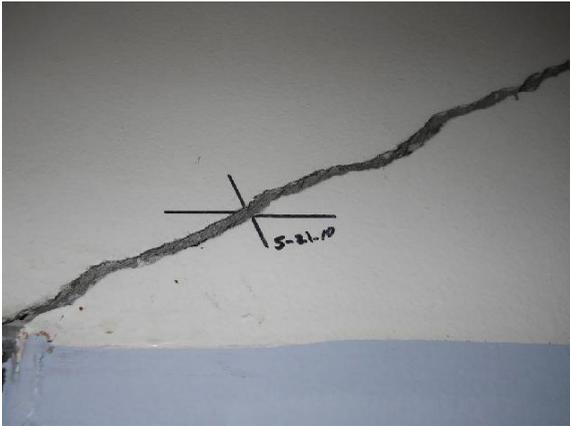
System: A1010 - Standard Foundations

Location: Lower level boys locker room
Material: Study Engineering Analysis
Distress: Damaged
Category: Safety
Priority: 3 - Necessary/Not Yet Critical (Years 2-5)
Correction: Conduct study/analysis
Qty: 1-Each
Estimate: \$34,010.16
Assessor Name: Dave Cunningham
Date Created: 01/24/2013

Notes: Building cracks in the walls

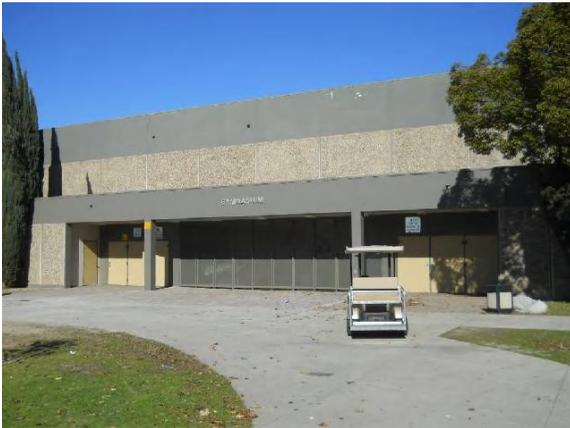
System: B1020 - Roof Construction

Location: Exterior wall
Material: Metal Stairs
Distress: Missing
Category: Safety
Priority: 1 - Currently Critical (Immediate)
Correction: Replace roof access ladder
Qty: 1-Ea.
Estimate: \$2,639.15
Assessor Name: Dave Cunningham
Date Created: 01/24/2013

Notes: No safe roof access from ground. Install a secure roof access ladder

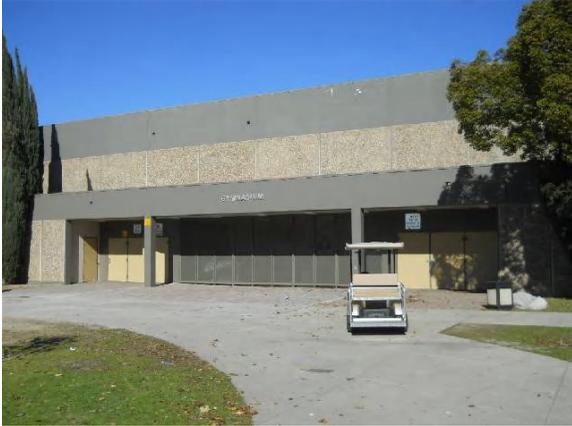
System: B2020 - Exterior Windows

Location: Exterior windows
Material: System
Distress: Beyond Service Life
Category: Capital Renewal
Priority: 4 - Recommended (Years 6-10)
Correction: Renew System
Qty: 1-Ea.
Estimate: \$39,689.18
Assessor Name: Dave Cunningham
Date Created: 01/24/2013

Notes: All exterior windows are original. Main entry window system and windows on lower level offices. New windows should be safety glass at main entry. Recommend replacement during next school renovation.

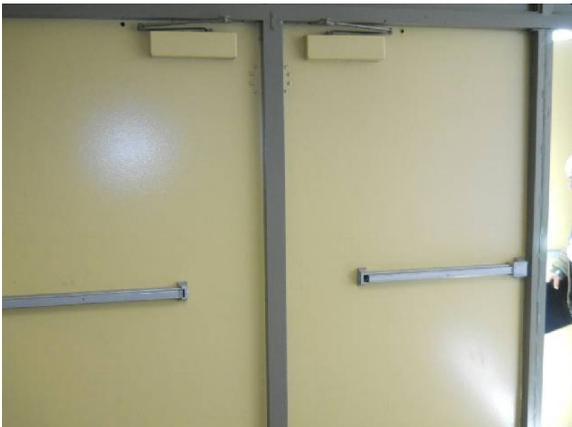
System: B2030 - Exterior Doors

Location: Throughout the building
Material: System
Distress: Beyond Service Life
Category: Capital Renewal
Priority: 3 - Necessary/Not Yet Critical (Years 2-5)
Correction: Renew System
Qty: 1-Ea.
Estimate: \$138,904.95
Assessor Name: Dave Cunningham
Date Created: 01/24/2013

Notes: All exterior door systems are original construction, beyond expected service life. Provide interior locking hardware at all classroom doors for security. Recommend replacement during next school renovation.
