Orange Unified School District

Facilities Condition Assessment for:

**Canyon High School
220 S. Imperial Highway
Anaheim, CA 92807**

Campus Report

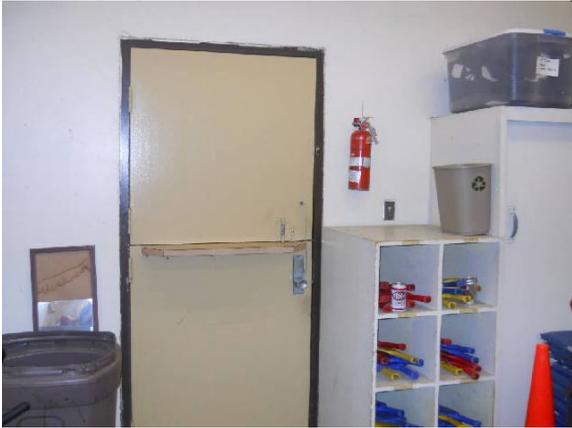
System: C1020 - Interior Doors

Location: Throughout the building
Material: System
Distress: Beyond Service Life
Category: Capital Renewal
Priority: 3 - Necessary/Not Yet Critical (Years 2-5)
Correction: Renew System
Qty: 1-Ea.
Estimate: \$138,207.99
Assessor Name: Dave Cunningham
Date Created: 01/24/2013

Notes: All interior door systems are original construction, beyond expected service life. Recommend replacement during next school renovation.

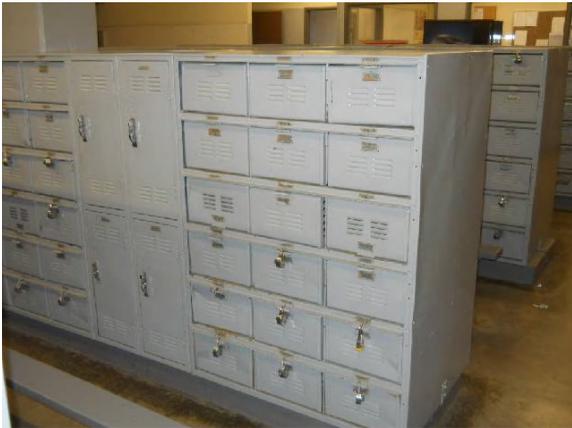
System: C1030 - Fittings

Location: Locker Rooms
Material: Fixed Furnishings - Lockers
Distress: Beyond Service Life
Category: Deferred Maintenance
Priority: 3 - Necessary/Not Yet Critical (Years 2-5)
Correction: Student lockers stacked 2-high
Qty: 600-Ea.
Estimate: \$283,510.08
Assessor Name: Dave Cunningham
Date Created: 01/24/2013

Notes: All student athletic lockers are old and beyond expected service life. Recommend replacement of approx 1400 lockers.

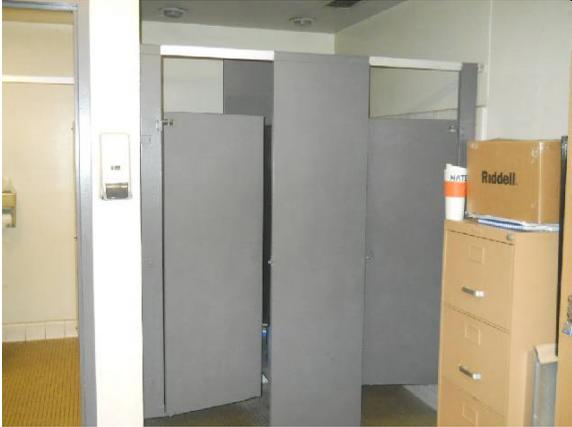
Location: Restrooms; Womens, Mens, Boys coach RR, girls coach RR

Notes: Restroom partitions are old, damaged, rusting. Partitions are beyond service life. Recommend replacement during next school renovation

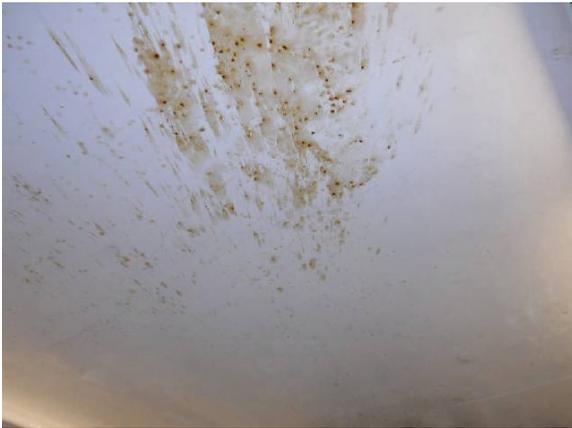
Location: Throughout the building

Notes: All wall surfaces need repair/replaced as necessary. CMU, drywall need patch and painted. Ceramic wall tiles in shower area need to be replaced. Recommend replacement/repairs to all wall surfaces during next school renovation.

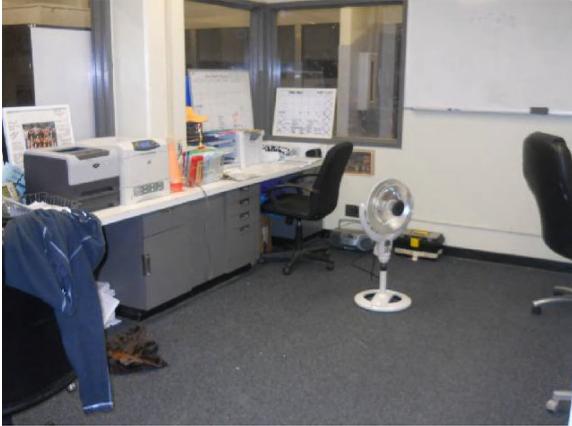
Location: Coaches offices
Material: System
Distress: Beyond Service Life
Category: Deferred Maintenance
Priority: 3 - Necessary/Not Yet Critical (Years 2-5)
Correction: Renew System
Qty: 1-Ea.
Estimate: \$8,181.36
Assessor Name: Dave Cunningham
Date Created: 01/24/2013

Notes: Carpet is old, dirty, and beyond useful life

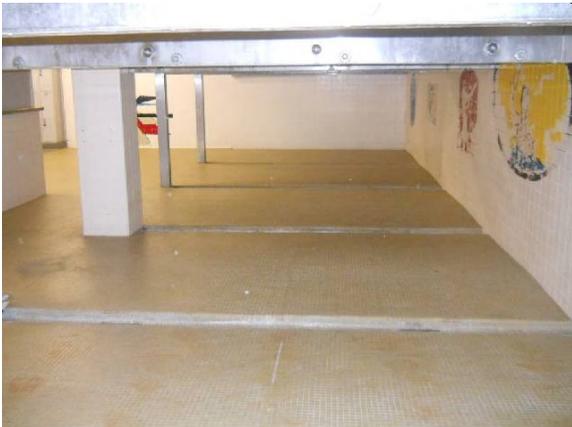
Location: Showers, Mens RR, Womens RR, Girls Toilet, Boys Toilet. Approx 3200 sq ft
Material: System
Distress: Beyond Service Life
Category: Capital Renewal
Priority: 3 - Necessary/Not Yet Critical (Years 2-5)
Correction: Renew System
Qty: 1-Ea.
Estimate: \$126,669.31
Assessor Name: Dave Cunningham
Date Created: 01/24/2013

Notes: Ceramic floors are aged and damaged, beyond useful life. Recommend replacement.

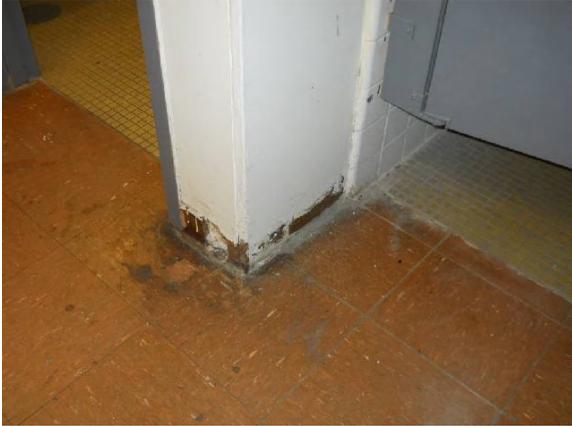
Location: Lower level offices, approx 1200 sq ft
Material: System
Distress: Beyond Service Life
Category: Capital Renewal
Priority: 3 - Necessary/Not Yet Critical (Years 2-5)
Correction: Renew System
Qty: 1-Ea.
Estimate: \$8,664.48
Assessor Name: Dave Cunningham
Date Created: 01/24/2013

Notes: VCT floor system is original construction, beyond expected service life. Recommend replacement during next school renovation.

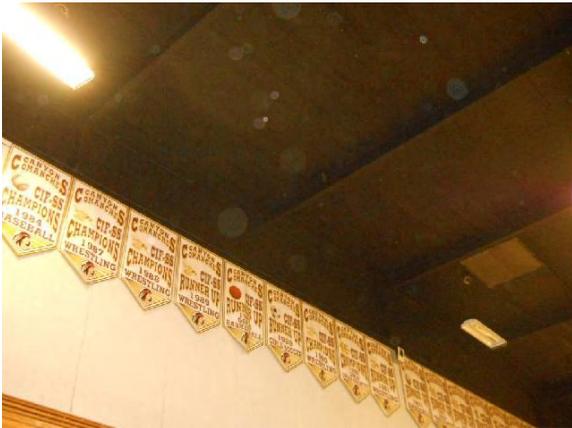
Location: Throughout the building
Material: System
Distress: Beyond Service Life
Category: Deferred Maintenance
Priority: 4 - Recommended (Years 6-10)
Correction: Renew System
Qty: 1-Ea.
Estimate: \$827,857.80
Assessor Name: Dave Cunningham
Date Created: 01/24/2013

Notes: All ceiling finishes are aged and damaged, beyond expected service life. Painted hard deck ceilings on both levels, as well as all grid and acoustical tile systems throughout the building. Recommend repair and/or replacement as required during the next school renovation.

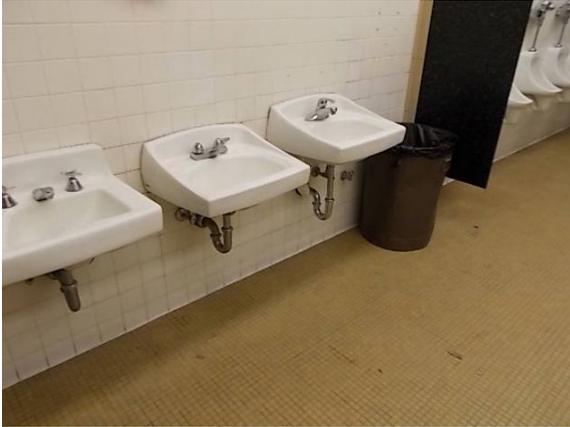
Location: Typical for all locations except as noted below

Notes: Plumbing fixtures are mostly original to building construction date of 1972, except the Boys restrooms which has been remodeled. Recommend replacing system, as required during next remodel or renovation.

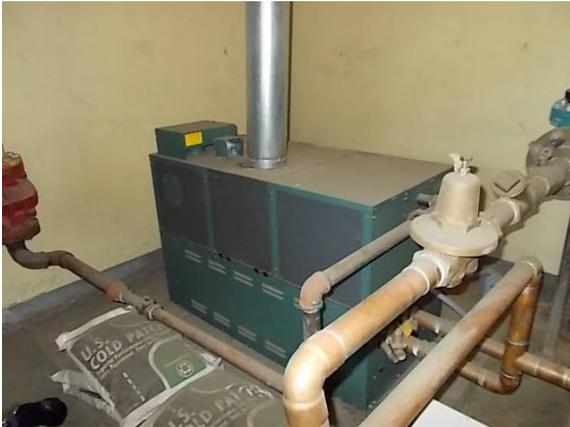
Location: System-Typical for all required building locations.

Notes: Recommend replacing system during next remodel or renovation, domestic hot water heater and storage tanks were replaced in 2003 and currently working properly; however most domestic water piping was installed during the 1972 original construction.

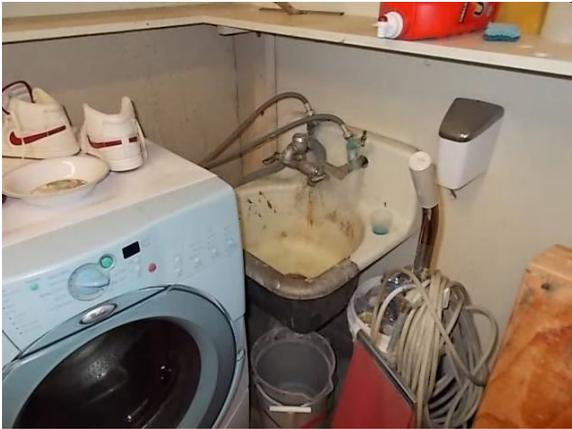
Location: System-Typical for all required building locations.

Notes: Recommend replacing all above grade sanitary waste and vent piping system during next remodel or renovation; below grade waste piping, recommend video inspection and replace as required.

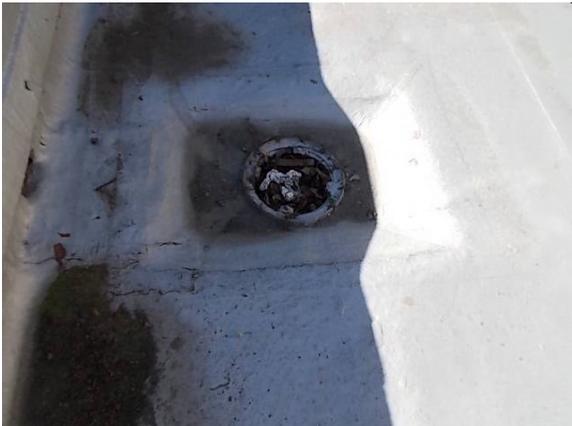
Location: System-Typical for all building locations.

Notes: Recommend replacing system during next remodel or renovation, roof drains are currently plugged and not working properly.

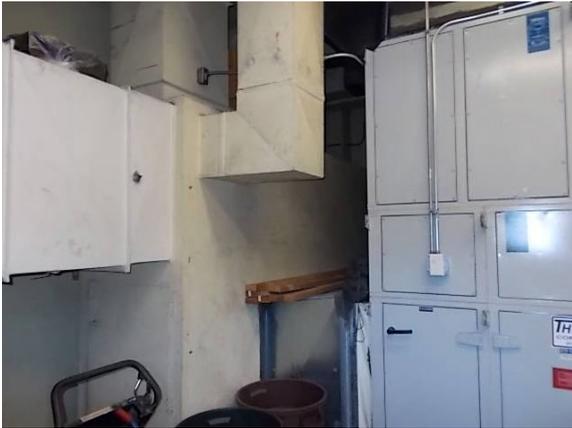
Location: System-Typical for all required building locations.
Material: System
Distress: Inadequate
Category: Capital Renewal
Priority: 4 - Recommended (Years 6-10)
Correction: Renew System
Qty: 1-Ea.
Estimate: \$426,472.20
Assessor Name: Dave Cunningham
Date Created: 01/24/2013

Notes: The GYM HVAC system was partially renewed in 2008; however most of the building spaces, large and small gymnasiums are not air conditioned, they have heat only and fresh air supply is inadequate. The infrared heating units in the Gym are not currently working. Most of the air distribution duct and exhaust fans were installed in 1972 and beyond expected life. Fresh air supply to all areas is inadequate. An engineering study by a PE is recommended for the HVAC System with recommendations for upgrades and replacement, as required during the next major renovation.

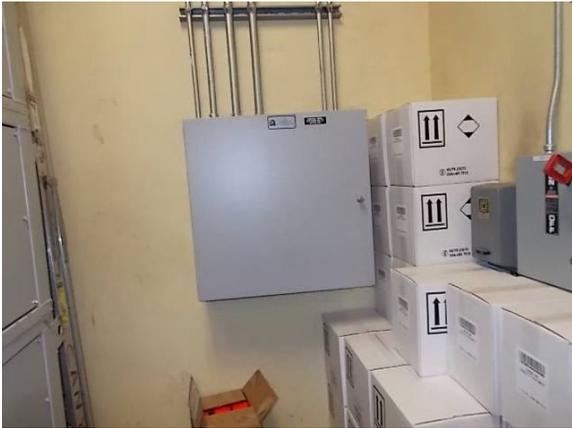
Location: System-Typical for all required building locations.

Notes: New HVAC DDC controls are recommended to be added during the HVAC upgrade. The GYM HVAC system was partially renewed in 2008; however most of the building spaces, large and small gymnasiums are not air conditioned, they have heat only and fresh air supply is inadequate. The infrared heating units in the Gym are not currently working. Most of the air distribution duct and exhaust fans were installed in 1972 and beyond expected life. Fresh air supply to all areas is inadequate. An engineering study by a PE is recommended for the HVAC System with recommendations for upgrades and replacement, as required during the next major renovation.

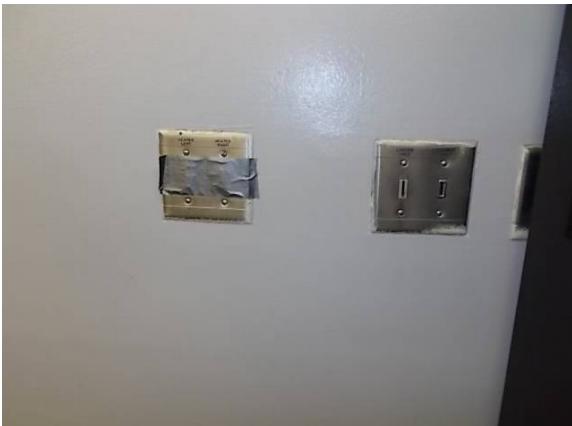
Location: System-Typical for all building locations.
Material: System
Distress: Beyond Service Life
Category: Capital Renewal
Priority: 4 - Recommended (Years 6-10)
Correction: Renew System
Qty: 1-Ea.
Estimate: \$930,712.86
Assessor Name: Dave Cunningham
Date Created: 01/24/2013

Notes: The branch wiring, electrical panels and devices are mostly original to the building construction date of 1972 and therefore beyond expected life. The system is recommended to be replaced during the next major renovation.

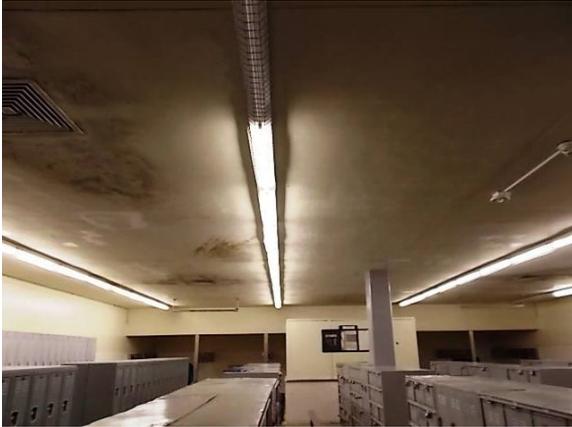
Location: Typical for all locations except Gym area-
See note below

Notes: The gymnasiums have new high bay type fluorescent light fixtures installed in 2008. All other spaces in the building are recommended to have new lighting installed during the next major remodel or renovation. This would include interior fluorescent fixtures, exit lights, emergency egress and task lighting as required.

Correction: Replace lighting system w/energy efficient
fixture

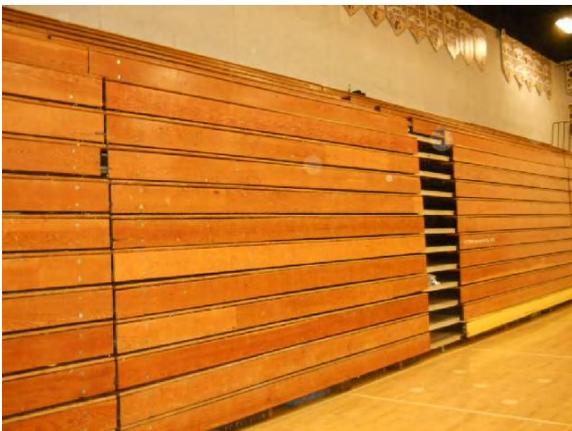
Location: Main Gym

Notes: Gym bleachers are original equipment, difficult to use/operate. System is beyond useful life. Recommend replacement during next school renovation.

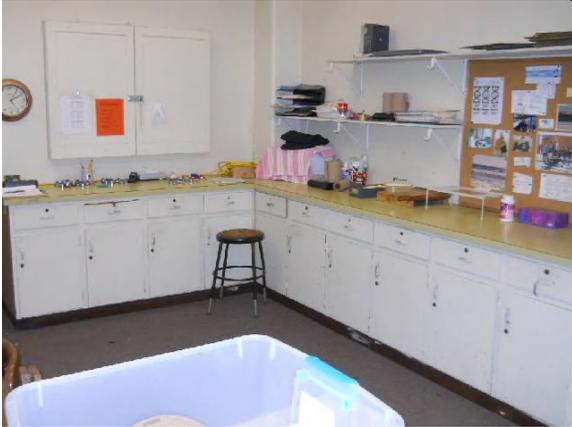
Location: Storage rooms, lower level. Storage 24, 06
Material: Fixed Casework
Distress: Beyond Expected Life
Category: Deferred Maintenance
Priority: 4 - Recommended (Years 6-10)
Correction: Replace Casework OUSD
Qty: 120-L.F.
Estimate: \$141,633.79
Assessor Name: Dave Cunningham
Date Created: 01/24/2013

Notes: Storage cabinet built in casework is beyond expected service life. Recommend replacement during next school renovation

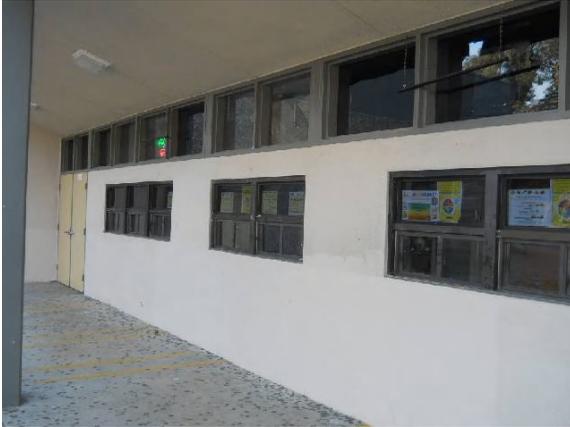
Location: Exterior windows at serving line, and staff patio large glass windows at patio area.

Notes: Window systems are original construction, beyond expected service life. Recommend replacement during school renovation.

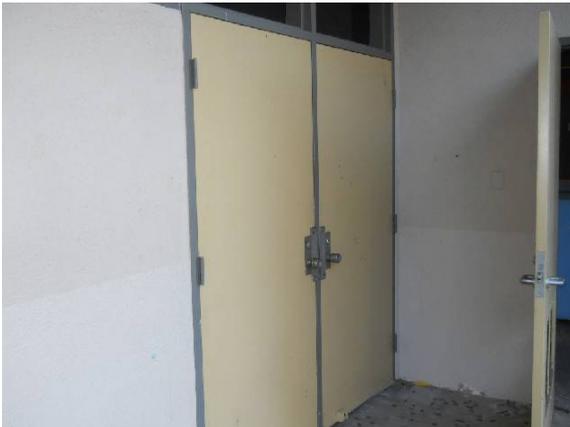
Location: All exterior doors, including the hand operated roll up doors at the serving line.

Notes: All exterior doors are original construction, beyond expected useful life. Provide interior locking hardware at all classroom doors for security. Recommend replacement as part of school renovation. Serving line roll-up doors approx \$9,000 ea

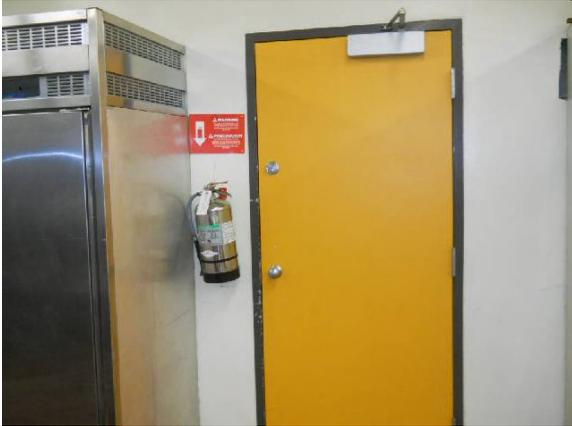
Location: Typical throughout the building
Material: System
Distress: Beyond Service Life
Category: Capital Renewal
Priority: 3 - Necessary/Not Yet Critical (Years 2-5)
Correction: Renew System
Qty: 1-Ea.
Estimate: \$77,896.22
Assessor Name: Dave Cunningham
Date Created: 01/24/2013

Notes: All interior doors are original construction, beyond expected service life. Recommend replacement during school renovation.

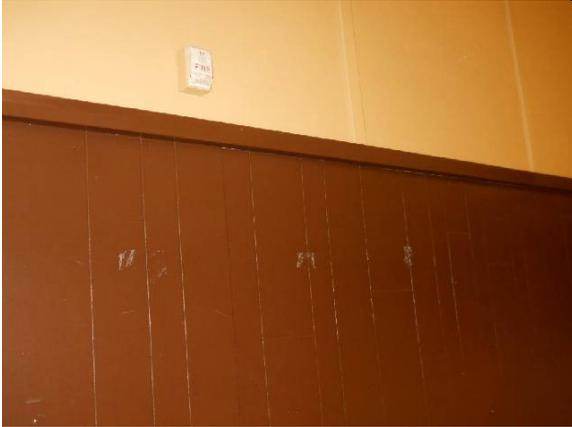
Location: Typical throughout the building
Material: System
Distress: Beyond Service Life
Category: Deferred Maintenance
Priority: 4 - Recommended (Years 6-10)
Correction: Renew System
Qty: 1-Ea.
Estimate: \$211,052.32
Assessor Name: Dave Cunningham
Date Created: 01/24/2013

Notes: All wall surfaces need to be replaced and/or repaired. Patch/paint or replace as required during school renovations

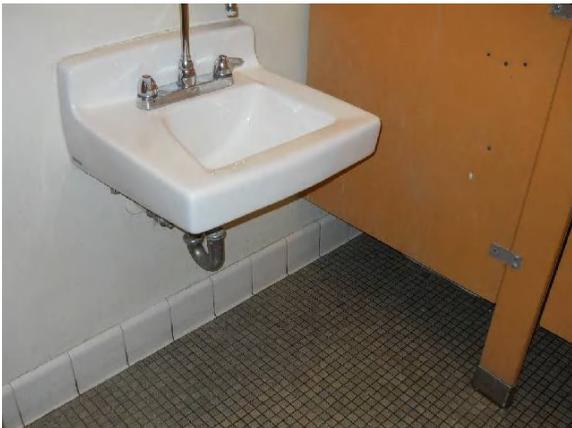
Location: Mens RR 27, Womens RR 26, Toilets 22, 04, 06
Material: System
Distress: Beyond Service Life
Category: Capital Renewal
Priority: 4 - Recommended (Years 6-10)
Correction: Renew System
Qty: 1-Ea.
Estimate: \$11,713.68
Assessor Name: Dave Cunningham
Date Created: 01/24/2013

Notes: All ceramic tile floor finishes are original construction. Recommend replacement during school renovations.

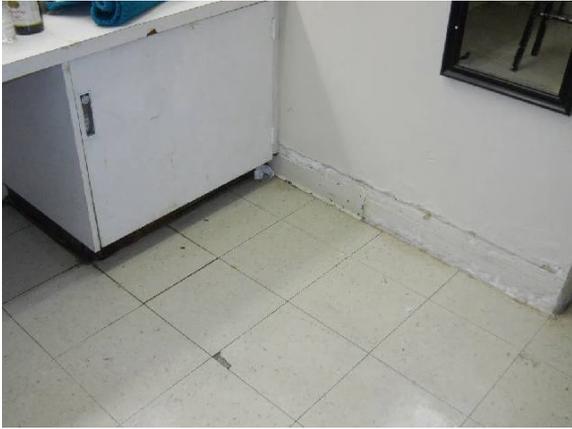
Location: Serving, Staff Lounge, Storage areas, Multi-Purpose Rm, Dressing Rooms (2), Office 24

Notes: VCT is aged and beyond expected service life. Recommend replacement as part of school renovation

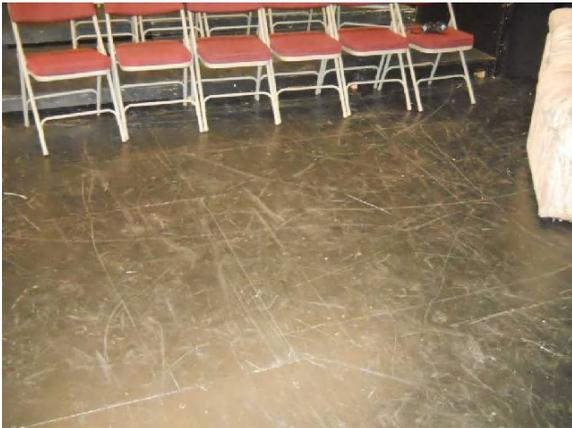
Location: Stage/Platform

Notes: Wood flooring is original construction. Recommend replacement during school renovations.

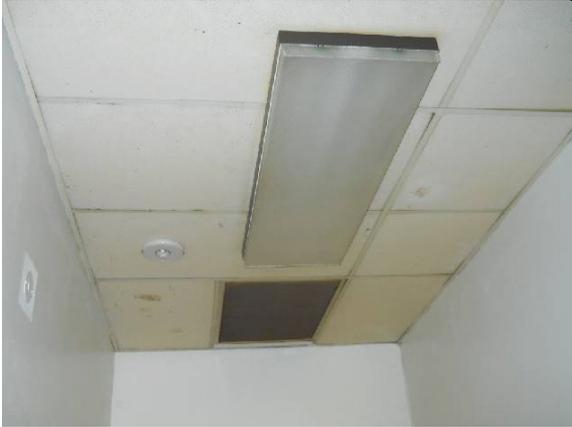
Location: Typical throughout the building; hard deck painted ceiling finishes and grid/acoustical tile systems

Notes: All ceiling finishes are beyond expected service life. Recommend replacement during school renovations.

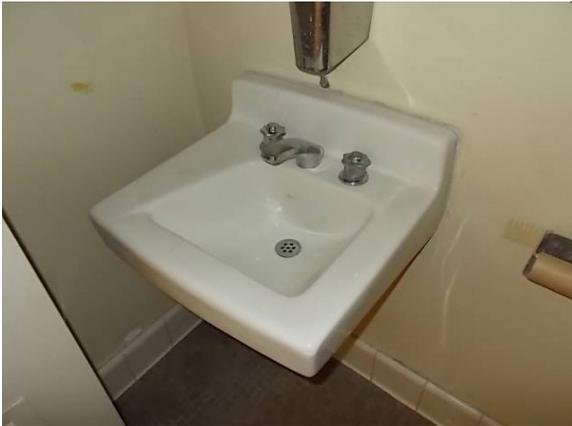
Location: System-Typical for all building locations.

Notes: Plumbing fixtures are mostly original to building construction date of 1972 and therefore are beyond expected life. Recommend replacing system during next remodel or renovation.

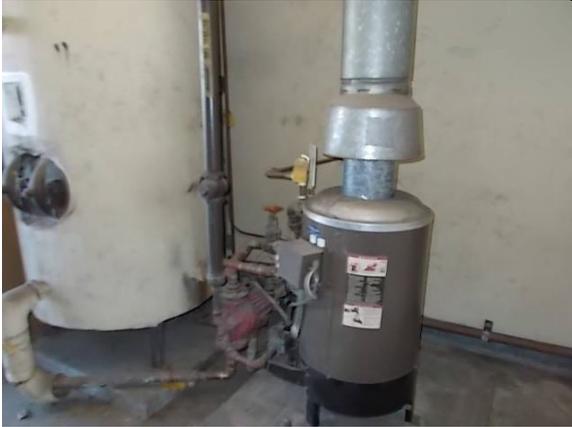
Location: System-Typical for all building locations.
Material: System
Distress: Beyond Service Life
Category: Deferred Maintenance
Priority: 3 - Necessary/Not Yet Critical (Years 2-5)
Correction: Renew System
Qty: 1-Ea.
Estimate: \$161,108.64
Assessor Name: Dave Cunningham
Date Created: 01/24/2013

Notes: Recommend replacing system during next remodel or renovation.

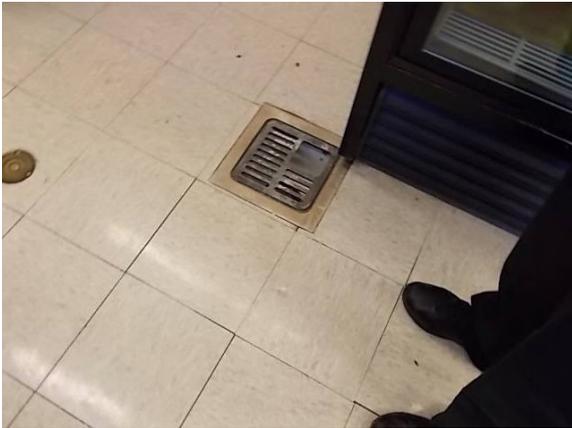
Location: System-Typical for all required building locations.
Material: System
Distress: Beyond Expected Life
Category: Capital Renewal
Priority: 4 - Recommended (Years 6-10)
Correction: Renew System
Qty: 1-Ea.
Estimate: \$102,879.37
Assessor Name: Dave Cunningham
Date Created: 01/24/2013

Notes: Recommend replacing all above grade sanitary waste and vent piping system during next remodel or renovation; below grade waste piping, recommend video inspection and replace as required.

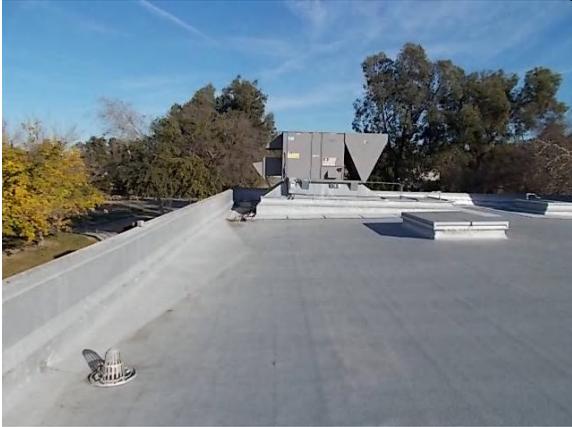
Location: System-Typical for all building locations.
Material: System
Distress: Beyond Expected Life
Category: Capital Renewal
Priority: 4 - Recommended (Years 6-10)
Correction: Renew System
Qty: 1-Ea.
Estimate: \$16,801.33
Assessor Name: Dave Cunningham
Date Created: 01/24/2013

Notes: Recommend replacing system during next remodel or renovation.

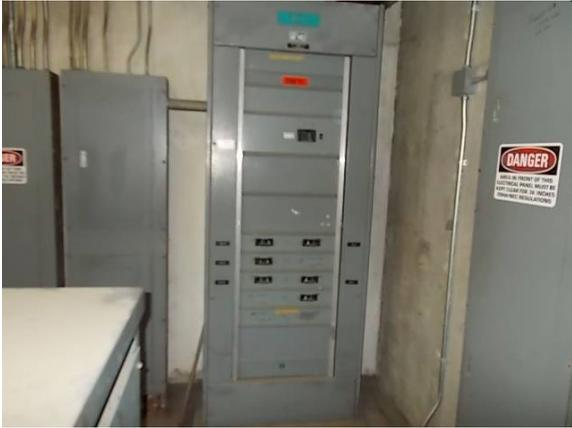
Location: System-Typical for all required building locations.

Notes: The main electrical switchgear, distribution panel boards and feeders are mostly original to the building construction date of 1972 and therefore beyond expected life. The system is recommended to be replaced during the next major renovation.

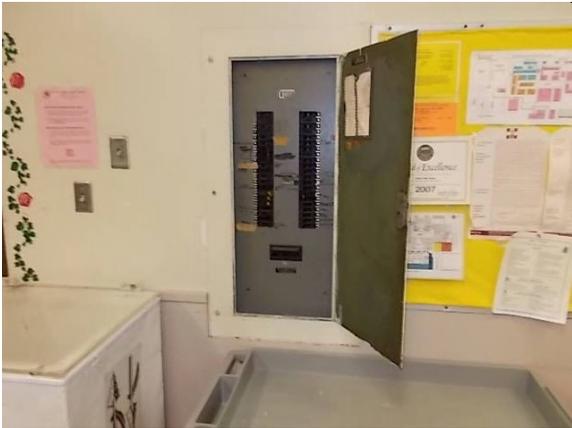
Location: System-Typical for all building locations.

Notes: The branch wiring, electrical panels and devices are mostly original to the building construction date of 1972 and therefore beyond expected life. The system is recommended to be replaced during the next major renovation.

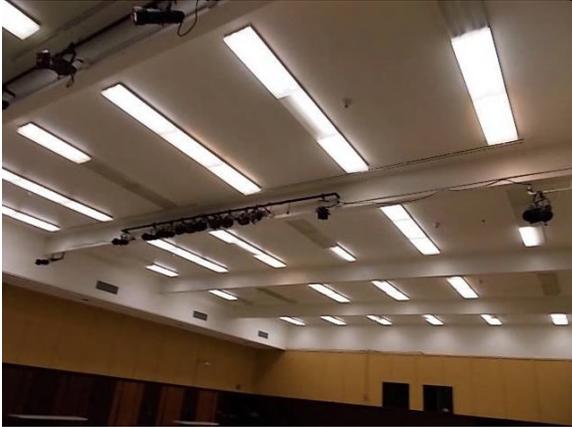
Location: System-Typical for all building locations.
Material: System
Distress: Beyond Expected Life
Category: Capital Renewal
Priority: 4 - Recommended (Years 6-10)
Correction: Renew System
Qty: 1-Ea.
Estimate: \$349,145.44
Assessor Name: Dave Cunningham
Date Created: 01/24/2013

Notes: The building light fixtures, lamps and ballast were upgraded to T8 fluorescent type in 2007 in most spaces; however we recommend replacing all lighting in the building during next remodel or renovation.

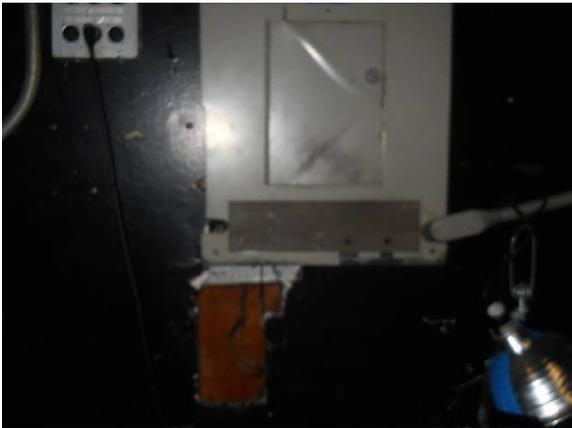
Location: Platform / Stage
Material: System
Distress: Beyond Service Life
Category: Capital Renewal
Priority: 3 - Necessary/Not Yet Critical (Years 2-5)
Correction: Renew System
Qty: 1-Ea.
Estimate: \$59,610.20
Assessor Name: Dave Cunningham
Date Created: 01/24/2013

Notes: Stage and theater equipment is aged and beyond expected useful life. Recommend replacement during school renovations

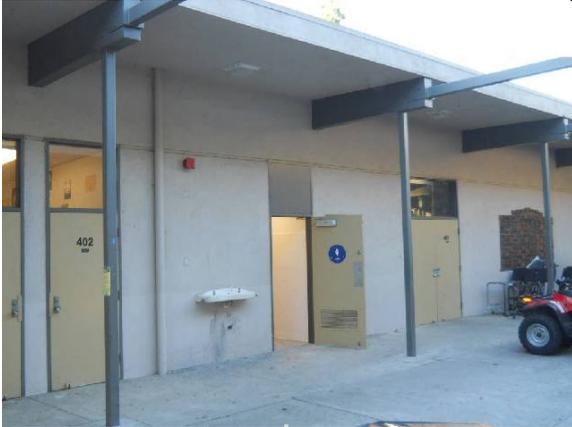
Location: Exterior windows, above doors
Material: System
Distress: Beyond Service Life
Category: Capital Renewal
Priority: 3 - Necessary/Not Yet Critical (Years 2-5)
Correction: Renew System
Qty: 1-Ea.
Estimate: \$9,288.58
Assessor Name: Dave Cunningham
Date Created: 01/24/2013

Notes: Windows are original construction, beyond expected service life. Recommend replacement during school renovations

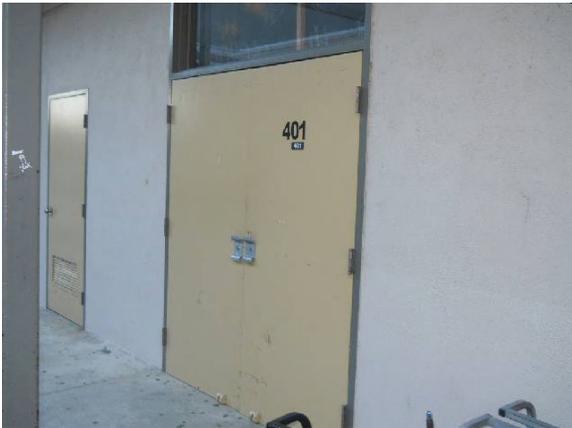
Location: All exterior doors
Material: System
Distress: Beyond Service Life
Category: Capital Renewal
Priority: 4 - Recommended (Years 6-10)
Correction: Renew System
Qty: 1-Ea.
Estimate: \$58,180.07
Assessor Name: Dave Cunningham
Date Created: 01/24/2013

Notes: Exterior door system is original construction, beyond expected service life. Provide interior locking hardware at all classroom doors for security. Recommend replacement during school renovation.

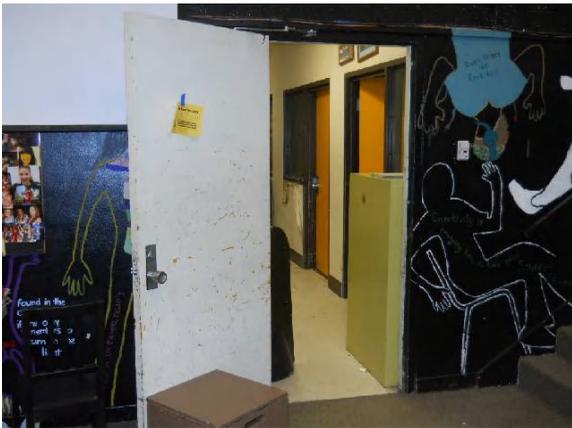
Location: All interior door systems
Material: System
Distress: Beyond Expected Life
Category: Capital Renewal
Priority: 3 - Necessary/Not Yet Critical (Years 2-5)
Correction: Renew System
Qty: 1-Ea.
Estimate: \$36,544.39
Assessor Name: Dave Cunningham
Date Created: 01/24/2013

Notes: All interior door systems are original construction, beyond expected service life. Recommend replacement during school renovation.

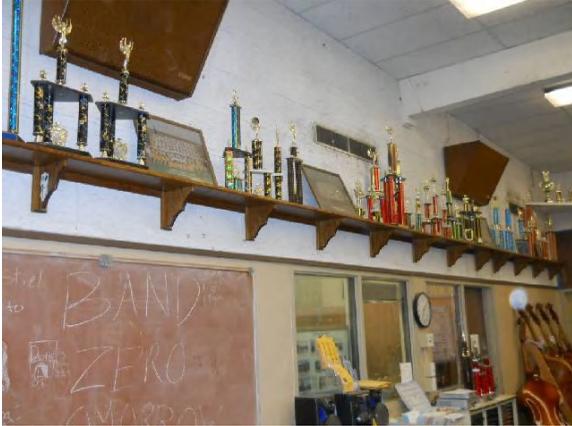
Location: Typical throughout the building.
Material: System
Distress: Beyond Service Life
Category: Capital Renewal
Priority: 4 - Recommended (Years 6-10)
Correction: Renew System
Qty: 1-Ea.
Estimate: \$135,265.20
Assessor Name: Dave Cunningham
Date Created: 01/24/2013

Notes: All wall surfaces require replacement (accoustical panels in music rooms) and/or repair/repaint in all remaining areas. Wall systems are beyond expected service life. Recommend replacement during next school renovation.

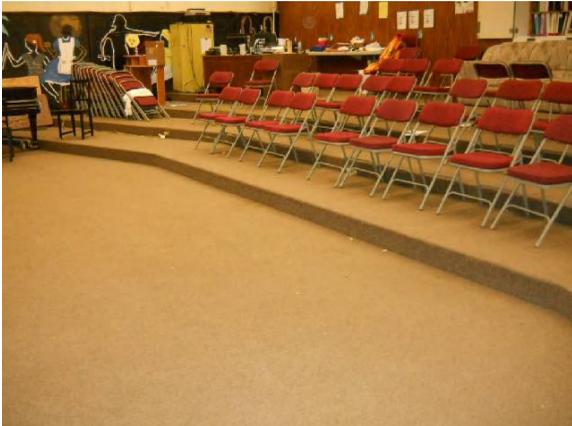
Location: Classroom 400, 401, 402, 403, practice rooms, office
Material: System
Distress: Beyond Service Life
Category: Capital Renewal
Priority: 3 - Necessary/Not Yet Critical (Years 2-5)
Correction: Renew System
Qty: 1-Ea.
Estimate: \$83,174.57
Assessor Name: Dave Cunningham
Date Created: 01/24/2013

Notes: Carpet is aged, worn, and dirty. Carpet is beyond expected service life. Recommend replacement during school renovations.

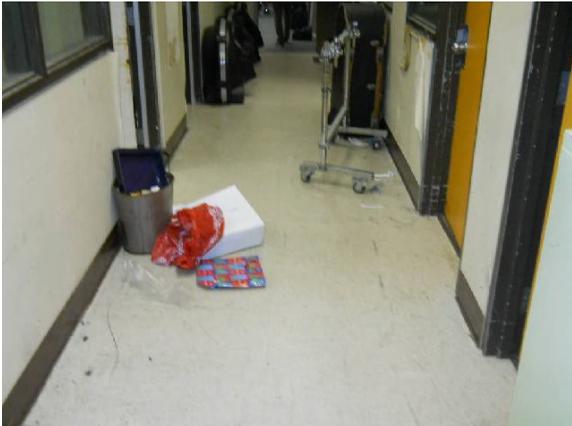
Location: Storage 10, Uniform storage, corridor 19
Material: System
Distress: Beyond Service Life
Category: Capital Renewal
Priority: 3 - Necessary/Not Yet Critical (Years 2-5)
Correction: Renew System
Qty: 1-Ea.
Estimate: \$5,693.69
Assessor Name: Dave Cunningham
Date Created: 01/24/2013

Notes: VCT floor covering is worn and beyond expected service life. Recommend replacement during school renovations.

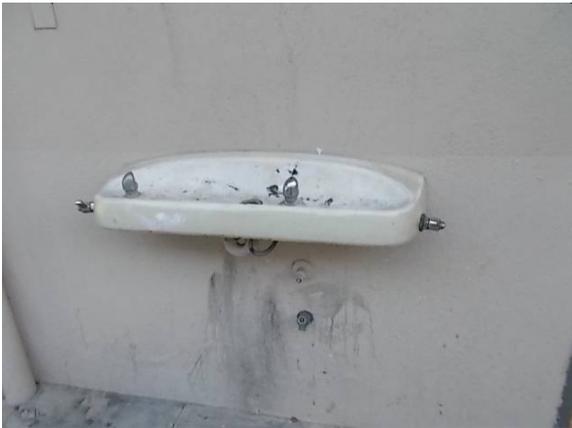
Location: Drinking fountain locations, typical for (2)
Material: Drinking Fountain
Distress: Beyond Expected Life
Category: Capital Renewal
Priority: 4 - Recommended (Years 6-10)
Correction: Replace fountain drinking fountain
Qty: 3-Ea.
Estimate: \$6,384.87
Assessor Name: Sonny Satterfield
Date Created: 01/28/2013

Notes: Replace wall mounted bubblers with (2) each electric drinking fountains and (1) ADA at each location.

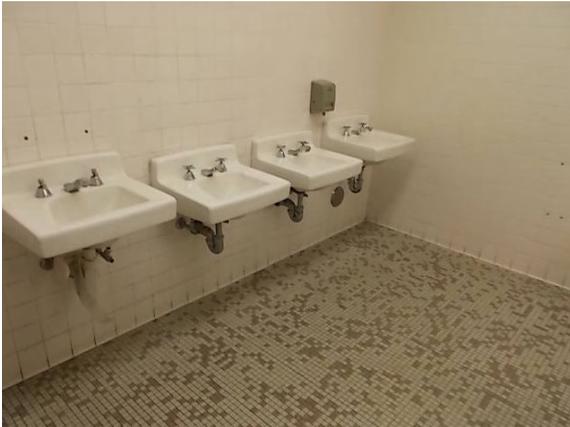
Location: System-Typical for all required building locations.
Material: System
Distress: Beyond Expected Life
Category: Capital Renewal
Priority: 4 - Recommended (Years 6-10)
Correction: Renew System
Qty: 1-Ea.
Estimate: \$81,545.27
Assessor Name: Dave Cunningham
Date Created: 01/24/2013

Notes: Recommend replacing system during next remodel or renovation.

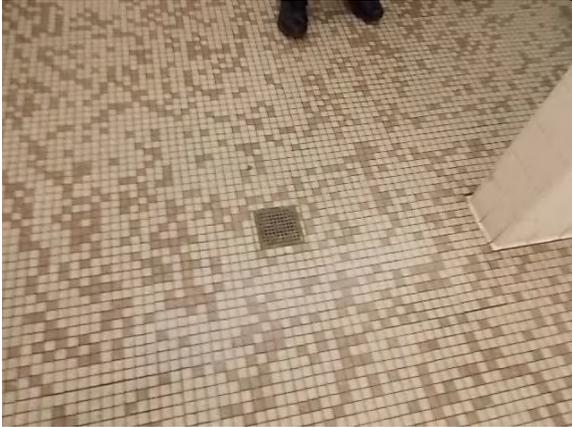
Location: System-Typical for all required building locations.

Notes: Recommend replacing all above grade sanitary waste and vent piping system during next remodel or renovation; below grade waste piping, recommend video inspection and replace as required.

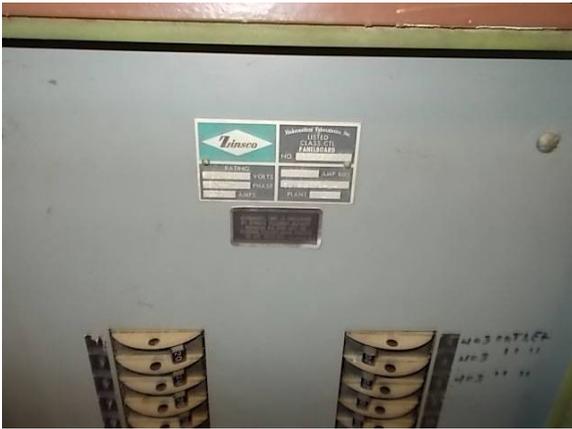
Location: System-Typical for all building locations.
Material: System
Distress: Beyond Expected Life
Category: Capital Renewal
Priority: 4 - Recommended (Years 6-10)
Correction: Renew System
Qty: 1-Ea.
Estimate: \$77,797.37
Assessor Name: Dave Cunningham
Date Created: 01/24/2013

Notes: The main electrical switchgear, distribution panel boards and feeders are mostly original to the building construction date of 1972 and therefore beyond expected life. The system is recommended to be replaced during the next major renovation.

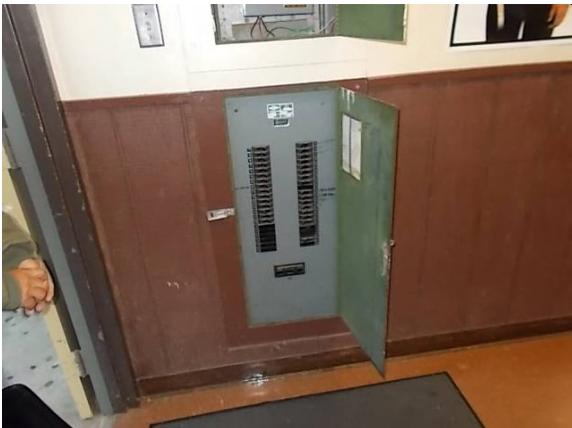
Location: System-Typical for all building locations.
Material: System
Distress: Beyond Expected Life
Category: Capital Renewal
Priority: 4 - Recommended (Years 6-10)
Correction: Renew System
Qty: 1-Ea.
Estimate: \$213,289.72
Assessor Name: Dave Cunningham
Date Created: 01/24/2013

Notes: The branch wiring, electrical panels and devices are mostly original to the building construction date of 1972 and therefore beyond expected life. The system is recommended to be replaced during the next major renovation.

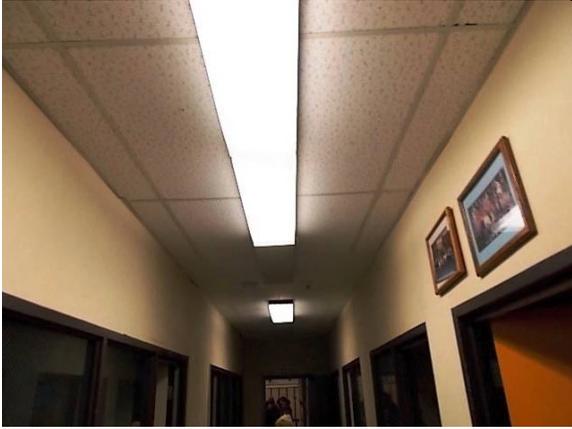
Location: System-Typical for all building locations.
Material: System
Distress: Beyond Service Life
Category: Capital Renewal
Priority: 4 - Recommended (Years 6-10)
Correction: Renew System
Qty: 1-Ea.
Estimate: \$176,832.85
Assessor Name: Dave Cunningham
Date Created: 01/24/2013

Notes: The building light fixtures, lamps and ballast were upgraded to T8 fluorescent type in 2007 in most spaces; however we recommend replacing all lighting in the building during next remodel or renovation.

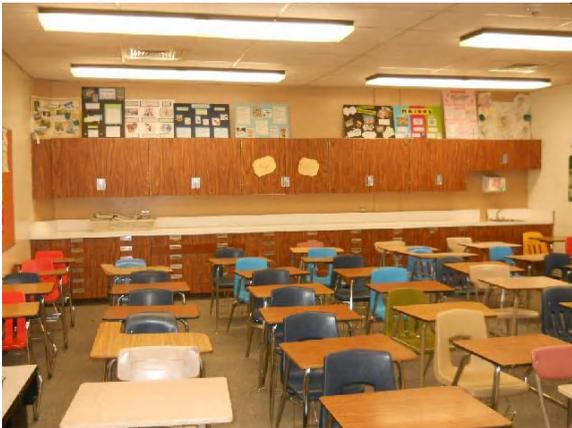
Location: Band Classroom, storage rooms
Material: Fixed Casework
Distress: Beyond Expected Life
Category: Deferred Maintenance
Priority: 3 - Necessary/Not Yet Critical (Years 2-5)
Correction: Replace Casework OUSD
Qty: 185-L.F.
Estimate: \$112,433.76
Assessor Name: Dave Cunningham
Date Created: 01/24/2013

Notes: Built in casework for band storage is original construction and beyond expected service life. Recommend replacement during school renovation.

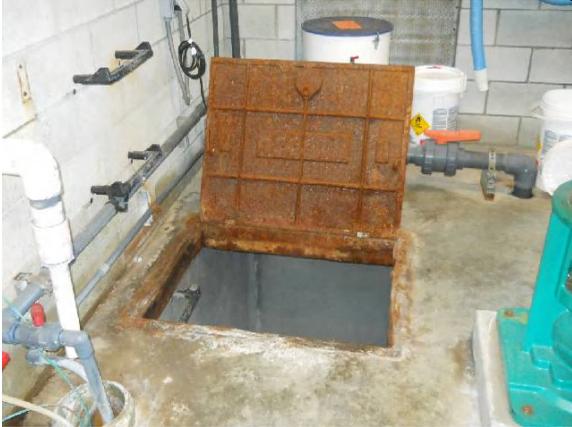
Location: Interior floor
Material: Floor Construction Concrete
Distress: Failing
Category: Safety
Priority: 3 - Necessary/Not Yet Critical (Years 2-5)
Correction: Floor Access Hatch
Qty: 2-S.F.
Estimate: \$6,468.91
Assessor Name: Dave Cunningham
Date Created: 01/25/2013

Notes: Floor access hatches to the basement water holding tanks are rusting and should be replaced during school renovations

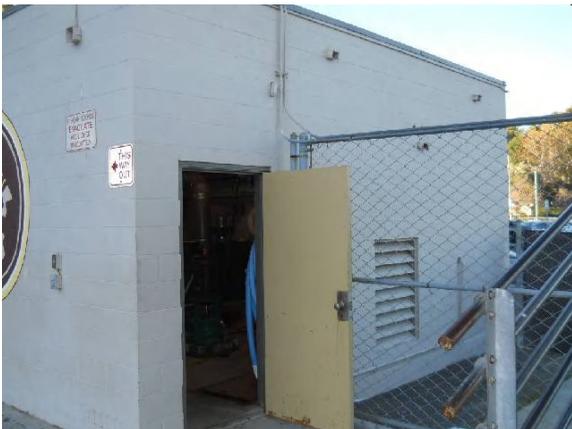
Location: Four exterior doors
Material: System
Distress: Beyond Service Life
Category: Deferred Maintenance
Priority: 3 - Necessary/Not Yet Critical (Years 2-5)
Correction: Renew System
Qty: 1-Ea.
Estimate: \$15,523.20
Assessor Name: Dave Cunningham
Date Created: 01/25/2013

Notes: All exterior doors are original construction, beyond expected service life. Doors are rusted and should be replaced during school renovations.

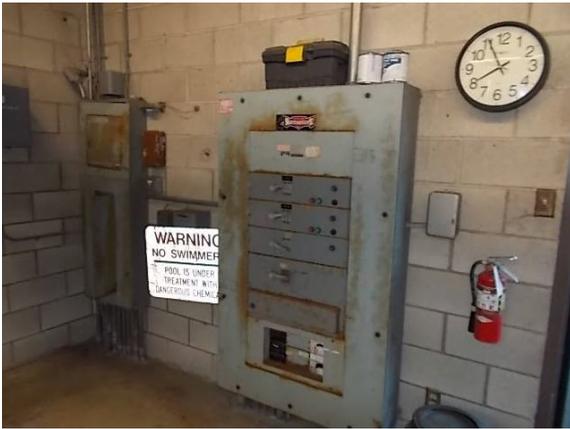
Location: System-Typical for all building locations
Material: System
Distress: Beyond Expected Life
Category: Capital Renewal
Priority: 4 - Recommended (Years 6-10)
Correction: Renew System
Qty: 1-Ea.
Estimate: \$24,567.84
Assessor Name: Dave Cunningham
Date Created: 01/25/2013

Notes: The main electrical switchgear, distribution panel boards and feeders are mostly original to the building construction date of 1976 and therefore beyond expected life. The system is recommended to be replaced during the next major renovation.

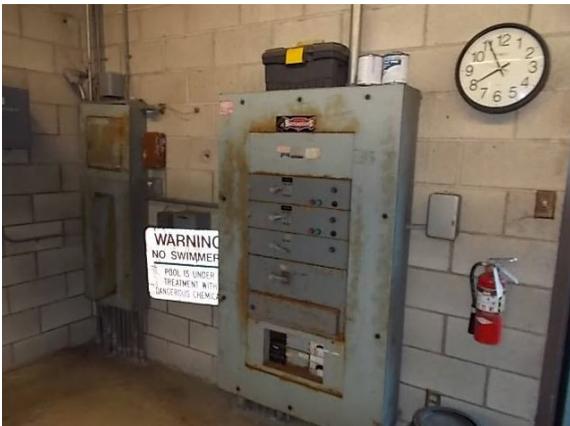
Location: System-Typical for all building locations.
Material: System
Distress: Beyond Service Life
Category: Capital Renewal
Priority: 4 - Recommended (Years 6-10)
Correction: Renew System
Qty: 1-Ea.
Estimate: \$14,284.51
Assessor Name: Dave Cunningham
Date Created: 01/25/2013

Notes: The branch wiring, electrical panels and devices are mostly original to the building construction date of 1976 and therefore beyond expected life. The system is recommended to be replaced during the next major renovation.

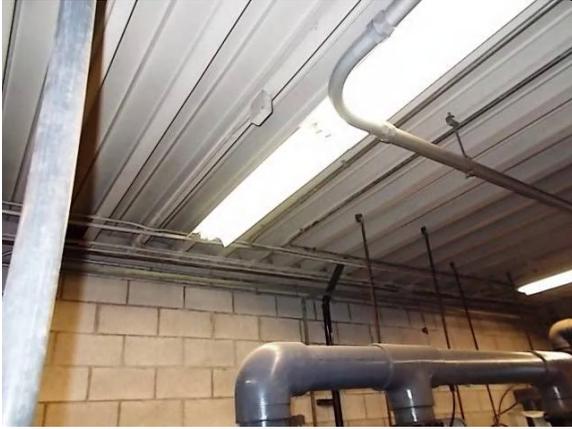
Location: System-Typical for all building locations.
Material: System
Distress: Beyond Expected Life
Category: Capital Renewal
Priority: 4 - Recommended (Years 6-10)
Correction: Renew System
Qty: 1-Ea.
Estimate: \$9,028.80
Assessor Name: Dave Cunningham
Date Created: 01/25/2013

Notes: Recommned replacing lighting fixtures, wiring and switches/controls during next remodel or renovation.

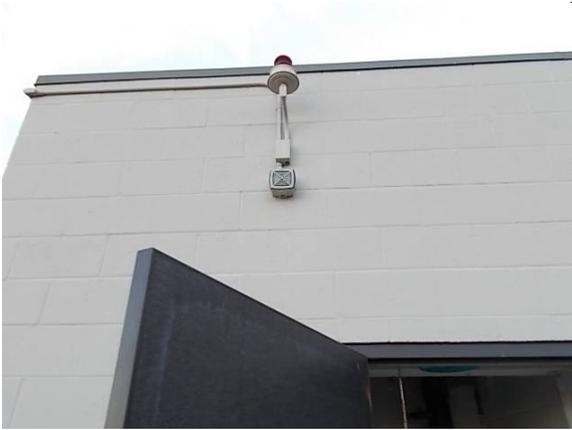
Location: System-Typical for all building locations.
Material: System
Distress: Inadequate
Category: Capital Renewal
Priority: 4 - Recommended (Years 6-10)
Correction: Renew System
Qty: 1-Ea.
Estimate: \$6,548.26
Assessor Name: Sonny Satterfield
Date Created: 01/29/2013

Notes: LAN/Tele, Security and Fire Alarm systems are missing or beyond expected life, recommend adding systems during next major renovation.

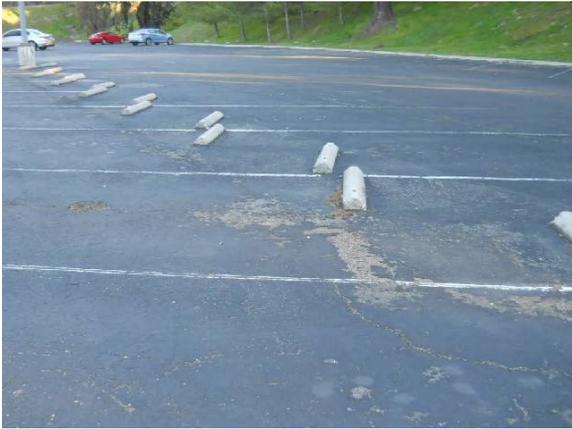
System: G2010 - Roadways

Location: Student parking lot and roadways, paved basketball play courts
Material: Ashphalt Paving parking lot
Distress: Failing
Category: Deferred Maintenance
Priority: 3 - Necessary/Not Yet Critical (Years 2-5)
Correction: Asphalt seal coat minor repairs paint stripes
Qty: 150,000-S.F.
Estimate: \$697,602.28
Assessor Name: Dave Cunningham
Date Created: 01/24/2013

Notes: Parking lots and paved courts are in need of minor repairs, seal-coat, paint stripe. Recommend repairs/renewal during school renovations

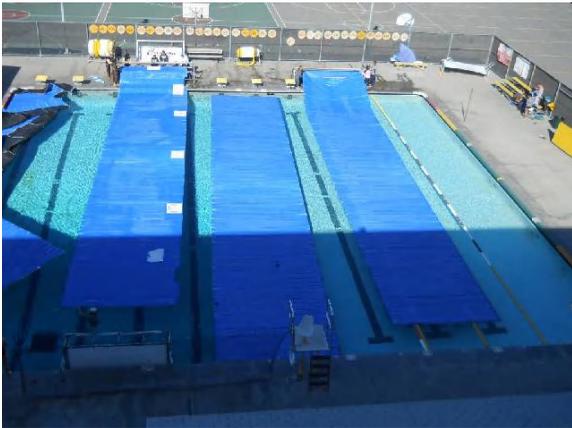
System: G2040920 - Swimming Pools

Location: Swimming Pool
Material: System
Distress: Beyond Service Life
Category: Capital Renewal
Priority: 4 - Recommended (Years 6-10)
Correction: Renew System
Qty: 1-Ea.
Estimate: \$711,216.00
Assessor Name: Dave Cunningham
Date Created: 01/24/2013

Notes: Recommend construction of competition size swimming pool.

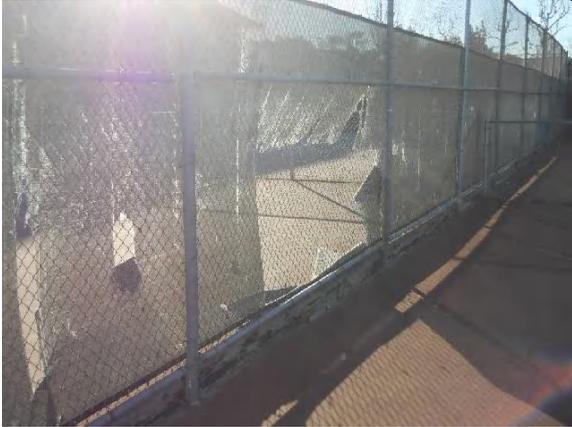
System: G2040940 - Playing Fields

Location: Tennis courts
Material: Tennis Court Resurfacing
Distress: Damaged
Category: Deferred Maintenance
Priority: 3 - Necessary/Not Yet Critical (Years 2-5)
Correction: Resurface asphalt tennis court
Qty: 1-Ea.
Estimate: \$1,266.84
Assessor Name: Dave Cunningham
Date Created: 01/24/2013

Notes: Wind screen netting had deteriorated and is not functional. Replace the wind screen material

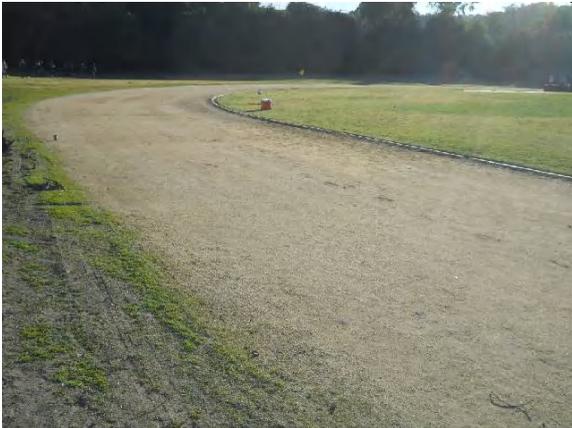
System: G2040940 - Playing Fields

Location: Track, Soccer field
Material: Running Track
Distress: Beyond Expected Life
Category: Capital Renewal
Priority: 4 - Recommended (Years 6-10)
Correction: Running Track competition grade
Qty: 1-Ea.
Estimate: \$1,487,111.04
Assessor Name: Dave Cunningham
Date Created: 01/31/2013

Notes: Recommend construction of competition grade running track / soccer field system.

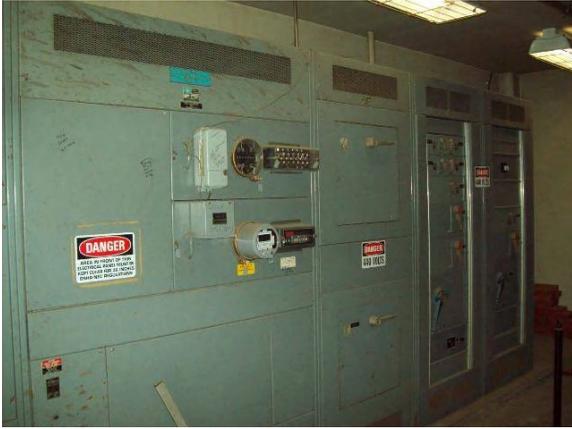
System: G4010 - Electrical Distribution

Location: Main electrical power service entrance and feeders to buildings

Notes: Site electrical incoming power switchgear, panels, equipment and underground feeders to buildings are beyond expected life; all are recommended to be replaced as part of the next major renovation.

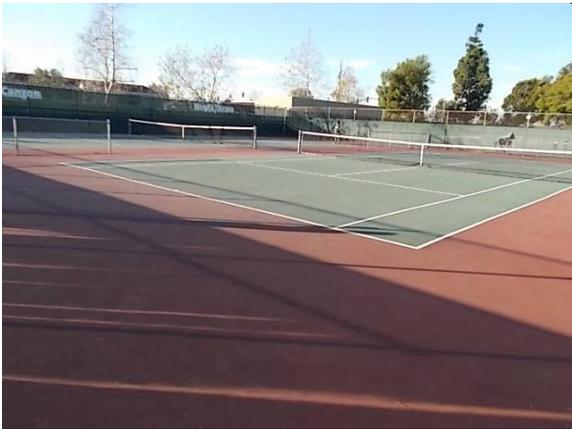
System: G4020 - Site Lighting

Location: System-Typical for all required locations.

Material: Outdoor Pole Lights

Distress: Inadequate

Notes: All existing site pole lighting fixtures were replaced with LED type fixtures in 2012, except the tennis courts have no lighting, recommend adding. Site is recommended for additional site pole fixtures and tennis court lighting; in order to provide adequate night time security for vehicle and pedestrian traffic and additional athletic field lighting.

Correction: Replace light pole, 2 fixtures (conc. base not inc)

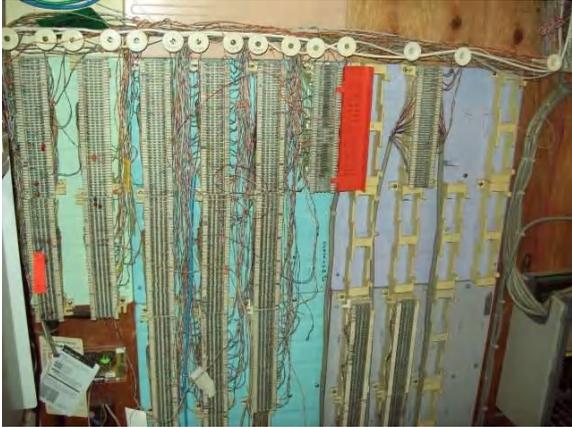
System: G4030 - Site Communications and Security

Location: Site cabling and all service building locations for communications backbone and security service cabling.

Distress: Inadequate

Correction: Replace communications and security cabling

Notes: Recommend upgrades and replacing as needed all communications and security cabling and equipment for enhancements
