Orange Unified School District

Facilities Condition Assessment for:

**Orange High School
525 N. Shaffer Street
Orange, CA 92867**

Report: Mar 11, 2013

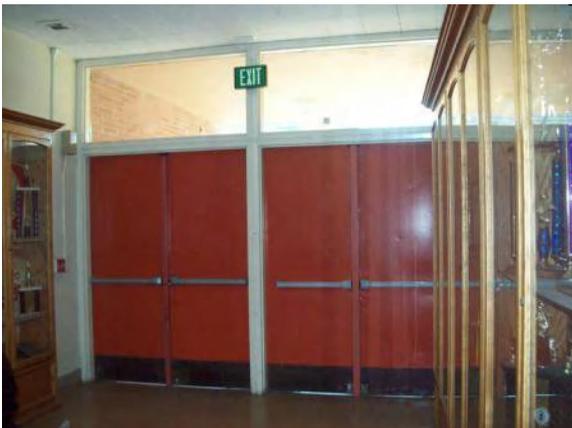
System: B2030 - Exterior Doors

Location: All exterior doors.
Material: System
Distress: Beyond Expected Life
Category: Capital Renewal
Priority: 3 - Necessary/Not Yet Critical (Years 2-5)
Correction: Renew System
Qty: 1-Ea.
Estimate: \$688,030.55
Assessor Name: Eduardo Lopez
Date Created: 01/21/2013

Notes: Exterior doors appear to be original with some replacement hardware. There are two large sliding doors at the back stage opening to the amphitheater. At classrooms, provide interior locking lever latches.

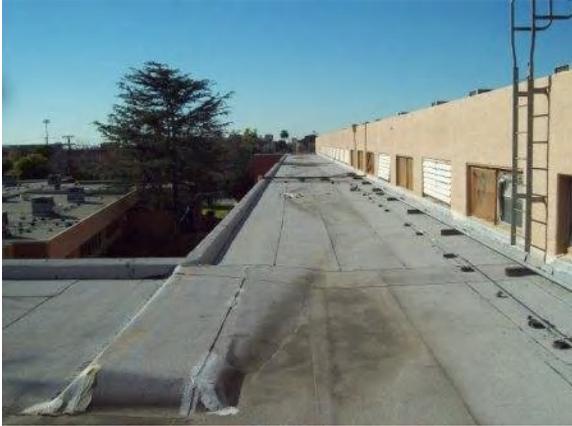
System: B3010105 - Built-Up

Location: Roof of 200 wing and N/S 1-story portion between 2-story and band room.
Material: Built-Up Roofing
Distress: Beyond Expected Life
Category: Capital Renewal
Priority: 1 - Currently Critical (Immediate)
Correction: Total roof replacement built-up roofing
Qty: 187-Sq.
Estimate: \$311,688.91
Assessor Name: Ann Buerger Linden
Date Created: 02/01/2013

Notes: These roof areas are well beyond their expected life with obvious deficiencies such as loss of granules in cap sheet, splitting, tears and holes at the perimeter, blistering and general degradation. Stained ceilings are common. Replacement of these areas is recommended. The science wing and band/auditorium areas were re-roofed in 1996.

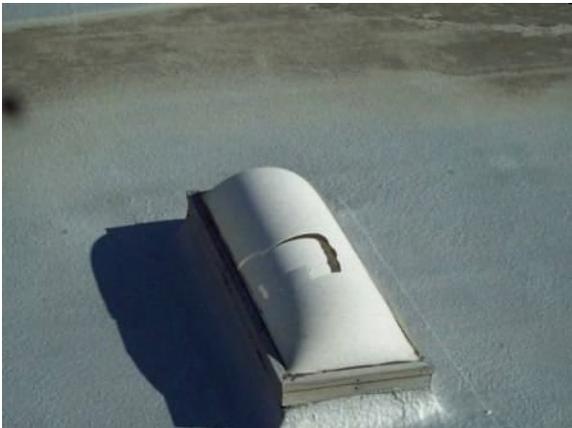
System: B3020 - Roof Openings

Location: Skylights over theater back stage. Roof hatches to 2-story and 1-story areas.
Material: System
Distress: Beyond Expected Life
Category: Capital Renewal
Priority: 3 - Necessary/Not Yet Critical (Years 2-5)
Correction: Renew System
Qty: 1-Ea.
Estimate: \$25,190.54
Assessor Name: Eduardo Lopez
Date Created: 01/21/2013

Notes: Skylites are beyond expected life. One is visibly broken. Interiors show ceiling staining around skylights. Replace skylites. Existing roof hatches are heavy and inoperable. Replace roof hatches and access ladders with code compliant assemblies to facilitate safe roof access for maintenance of roofs and roof mounted equipment.

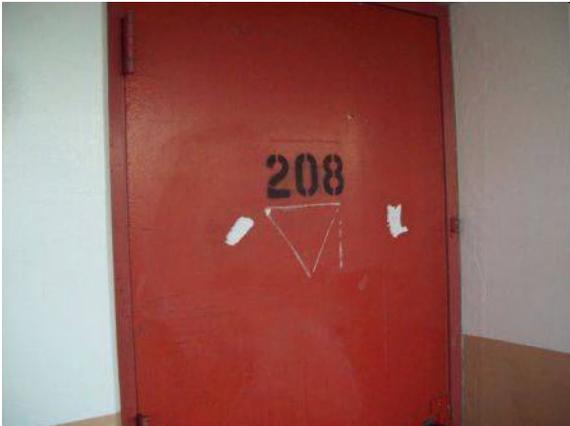
System: C1030 - Fittings

Location: Building wide.
Material: Signage
Distress: Inadequate
Category: Capital Renewal
Priority: 3 - Necessary/Not Yet Critical (Years 2-5)
Correction: Replace/Install code compliant signage
Qty: 36,984-S.F.
Estimate: \$7,988.54
Assessor Name: Ann Buerger Linden
Date Created: 02/01/2013

Notes: Provide code compliant signage throughout the building.

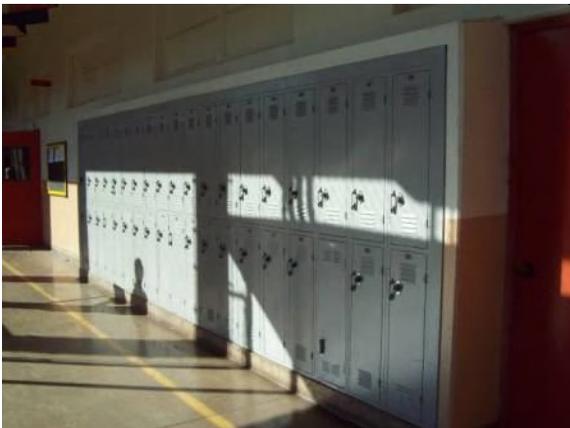
System: C1030 - Fittings

Location: Building exterior sheltered walls.
Material: Fixed Furnishings - Lockers
Distress: Beyond Expected Life
Category: Capital Renewal
Priority: 3 - Necessary/Not Yet Critical (Years 2-5)
Correction: Student lockers stacked 2-high
Qty: 700-Ea.
Estimate: \$485,805.60
Assessor Name: Ann Buerger Linden
Date Created: 02/01/2013

Notes: Most lockers are missing. Those that are present are original and in fair to poor condition.

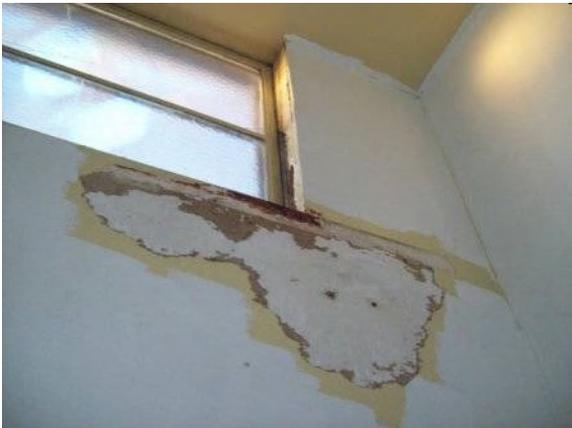
System: C3010 - Wall Finishes

Location: All interiors.
Material: System
Distress: Beyond Expected Life
Category: Capital Renewal
Priority: 3 - Necessary/Not Yet Critical (Years 2-5)
Correction: Renew System
Qty: 1-Ea.
Estimate: \$456,489.63
Assessor Name: Eduardo Lopez
Date Created: 01/21/2013

Notes: Although generally well maintained, expected renovations of adjacent building systems such as exterior windows, interior doors, cabinetry and partition reconfigurations will necessitate replacing all interior wall surfaces including paint, ceramic tile, and panelling

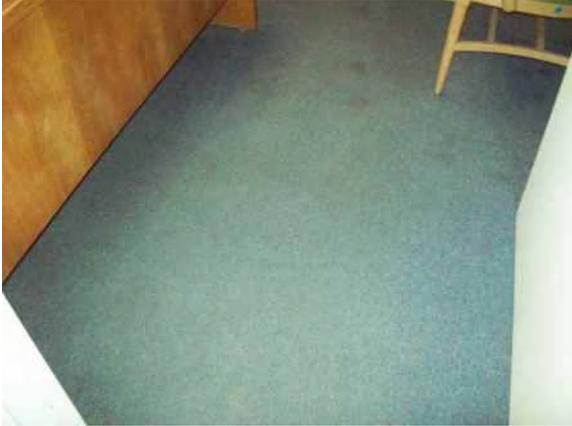
System: C3020210 - Carpet

Location: Office areas. Portion of band room. Aisles of theater.

Notes: Carpeting is in stained and worn condition. System renewal is recommended.

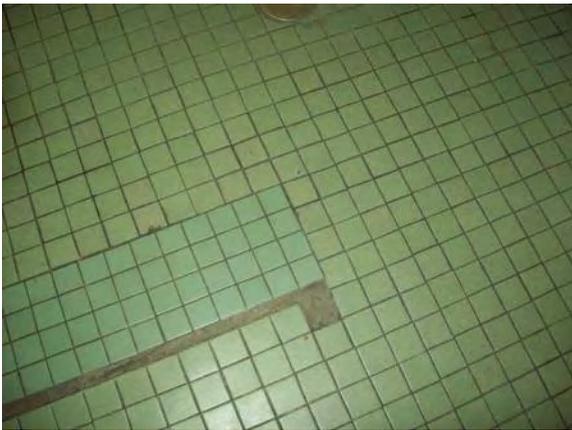
System: C3020210 - Ceramic Tile

Location: All student and staff restrooms.

Notes: Ceramic tile floors are original and in fair to poor condition.

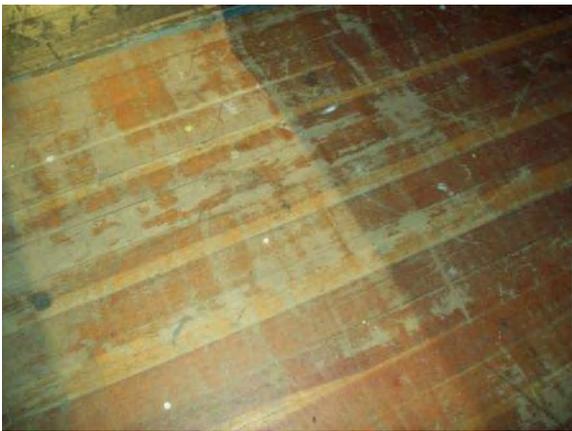
System: C3020410 - Wood

Location: Theater stage
Material: System
Distress: Beyond Expected Life
Category: Capital Renewal
Priority: 3 - Necessary/Not Yet Critical (Years 2-5)
Correction: Renew System
Qty: 1-Ea.
Estimate: \$43,704.14
Assessor Name: Eduardo Lopez
Date Created: 01/21/2013

Notes: Wood flooring at the theater stage is expired.

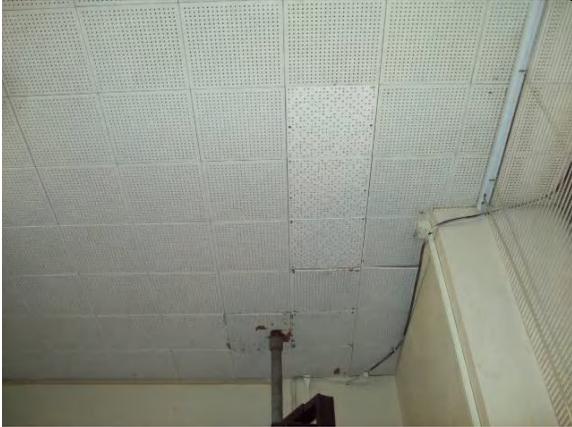
System: C3030 - Ceiling Finishes

Location: Building wide.
Material: System
Distress: Beyond Expected Life
Category: Capital Renewal
Priority: 3 - Necessary/Not Yet Critical (Years 2-5)
Correction: Renew System
Qty: 1-Ea.
Estimate: \$811,466.19
Assessor Name: Eduardo Lopez
Date Created: 01/21/2013

Notes: Ceiling types include 12" glue-on tile, suspended acoustical systems, and plaster. Suspended systems are not original but are in expired condition with staining from roof or plumbing leaks, missing and mis-matched tile, and sagging tile in suspended systems all common. All ceilings are recommended for replacement.

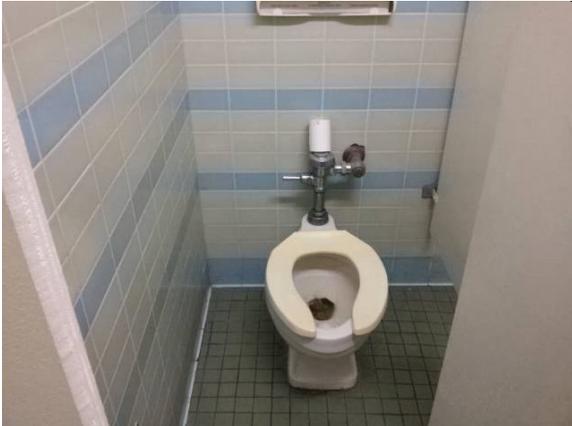
System: D2010 - Plumbing Fixtures

Location: Women, Men & Staff restrooms, both levels
Material: Tankless Water Closet
Distress: Beyond Expected Life
Category: Capital Renewal
Priority: 4 - Recommended (Years 6-10)
Correction: Replace tankless water closet
Qty: 21-Ea.
Estimate: \$25,944.71
Assessor Name: Eduardo Lopez
Date Created: 01/22/2013

Notes: Replace during next remodel or renovation.

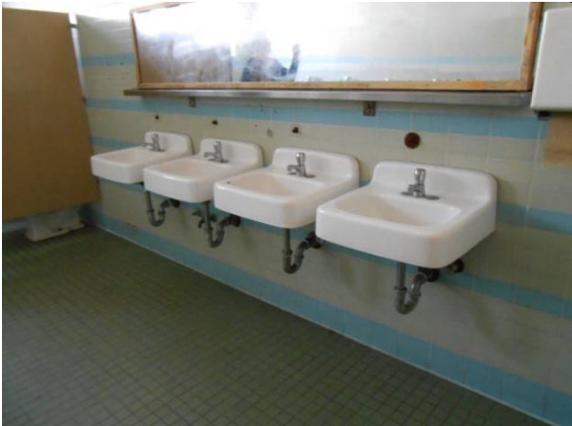
System: D2010 - Plumbing Fixtures

Location: Women, Men & Staff restrooms, both levels
Material: Lavatory, Vitreous China
Distress: Beyond Expected Life
Category: Capital Renewal
Priority: 4 - Recommended (Years 6-10)
Correction: Replace lavatory, vitreous china
Qty: 26-Ea.
Estimate: \$27,949.71
Assessor Name: Eduardo Lopez
Date Created: 01/22/2013

Notes: Replace during next remodel or renovation.

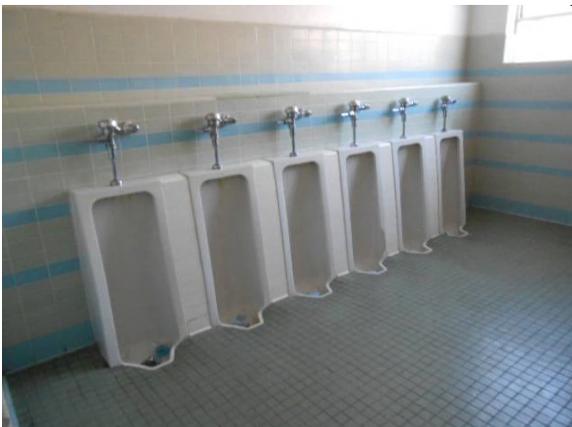
System: D2010 - Plumbing Fixtures

Location: Men restrooms
Material: Urinal
Distress: Beyond Expected Life
Category: Capital Renewal
Priority: 4 - Recommended (Years 6-10)
Correction: Replace wall-hung urinal
Qty: 14-Ea.
Estimate: \$21,718.37
Assessor Name: Eduardo Lopez
Date Created: 01/22/2013

Notes: Replace during next remodel or renovation.

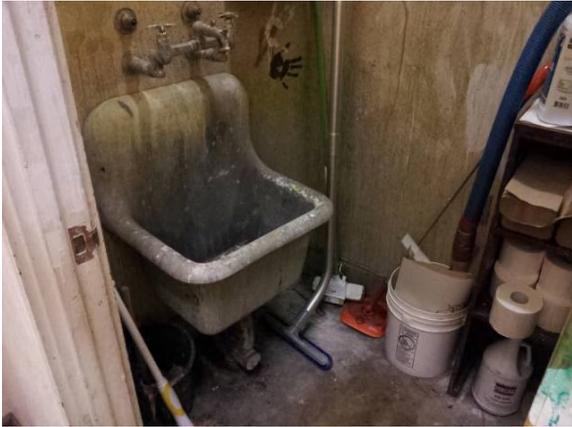
System: D2010 - Plumbing Fixtures

Location: Custodial Rooms
Material: Service/Utility Sink
Distress: Beyond Expected Life
Category: Capital Renewal
Priority: 4 - Recommended (Years 6-10)
Correction: Replace sink and fixtures
Qty: 3-Ea.
Estimate: \$9,892.93
Assessor Name: Eduardo Lopez
Date Created: 01/22/2013

Notes: Replace during next remodel or renovation.

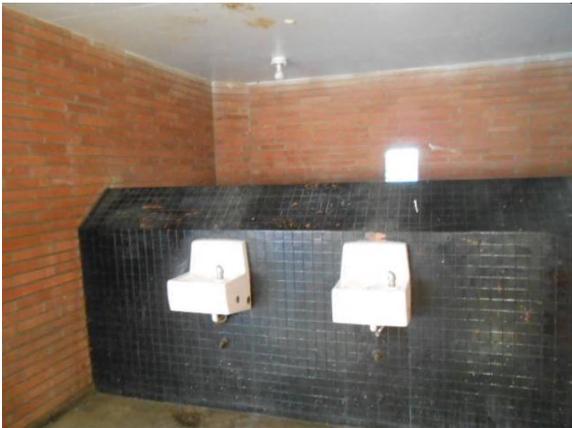
System: D2010 - Plumbing Fixtures

Location: Theater Foyer and both ends on 2nd Floor
Material: Drinking Fountain
Distress: Missing
Category: Code Compliance
Priority: 4 - Recommended (Years 6-10)
Correction: Replace fountain drinking fountain
Qty: 6-Ea.
Estimate: \$14,439.04
Assessor Name: Eduardo Lopez
Date Created: 01/22/2013

Notes: Drinking fountain is beyond its expected life and is recommended to be replaced including (1) ADA during next remodel or renovation.

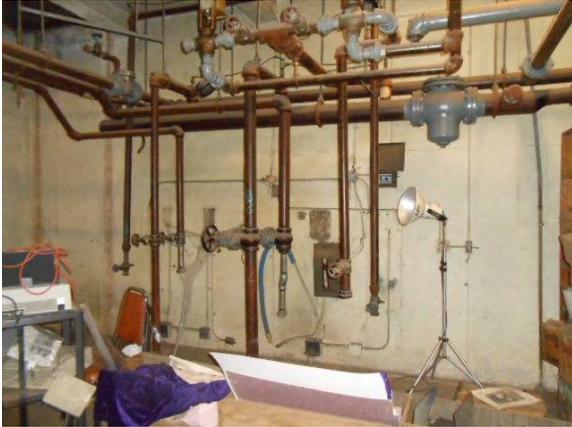
System: D2020 - Domestic Water Distribution

Location: Typical for entire building
Material: System
Distress: Beyond Expected Life
Category: Capital Renewal
Priority: 4 - Recommended (Years 6-10)
Correction: Renew System
Qty: 1-Ea.
Estimate: \$65,760.05
Assessor Name: Eduardo Lopez
Date Created: 01/29/2013

Notes: Domestic Water Distribution is beyond its expected life and it is recommended to replace the domestic water distribution system during next remodel or renovation.

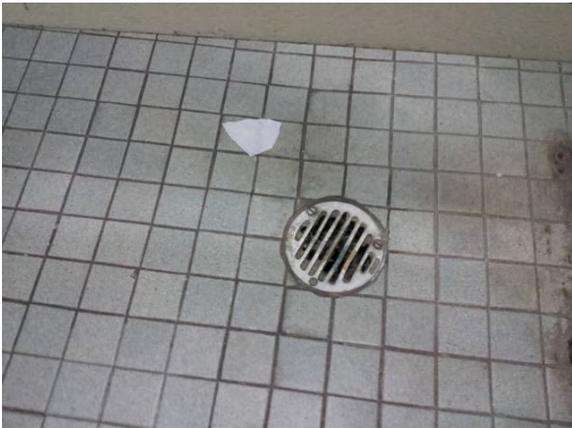
System: D2030 - Sanitary Waste

Location: Typical for entire building
Material: System
Distress: Beyond Expected Life
Category: Capital Renewal
Priority: 4 - Recommended (Years 6-10)
Correction: Renew System
Qty: 1-Ea.
Estimate: \$222,818.02
Assessor Name: Eduardo Lopez
Date Created: 01/29/2013

Notes: Replace all above grade sanitary waste and vent piping during next remodel or renovation; below grade as needed.

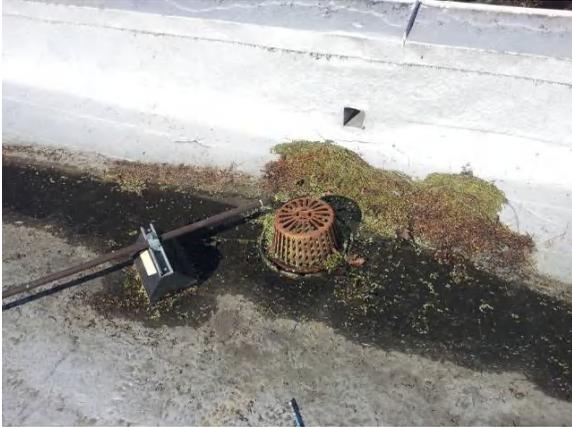
System: D2040 - Rain Water Drainage

Location: Typical for entire building
Material: System
Distress: Beyond Expected Life
Category: Capital Renewal
Priority: 4 - Recommended (Years 6-10)
Correction: Renew System
Qty: 1-Ea.
Estimate: \$35,753.03
Assessor Name: Eduardo Lopez
Date Created: 01/29/2013

Notes: Replace system during next remodel or renovation.

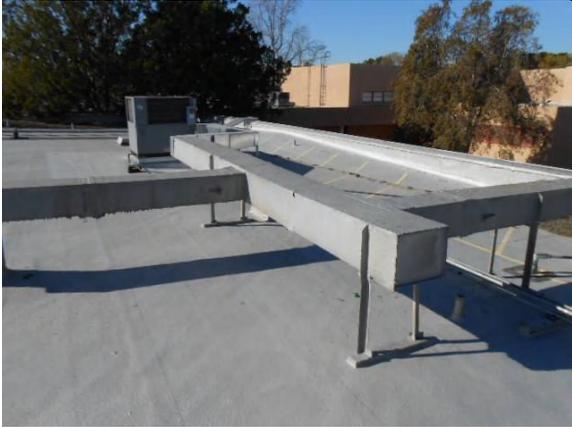
System: D3040 - Distribution Systems

Location: Typical for entire building
Material: System
Distress: Beyond Expected Life
Category: Capital Renewal
Priority: 4 - Recommended (Years 6-10)
Correction: Renew System
Qty: 1-Ea.
Estimate: \$886,802.94
Assessor Name: Eduardo Lopez
Date Created: 01/28/2013

Notes: HVAC system was replaced in 2008, however the ductwork, ventilation diffusers/grilles and fresh air supply is recommended to be upgraded during the next major renovation.

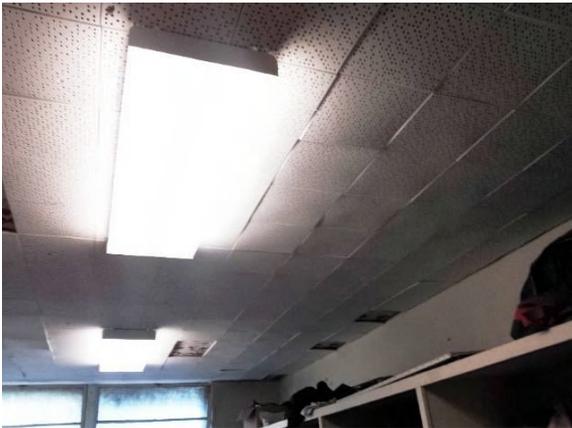
System: D3050 - Terminal & Package Units

Location: Men & Women Dressing Rooms including Restrooms
Material: Single Zone Air Conditioner
Distress: Missing
Category: Capital Renewal
Priority: 1 - Currently Critical (Immediate)
Correction: Replace single zone rt. unit, 3 ton
Qty: 1-Ea.
Estimate: \$14,230.80
Assessor Name: Eduardo Lopez
Date Created: 01/29/2013

Notes: Dressing Rooms behind stage including restrooms for both men and women have no A/C and should be provided.

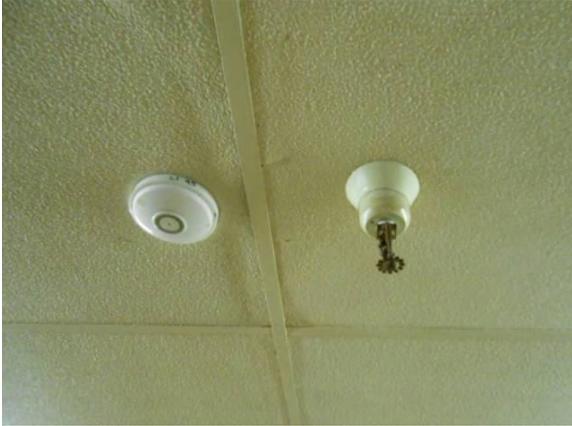
System: D4010 - Sprinklers

Location: Typical for entire building
Material: System
Distress: Beyond Expected Life
Category: Capital Renewal
Priority: 5 - Codes or Standards Compliance
Correction: Renew System
Qty: 1-Ea.
Estimate: \$301,985.45
Assessor Name: Eduardo Lopez
Date Created: 01/28/2013

Notes: Building is partially sprinklered, wet type fire sprinklers are currently located in the storage/electrical/theater stage and it's recommended to be added throughout building wide during next major renovation.

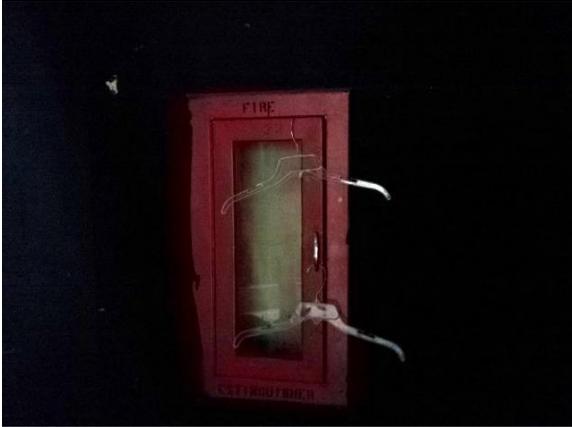
System: D4030 - Fire Protection Specialties

Location: Typical for entire building
Material: System
Distress: Inadequate
Category: Capital Renewal
Priority: 5 - Codes or Standards Compliance
Correction: Renew System
Qty: 1-Ea.
Estimate: \$9,576.71
Assessor Name: Eduardo Lopez
Date Created: 01/28/2013

Notes: Fire Extinguishers are missing in different locations and should be provided.

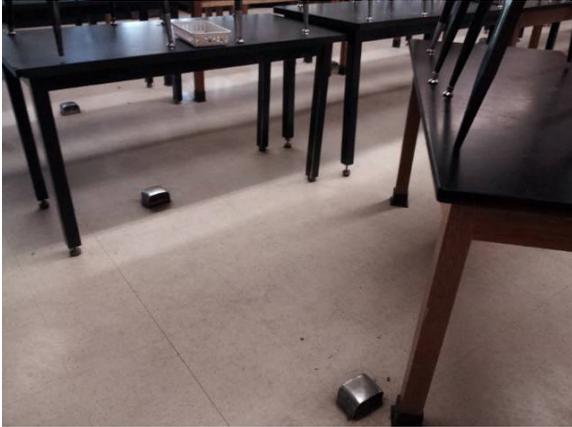
System: D5020 - Branch Wiring

Location: Typical for entire building
Material: System
Distress: Beyond Expected Life
Category: Capital Renewal
Priority: 4 - Recommended (Years 6-10)
Correction: Renew System
Qty: 1-Ea.
Estimate: \$1,147,289.33
Assessor Name: Eduardo Lopez
Date Created: 01/28/2013

Notes: The branch wiring, electrical panels and devices are mostly original to the building age. It is recommended to be replaced during the next major renovation.

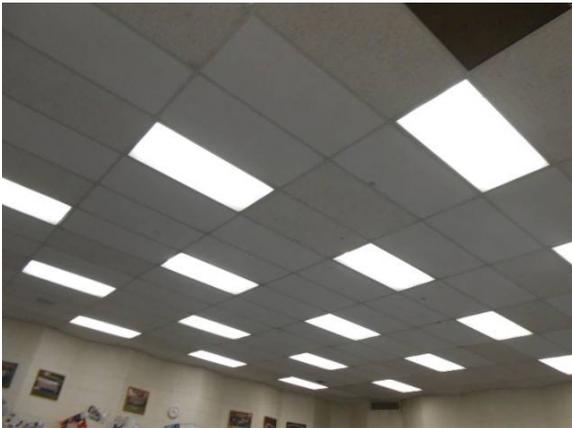
System: D5020 - Lighting

Location: Typical for entire building
Material: System
Distress: Beyond Expected Life
Category: Capital Renewal
Priority: 4 - Recommended (Years 6-10)
Correction: Renew System
Qty: 1-Ea.
Estimate: \$902,125.67
Assessor Name: Eduardo Lopez
Date Created: 01/29/2013

Notes: T8 fluorescent lamps and ballasts were updated and light fixtures in corridor were replaced; however light fixtures, switches and wiring are original to building age and it is recommended to be replaced during next remodel or renovation.

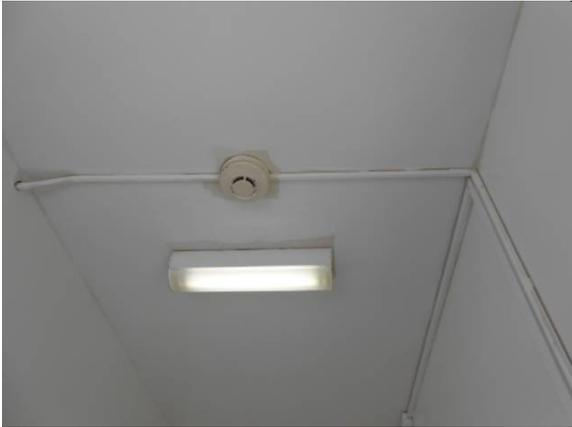
System: D5030910 - Fire Alarm System

Location: Typical for entire building
Material: Smoke Detector
Distress: Inadequate
Category: Capital Renewal
Priority: 5 - Codes or Standards Compliance
Correction: Install Smoke Detectors
Qty: 50-Ea.
Estimate: \$126,943.56
Assessor Name: Eduardo Lopez
Date Created: 01/28/2013

Notes: Fire Alarm System is missing smoke detectors, they are located mostly in Storage, Offices and Stage Area only and it is recommended to be provided throughout the building during next major remodel or renovation.

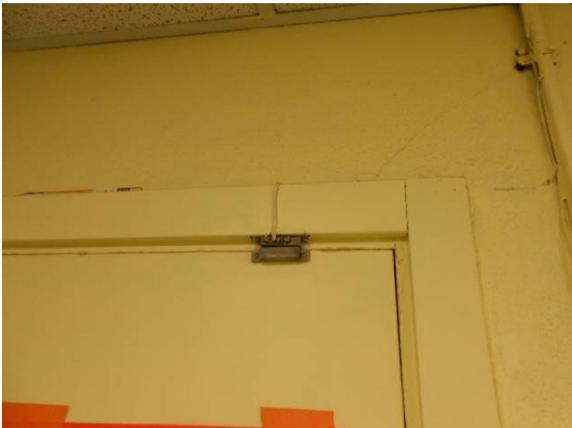
System: D5030910 - Security System, Camers, Access Control

Location: Typical for entire building
Material: System
Distress: Beyond Expected Life
Category: Capital Renewal
Priority: 4 - Recommended (Years 6-10)
Correction: Renew System
Qty: 1-Ea.
Estimate: \$52,236.58
Assessor Name: Eduardo Lopez
Date Created: 01/29/2013

Notes: Security is needing upgrades. Recommend replacing and enhancing during the next building renovation.

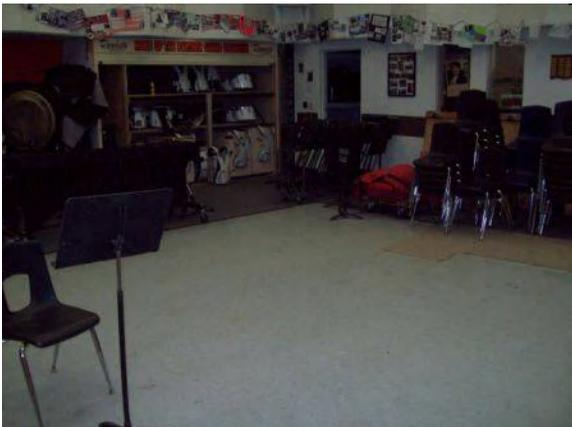
System: E1020 - Institutional Equipment

Location: Band classroom 108
Material: Instrumental Equipment
Distress: Beyond Expected Life
Category: Capital Renewal
Priority: 3 - Necessary/Not Yet Critical (Years 2-5)
Correction: Replace instrument storage.
Qty: 1-Job
Estimate: \$17,625.60
Assessor Name: Ann Buerger Linden
Date Created: 02/01/2013

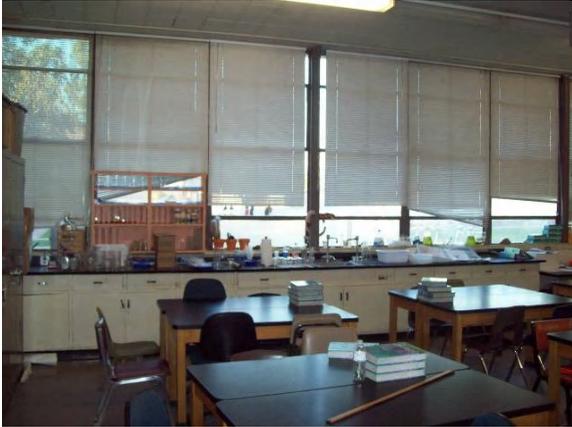
System: E2010 - Fixed Furnishings

Location: Exterior windows.
Material: Blinds and Other Window Treatment
Distress: Beyond Service Life
Category: Capital Renewal
Priority: 1 - Currently Critical (Immediate)
Correction: Replace window blinds
Qty: 3,600-S.F.
Estimate: \$39,035.52
Assessor Name: Ann Buerger Linden
Date Created: 02/01/2013

Notes: Window blinds are in fair to poor condition, or missing, a approximately 50% of exterior windows.

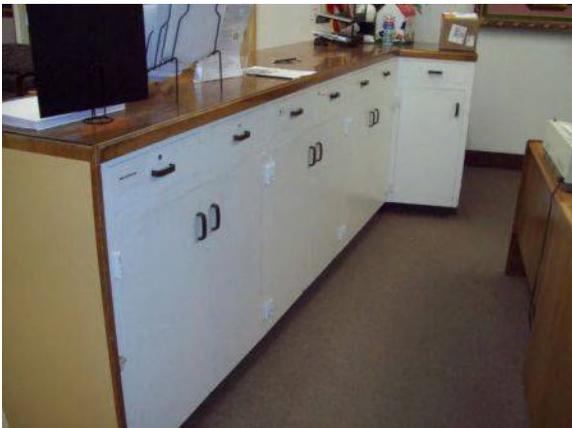
System: E2010 - Fixed Furnishings

Location: Classrooms, Health, Counseling, Reception, some Offices
Material: Fixed Casework
Distress: Beyond Expected Life
Category: Capital Renewal
Priority: 3 - Necessary/Not Yet Critical (Years 2-5)
Correction: Replace Casework OUSD
Qty: 204-L.F.
Estimate: \$208,214.71
Assessor Name: Ann Buerger Linden
Date Created: 02/01/2013

Notes: All millwork and cabinetry in the building is original and in generally fair to poor condition. Note that science classroom fixed furnishings are addressed in Institutional Equipment.

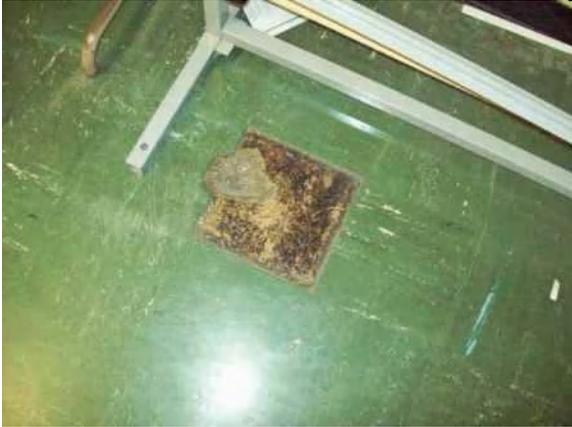
System: F2020 - Hazardous Components Abatement

Location: Friable material in theater spotlight wire insulation, pipe insulation, flex collars, fire door insulation, transite pipe, drywall mud, 9" and 12" VAT and mastic, stucco, window putty, interior plaster, transite table/counter tops/sinks, transite fume hood base.

Material: Removal of Hazardous Components

Notes: The AHERA six-month surveillance of asbestos-containing materials - Summer 2012, identifies ACM at this building. Complete abatement is recommended.

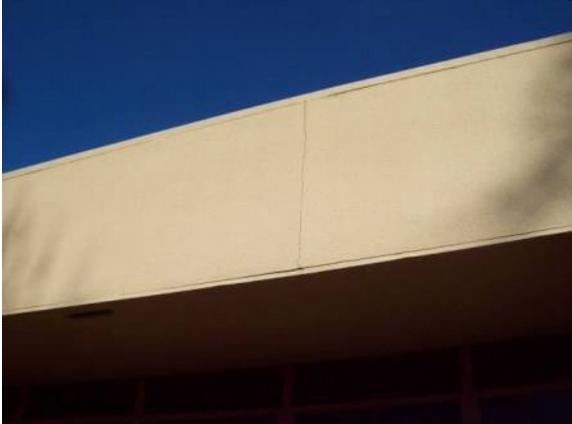
System: B2010 - Exterior Walls

Location: Exterior stucco walls, soffits, and fascia.
Material: Plaster Soffits
Distress: Damaged
Category: Deferred Maintenance
Priority: 3 - Necessary/Not Yet Critical (Years 2-5)
Correction: Replace plaster soffits
Qty: 3,600-S.F.
Estimate: \$24,416.64
Assessor Name: Ann Buerger Linden
Date Created: 01/30/2013

Notes: Stucco cracking is fairly frequent at this building. Repair is recommended.

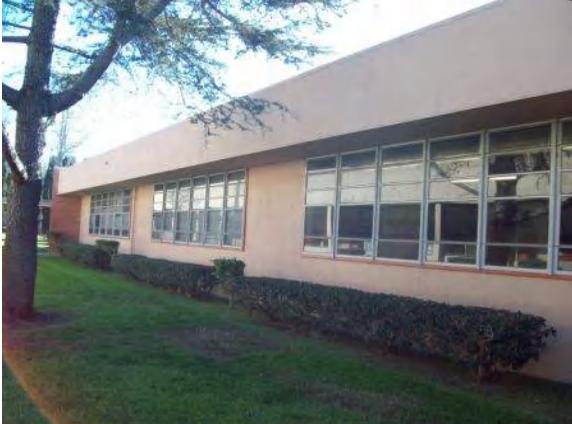
System: B2020 - Exterior Windows

Location: Windows in exterior walls.
Material: System
Distress: Beyond Expected Life
Category: Capital Renewal
Priority: 3 - Necessary/Not Yet Critical (Years 2-5)
Correction: Renew System
Qty: 1-Ea.
Estimate: \$387,889.92
Assessor Name: Eduardo Lopez
Date Created: 01/21/2013

Notes: Existing windows are typically single glazed in steel or aluminum frames with operable sections. Obscure glass is used at restrooms and the lounge. Window systems are expired and security is compromised by failing hardware.

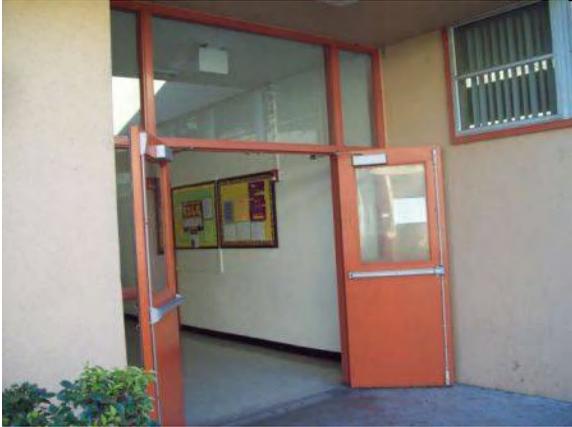
System: B2030 - Exterior Doors

Location: Exterior entrances and exits.
Material: System
Distress: Beyond Expected Life
Category: Capital Renewal
Priority: 3 - Necessary/Not Yet Critical (Years 2-5)
Correction: Renew System
Qty: 1-Ea.
Estimate: \$82,753.74
Assessor Name: Eduardo Lopez
Date Created: 01/21/2013

Notes: Original doors are beyond their expected life. Recommend installation of handicap operator at one or two main entries. Replace all doors, frames, and hardware.

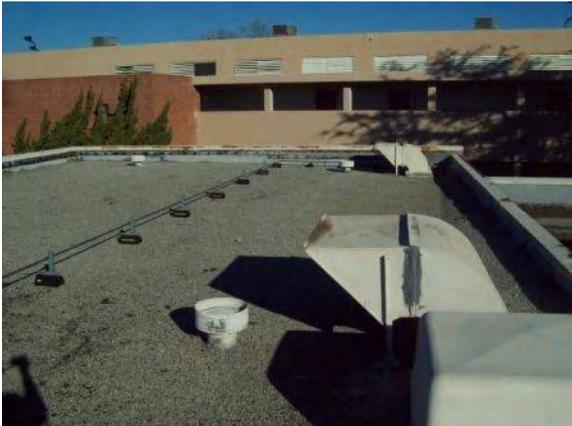
System: B3010105 - Built-Up

Location: Roof
Material: System
Distress: Beyond Expected Life
Category: Capital Renewal
Priority: 1 - Currently Critical (Immediate)
Correction: Renew System
Qty: 1-Ea.
Estimate: \$402,730.02
Assessor Name: Eduardo Lopez
Date Created: 01/21/2013

Notes: Roof is expired. Damage/tears particularly visible at perimeters. Interior evidence of leaks on ceilings. Recommend metal cap flashing at top of all walls.

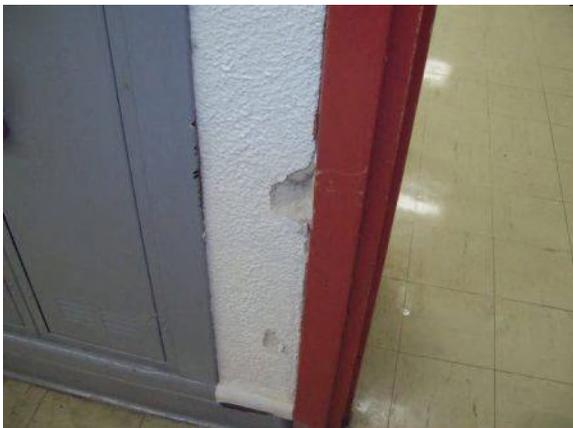
System: C1010 - Partitions

Location: Building wide - interiors.
Material: Interior Partitions
Distress: Beyond Expected Life
Category: Capital Renewal
Priority: 3 - Necessary/Not Yet Critical (Years 2-5)
Correction: Allowance repair/remodel interior partitions
OUSD
Qty: 1-Job
Estimate: \$44,064.00
Assessor Name: Ann Buerger Linden
Date Created: 01/30/2013

Notes: Provide an allowance to repair existing damage and to remodel interior partitions as needed to accommodate renovations to adjacent systems and update configurations for ADA compliance and operational efficiency.

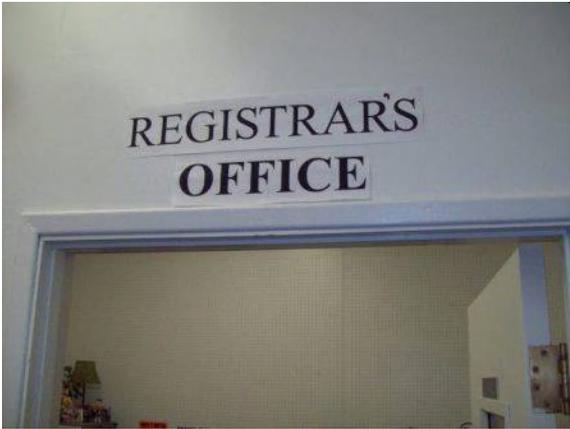
System: C1030 - Fittings

Location: Building wide.
Material: Signage
Distress: Inadequate
Category: Capital Renewal
Priority: 3 - Necessary/Not Yet Critical (Years 2-5)
Correction: Replace/Install code compliant signage
Qty: 14,825-S.F.
Estimate: \$3,202.20
Assessor Name: Ann Buerger Linden
Date Created: 01/30/2013

Notes: Provide code compliant signage throughout the building

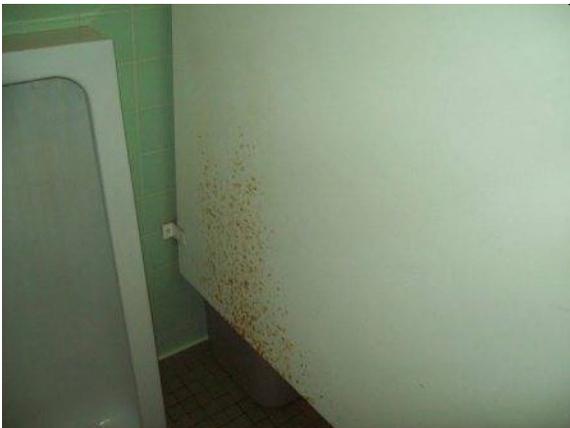
System: C1030 - Fittings

Location: Student and staff restrooms.
Material: Toilet Partitions
Distress: Beyond Expected Life
Category: Capital Renewal
Priority: 3 - Necessary/Not Yet Critical (Years 2-5)
Correction: Replace toilet partitions and accessories
OUSD
Qty: 6-Ea.
Estimate: \$19,762.76
Assessor Name: Ann Buerger Linden
Date Created: 01/30/2013

Notes: Toilet partitions and accessories are in poor condition. Rust is present. ADA compliance is recommended.

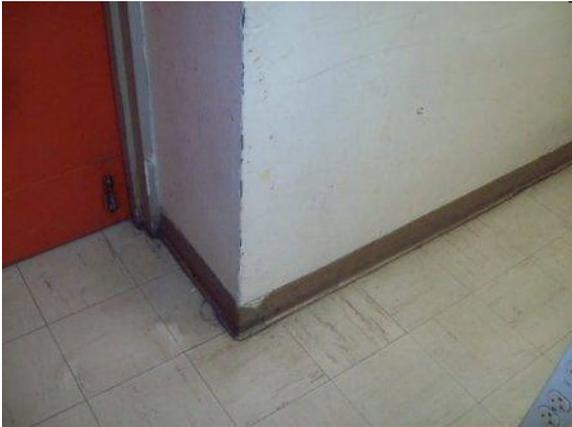
System: C3010 - Wall Finishes

Location: Building wide interiors.
Material: System
Distress: Beyond Expected Life
Category: Capital Renewal
Priority: 3 - Necessary/Not Yet Critical (Years 2-5)
Correction: Renew System
Qty: 1-Ea.
Estimate: \$222,382.12
Assessor Name: Ann Buerger Linden
Date Created: 01/30/2013

Notes: Interior wall finishes are primarily paint. There is ceramic wall tile at student and staff restrooms, some exposed brick and some wood panelling. Expected renovations throughout the building, including ACM removal, millwork and marker/tack board replacement, etc, will necessitate interior wall finish system renewal.

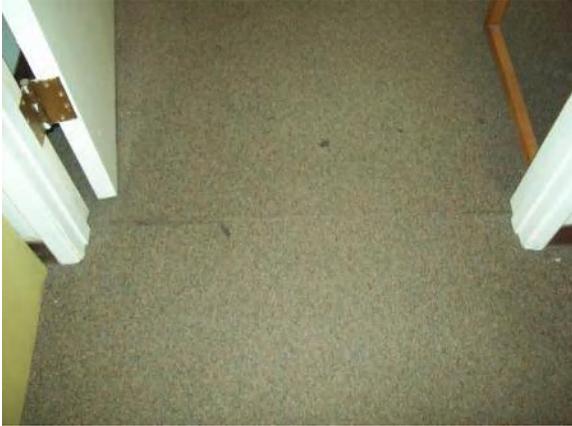
System: C3020210 - Carpet

Location: Career center, classroom 309
Material: System
Distress: Beyond Expected Life
Category: Capital Renewal
Priority: 3 - Necessary/Not Yet Critical (Years 2-5)
Correction: Renew System
Qty: 1-Ea.
Estimate: \$43,366.75
Assessor Name: Eduardo Lopez
Date Created: 01/21/2013

Notes: Existing flooring is carpet over VAT. Carpet system renewal is recommended.

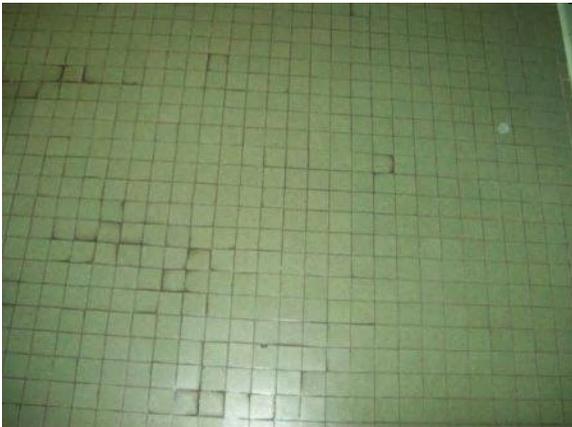
System: C3020210 - Ceramic Tile

Location: Girl's toilet room, staff toilet room, boy's toilet room.
Material: System
Distress: Beyond Expected Life
Category: Capital Renewal
Priority: 3 - Necessary/Not Yet Critical (Years 2-5)
Correction: Renew System
Qty: 1-Ea.
Estimate: \$20,172.24
Assessor Name: Eduardo Lopez
Date Created: 01/21/2013

Notes: Ceramic floor tile is original and worn looking.

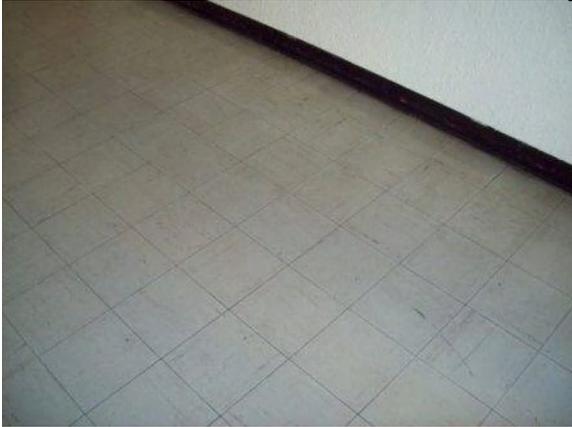
System: C3020410 - VCT

Location: All classrooms except 309, corridors, storage and workrooms.

Material: System

Notes: Typical interior flooring is 9" VAT. Abatement is considered at the hazardous materials deficiency.
Replace interior resilient floor finishes.

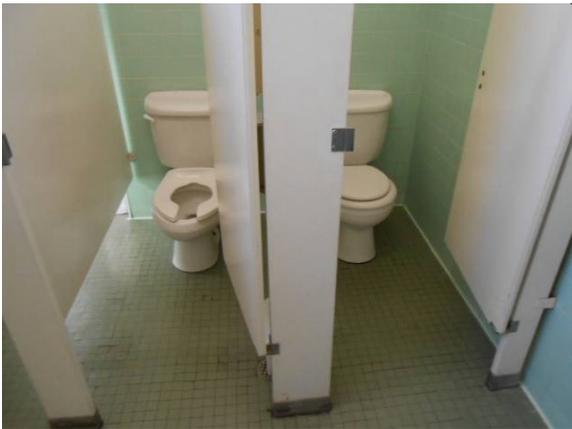
System: D2010 - Plumbing Fixtures

Location: Women, Men & Staff restrooms at East end

Material: Tankless Water Closet

Priority: 4 - Recommended (Years 6-10)

Correction: Replace tankless water closet

Notes: Replace during next remodel or renovation.

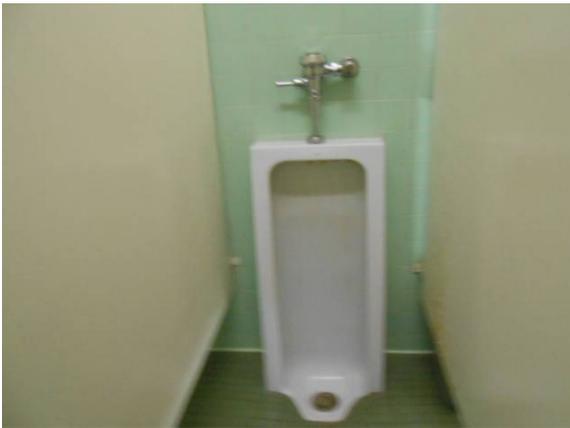
System: D2010 - Plumbing Fixtures

Location: Men restrooms, East end of building
Material: Urinal
Distress: Beyond Expected Life
Category: Capital Renewal
Priority: 4 - Recommended (Years 6-10)
Correction: Replace wall-hung urinal
Qty: 1-Ea.
Estimate: \$1,551.31
Assessor Name: Eduardo Lopez
Date Created: 01/22/2013

Notes: Replace during next remodel or renovation.

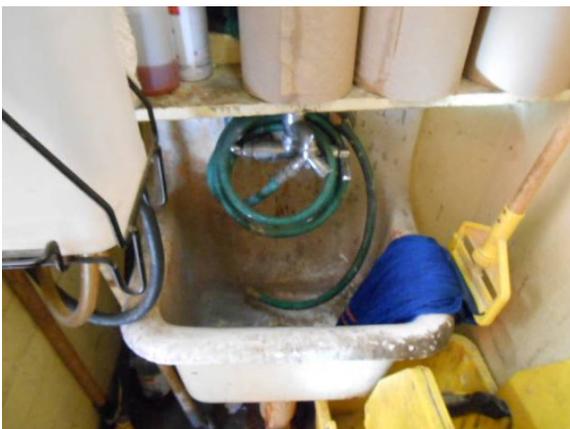
System: D2010 - Plumbing Fixtures

Location: Janitor Closet
Material: Service/Utility Sink
Distress: Beyond Expected Life
Category: Capital Renewal
Priority: 4 - Recommended (Years 6-10)
Correction: Replace sink and fixtures
Qty: 1-Ea.
Estimate: \$3,297.64
Assessor Name: Eduardo Lopez
Date Created: 01/22/2013

Notes: Replace during next remodel or renovation.

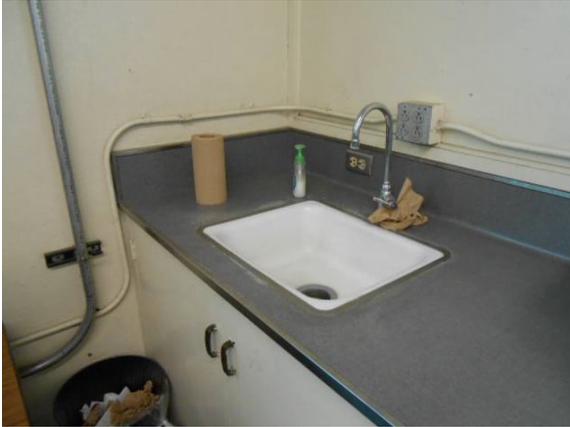
System: D2010 - Plumbing Fixtures

Location: Classroom 309
Material: Sink, Stainless Steel
Distress: Beyond Expected Life
Category: Capital Renewal
Priority: 4 - Recommended (Years 6-10)
Correction: Replace sink, stainless steel
Qty: 1-Ea.
Estimate: \$1,510.14
Assessor Name: Eduardo Lopez
Date Created: 01/24/2013

Notes: Sink is original and beyond expected life and it is recommended to be replaced during next remodel or renovation.

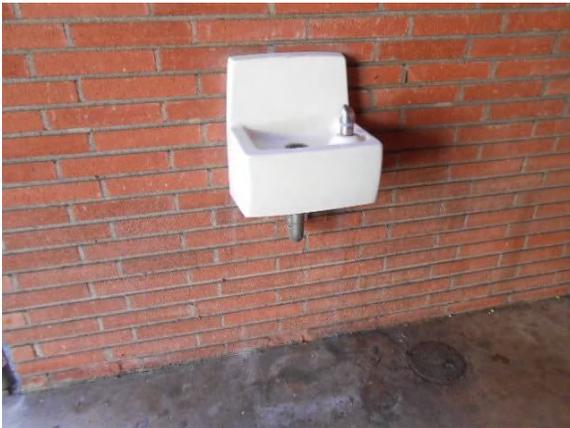
System: D2010 - Plumbing Fixtures

Location: North Entry
Material: Drinking Fountain
Distress: Beyond Expected Life
Category: Capital Renewal
Priority: 4 - Recommended (Years 6-10)
Correction: Replace fountain drinking fountain
Qty: 2-Ea.
Estimate: \$4,813.01
Assessor Name: Eduardo Lopez
Date Created: 01/22/2013

Notes: A drinking fountain is beyond its expected life and it is recommended to be replaced during next remodel or renovation.

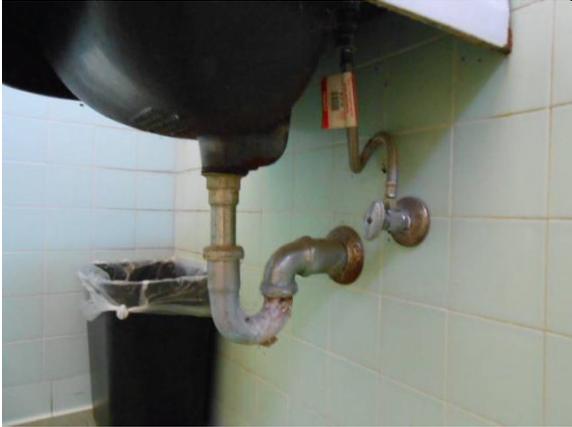
System: D2020 - Domestic Water Distribution

Location: Typical for entire building
Material: System
Distress: Beyond Expected Life
Category: Capital Renewal
Priority: 4 - Recommended (Years 6-10)
Correction: Renew System
Qty: 1-Ea.
Estimate: \$31,936.61
Assessor Name: Eduardo Lopez
Date Created: 01/28/2013

Notes: Domestic Water Distribution is beyond its expected life and it is recommended to replace the domestic water distribution system during next remodel or renovation.

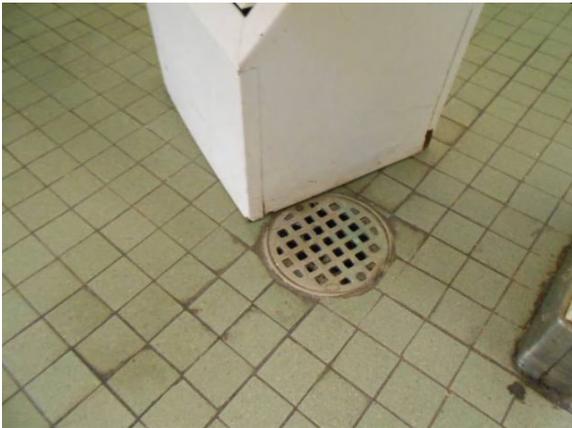
System: D2030 - Sanitary Waste

Location: Typical for entire building
Material: System
Distress: Beyond Expected Life
Category: Capital Renewal
Priority: 4 - Recommended (Years 6-10)
Correction: Renew System
Qty: 1-Ea.
Estimate: \$108,725.36
Assessor Name: Eduardo Lopez
Date Created: 01/28/2013

Notes: Replace all above grade sanitary waste and vent piping during next remodel or renovation; below grade as needed.

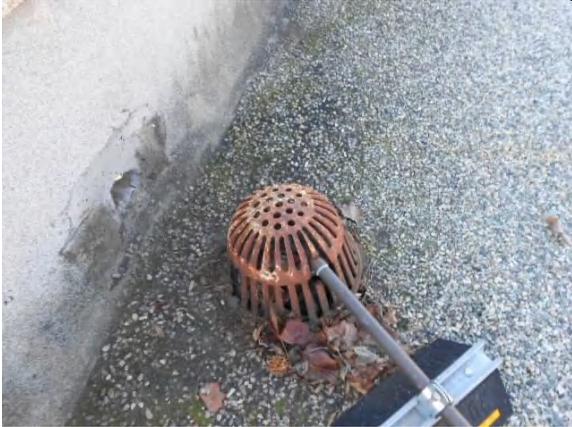
System: D2040 - Rain Water Drainage

Location: Typical for entire building
Material: System
Distress: Beyond Expected Life
Category: Capital Renewal
Priority: 4 - Recommended (Years 6-10)
Correction: Renew System
Qty: 1-Ea.
Estimate: \$17,612.10
Assessor Name: Eduardo Lopez
Date Created: 01/28/2013

Notes: Replace system during next remodel or renovation.

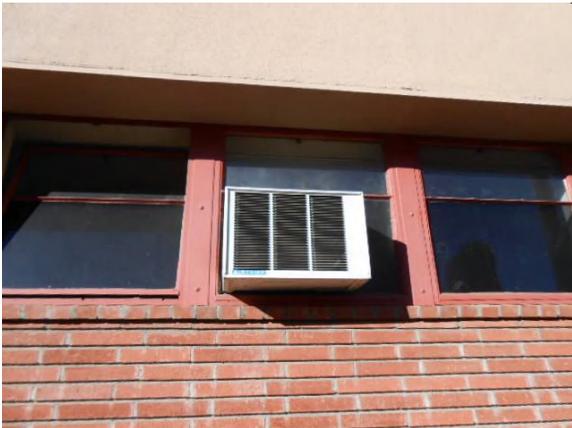
System: D3050 - Terminal & Package Units

Location: Staff Lounge
Material: Air Conditioner, Window 1 Ton
Distress: Damaged
Category: Deferred Maintenance
Priority: 2 - Potentially Critical (Year 1)
Correction: Replace air conditioner, window, 1 ton
Qty: 1-Ea.
Estimate: \$1,494.50
Assessor Name: Eduardo Lopez
Date Created: 01/28/2013

Notes: Recommend replacing existing window A/C unit with additional or auxiliary A/C. Include cost for an evaluation by a PE for HVAC system in the next renovation project.

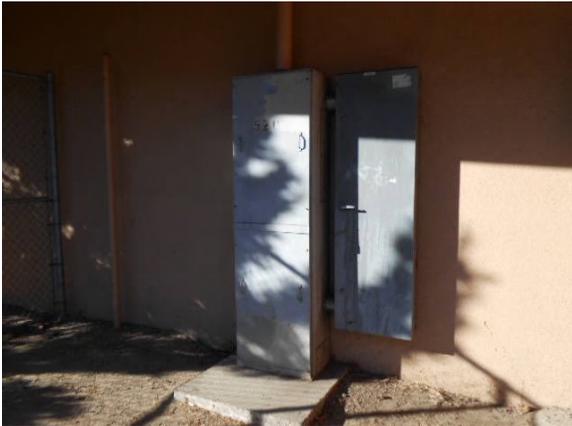
System: D5010 - Electrical Service/Distribution

Location: Typical for entire building
Material: System
Distress: Beyond Expected Life
Category: Capital Renewal
Priority: 4 - Recommended (Years 6-10)
Correction: Renew System
Qty: 1-Ea.
Estimate: \$162,031.32
Assessor Name: Eduardo Lopez
Date Created: 01/28/2013

Notes: The main electrical panels, distribution panel boards and feeders are mostly original to the building age. It is recommended to be replaced during the next major renovation.

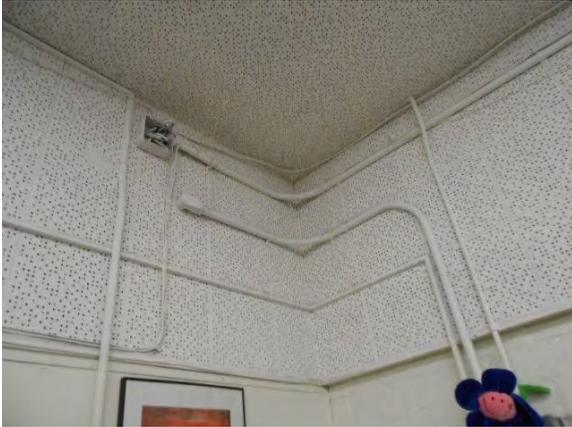
System: D5020 - Branch Wiring

Location: Typical for entire building
Material: System
Distress: Beyond Expected Life
Category: Capital Renewal
Priority: 4 - Recommended (Years 6-10)
Correction: Renew System
Qty: 1-Ea.
Estimate: \$558,420.98
Assessor Name: Eduardo Lopez
Date Created: 01/28/2013

Notes: The branch wiring, electrical panels and devices are mostly original to the building age. It is recommended to be replaced during the next major renovation.

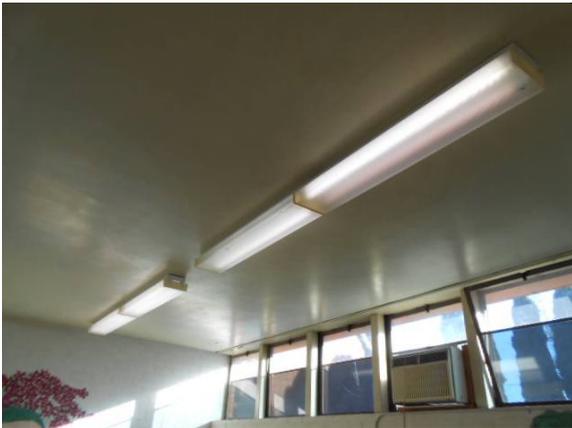
System: D5020 - Lighting

Location: Typical for entire building
Material: System
Distress: Beyond Expected Life
Category: Capital Renewal
Priority: 4 - Recommended (Years 6-10)
Correction: Renew System
Qty: 1-Ea.
Estimate: \$438,893.53
Assessor Name: Eduardo Lopez
Date Created: 01/28/2013

Notes: T8 fluorescent lamps and ballasts were updated; however light fixtures, switches and wiring are original to building age and it is recommended to be replaced during next remodel or renovation.

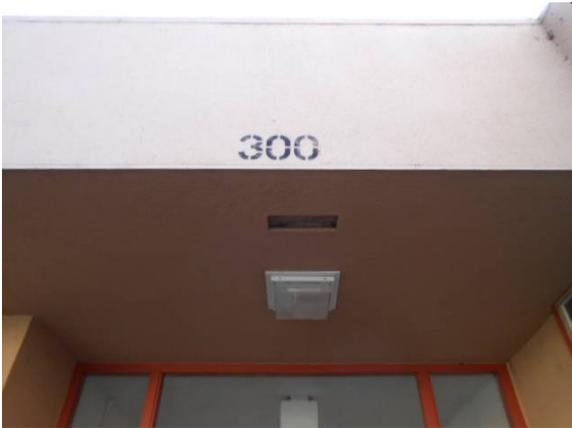
System: D5030910 - Security System, Camers, Access Control

Location: Typical for entire building
Material: System
Distress: Missing
Category: Capital Renewal
Priority: 4 - Recommended (Years 6-10)
Correction: Renew System
Qty: 1-Ea.
Estimate: \$25,404.12
Assessor Name: Eduardo Lopez
Date Created: 01/28/2013

Notes: Building is Security System and it is recommended to be added throughout building wide during next major renovation.

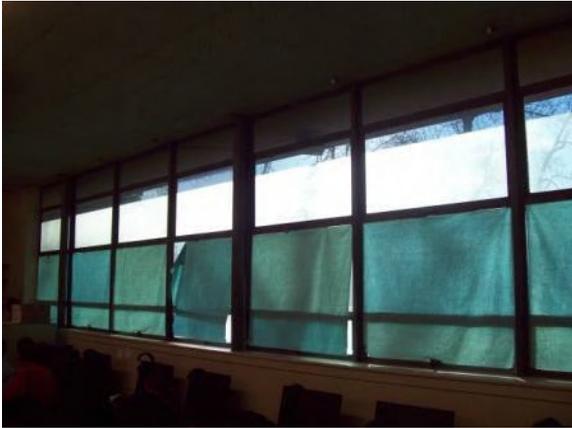
System: E2010 - Fixed Furnishings

Location: At exterior windows.
Material: Blinds and Other Window Treatment
Distress: Inadequate
Category: Capital Renewal
Priority: 1 - Currently Critical (Immediate)
Correction: Replace window blinds
Qty: 1,750-S.F.
Estimate: \$18,975.60
Assessor Name: Ann Buerger Linden
Date Created: 01/30/2013

Notes: Provide blinds at exterior windows to control glare and to facilitate A/V presentations.

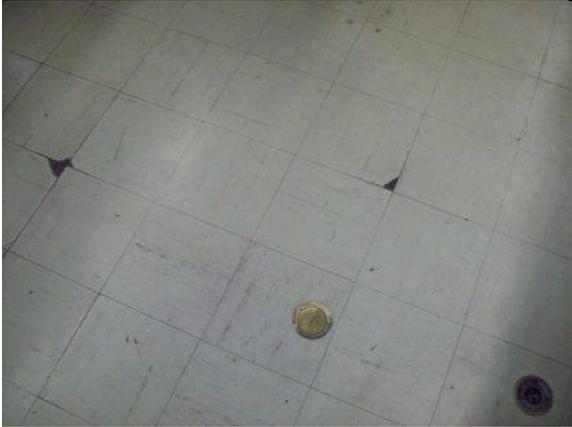
System: F2020 - Hazardous Components Abatement

Location: Non-friable material in exterior wall and overhang stucco, window putty, interior plaster, and 9" floor tile.

Notes: The AHERA six-month surveillance of asbestos-containing materials - Summer 2012, identifies ACM at this building. Complete abatement is recommended.

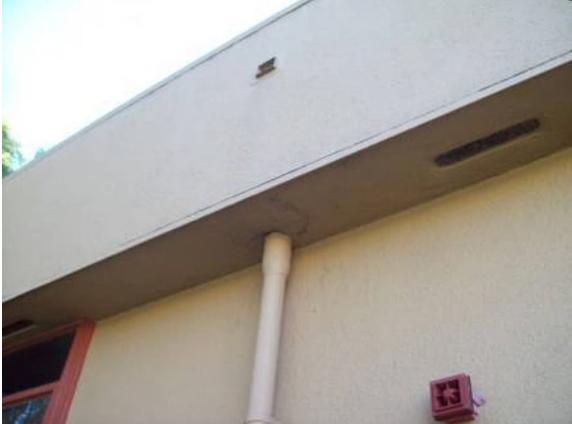
System: B2010 - Exterior Walls

Location: Exterior soffits.
Material: Plaster Soffits
Distress: Damaged
Category: Deferred Maintenance
Priority: 3 - Necessary/Not Yet Critical (Years 2-5)
Correction: Replace plaster soffits
Qty: 1,400-S.F.
Estimate: \$9,961.69
Assessor Name: Ann Buerger Linden
Date Created: 01/30/2013

Notes: Exterior soffits are damaged from roof leakage.

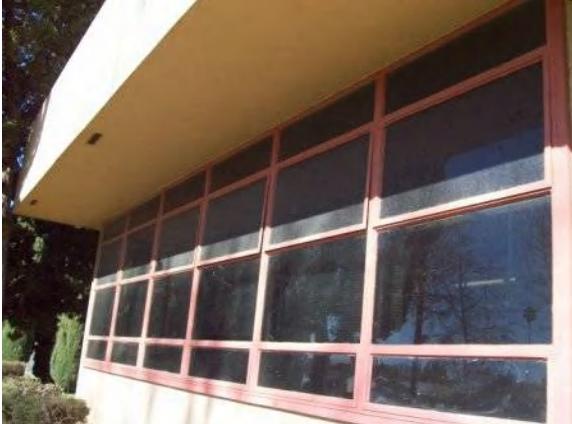
System: B2020 - Exterior Windows

Location: North and south classroom elevations.
Sidelights and transoms at exterior entrance doors.
Material: System
Distress: Beyond Expected Life
Category: Capital Renewal
Priority: 3 - Necessary/Not Yet Critical (Years 2-5)
Correction: Renew System
Qty: 1-Ea.
Estimate: \$300,067.42
Assessor Name: Eduardo Lopez
Date Created: 01/21/2013

Notes: Windows are typically operable, single glazed, steel framed. Windows are in fair condition. Operable windows do not function properly creating security issues. Windows surrounding entrances are single pane fixed glass or plexiglass in hollow metal frames. Frames are deteriorated. Assemblies should be replaced.

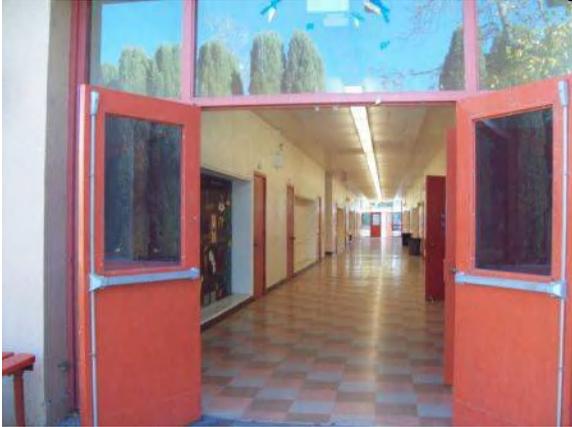
System: B2030 - Exterior Doors

Location: Exterior doors.
Material: System
Distress: Beyond Expected Life
Category: Capital Renewal
Priority: 3 - Necessary/Not Yet Critical (Years 2-5)
Correction: Renew System
Qty: 1-Ea.
Estimate: \$58,191.85
Assessor Name: Eduardo Lopez
Date Created: 01/21/2013

Notes: Exterior doors appear to be original in original frames. They are well beyond their expected life. System replacement is recommended.

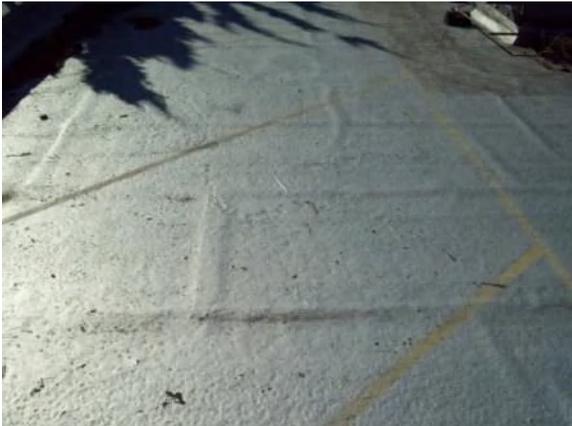
System: B3010105 - Built-Up

Location: Roof
Material: System
Distress: Beyond Expected Life
Category: Capital Renewal
Priority: 1 - Currently Critical (Immediate)
Correction: Renew System
Qty: 1-Ea.
Estimate: \$328,367.95
Assessor Name: Eduardo Lopez
Date Created: 01/21/2013

Notes: Existing roof is beyond it's expected life and is failing. Staining is visible on ceilings and soffits. The roof crunches when you walk on it. Perimeter flashings are in very poor condition, several are cracked, open and pulling away. There appears to be sufficient slope, however drains are typically clogged with tree debris.

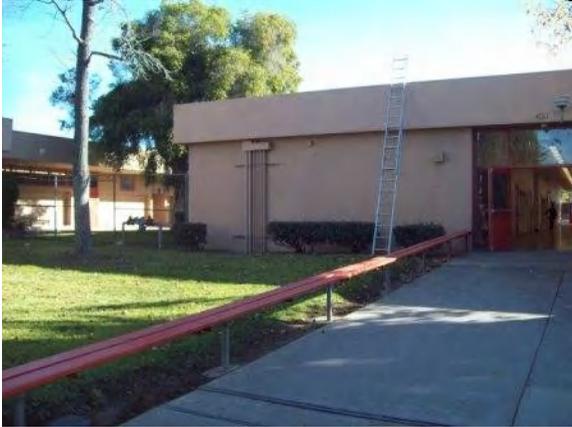
System: B3020 - Roof Openings

Location: Recommended location is storage room between classrooms 406 and 407.

Distress: Missing

Notes: Install a code compliant roof hatch/access ladder assembly to more safely facilitate roof and rooftop equipment maintenance.
