Orange Unified School District

Facilities Condition Assessment for:

**Orange High School
525 N. Shaffer Street
Orange, CA 92867**

Report: Mar 11, 2013

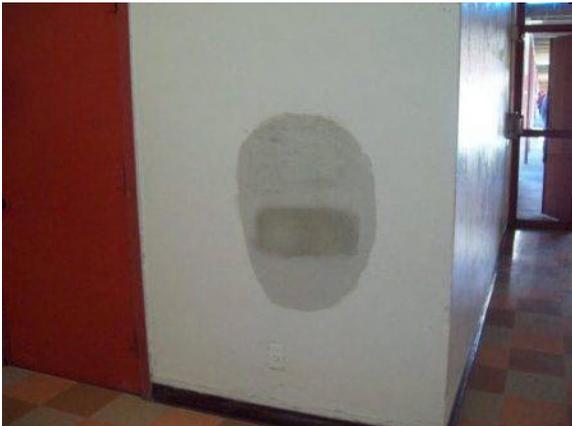
System: C1010 - Partitions

Location: Building wide - interiors.

Distress: Damaged

Notes: There is minor damage to interior walls throughout the building. Provide an allowance to repair and remodel interior partitions as needed to accommodate renovations to adjacent systems such as interior door replacement.

Correction: Allowance repair/remodel interior partitions
OUSD

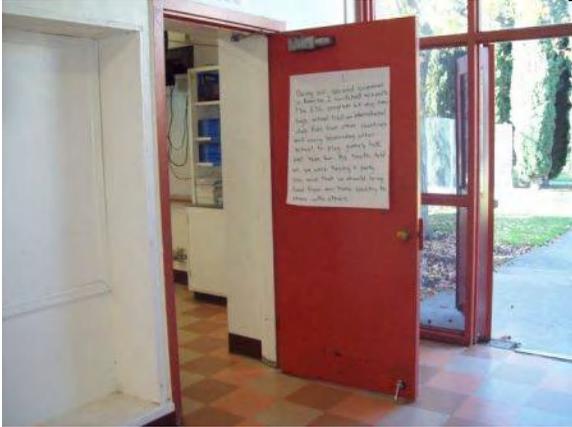
System: C1020 - Interior Doors

Location: Interior doors to classrooms and storage room.

Notes: Interior doors and frames are original wood. Hardware is worn. Doors and frames have painted over damage. Replacement of doors, frames and hardware is recommended. Install interior locking lever latches at classrooms.

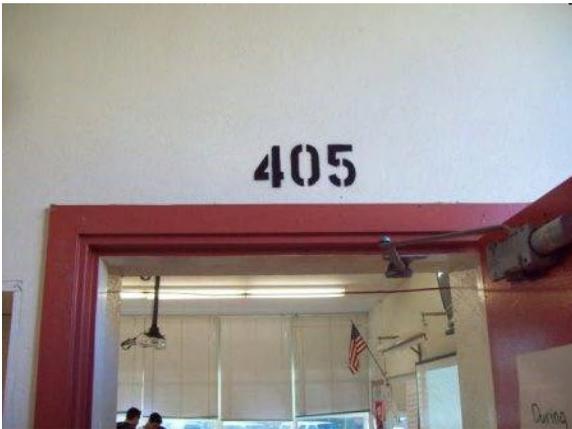
System: C1030 - Fittings

Location: Building wide.

Distress: Inadequate

Correction: Replace/Install code compliant signage

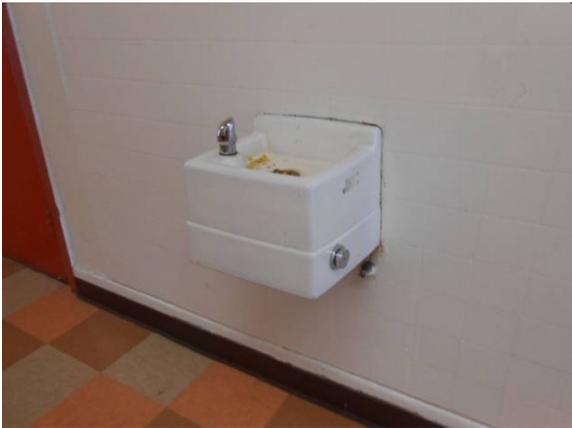
System: D2010 - Plumbing Fixtures

Location: Corridor
Material: Drinking Fountain
Distress: Beyond Expected Life
Category: Capital Renewal
Priority: 4 - Recommended (Years 6-10)
Correction: Replace fountain drinking fountain
Qty: 2-Ea.
Estimate: \$4,813.01
Assessor Name: Eduardo Lopez
Date Created: 01/22/2013

Notes: A drinking fountain is beyond its expected life and it is recommended to be replaced during next remodel or renovation.

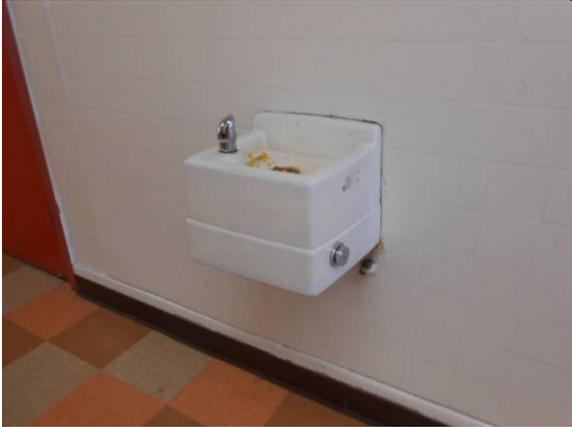
System: D2020 - Domestic Water Distribution

Location: Typical for entire building
Material: System
Distress: Beyond Expected Life
Category: Capital Renewal
Priority: 4 - Recommended (Years 6-10)
Correction: Renew System
Qty: 1-Ea.
Estimate: \$20,417.89
Assessor Name: Eduardo Lopez
Date Created: 01/28/2013

Notes: Domestic Water Distribution is beyond its expected life and it is recommended to replace the domestic water distribution system during next remodel or renovation.

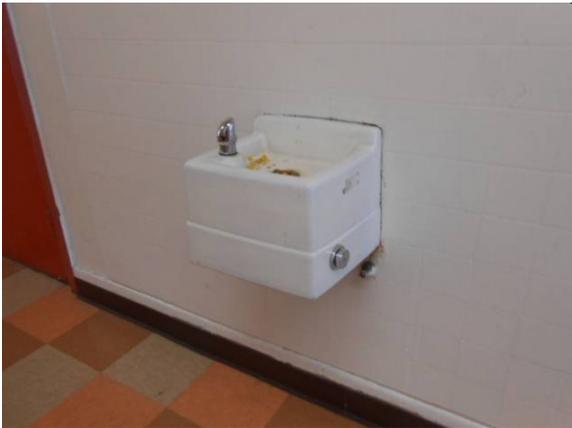
System: D2030 - Sanitary Waste

Location: Typical for entire building
Material: System
Distress: Beyond Expected Life
Category: Capital Renewal
Priority: 4 - Recommended (Years 6-10)
Correction: Renew System
Qty: 1-Ea.
Estimate: \$23,334.73
Assessor Name: Eduardo Lopez
Date Created: 01/28/2013

Notes: Replace all above grade sanitary waste and vent piping during next remodel or renovation; below grade as needed.

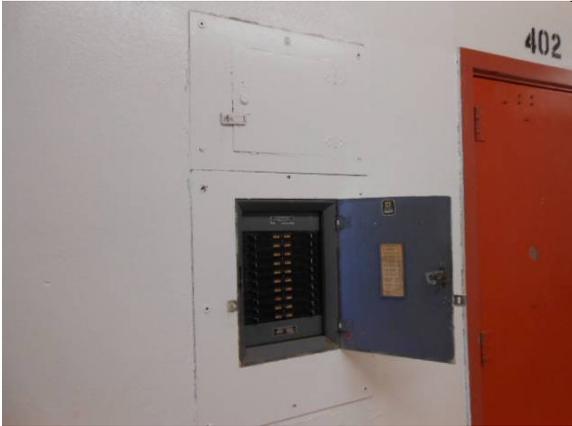
System: D5010 - Electrical Service/Distribution

Location: Typical for entire building
Material: System
Distress: Beyond Expected Life
Category: Capital Renewal
Priority: 4 - Recommended (Years 6-10)
Correction: Renew System
Qty: 1-Ea.
Estimate: \$117,949.76
Assessor Name: Eduardo Lopez
Date Created: 01/28/2013

Notes: The main electrical panels, distribution panel boards and feeders are mostly original to the building age. It is recommended to be replaced during the next major renovation.

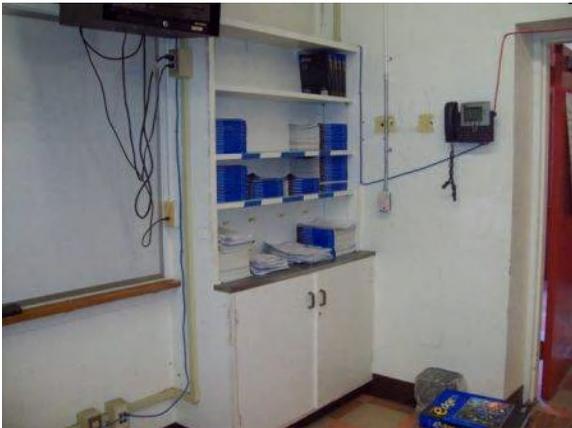
System: E2010 - Fixed Furnishings

Location: All classrooms.
Material: Fixed Casework
Distress: Beyond Expected Life
Category: Capital Renewal
Priority: 3 - Necessary/Not Yet Critical (Years 2-5)
Correction: Replace Casework OUSD
Qty: 120-L.F.
Estimate: \$71,491.68
Assessor Name: Ann Buerger Linden
Date Created: 01/30/2013

Notes: All millwork and cabinetry in the building is original and in generally poor condition.

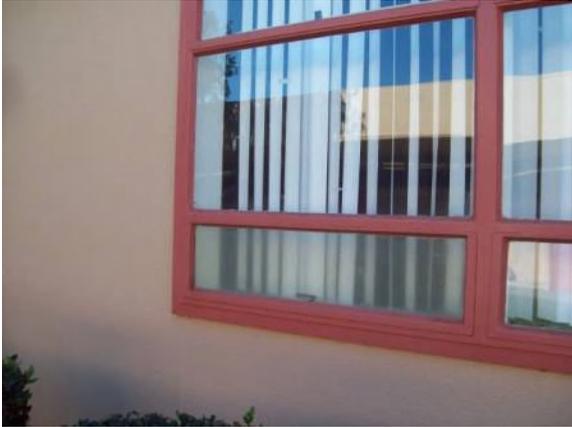
System: F2020 - Hazardous Components Abatement

Location: Non-friable material in exterior window putty, exterior stucco on walls and soffits, and interior plaster.

Notes: The AHERA six-month surveillance of asbestos-containing materials - Summer 2012, identifies ACM at this building. Complete abatement is recommended. Note that 9" floor tile has previously been removed.

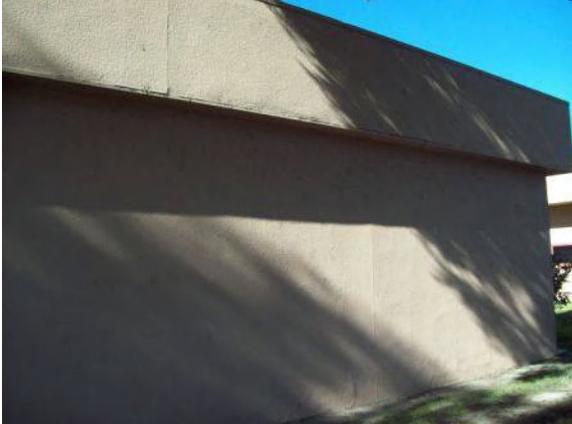
System: B2010 - Exterior Walls

Location: Exterior walls, soffits, and fascia.
Material: Exterior Walls
Distress: Damaged
Category: Capital Renewal
Priority: 3 - Necessary/Not Yet Critical (Years 2-5)
Correction: Repair Damaged Exterior Wall
Qty: 5,000-S.F.
Estimate: \$116,856.00
Assessor Name: Ann Buerger Linden
Date Created: 02/02/2013

Notes: Exterior stucco walls, soffits and fascia panels have cracking and water damage, much of it appears to be from roof issues. Repairs are recommended

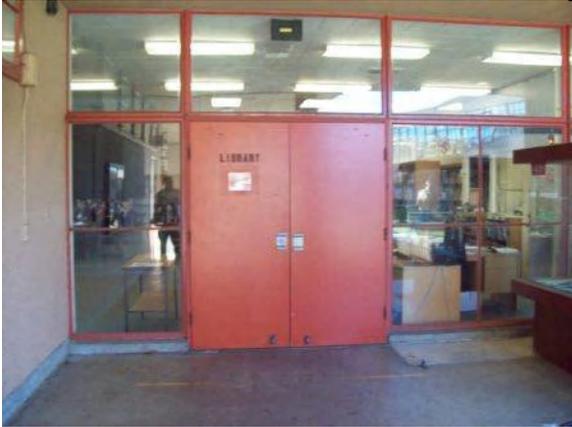
System: B2030 - Exterior Doors

Location: All exterior doors.
Material: System
Distress: Beyond Expected Life
Category: Capital Renewal
Priority: 3 - Necessary/Not Yet Critical (Years 2-5)
Correction: Renew System
Qty: 1-Ea.
Estimate: \$278,099.52
Assessor Name: Eduardo Lopez
Date Created: 01/21/2013

Notes: Exterior doors are typically original wood in wood or hollow metal frames. Doors and hardware are maintained in operable condition, however there is wear and tear. System replacement is recommended. Provide interior locking lever latchsets at classroom doors.

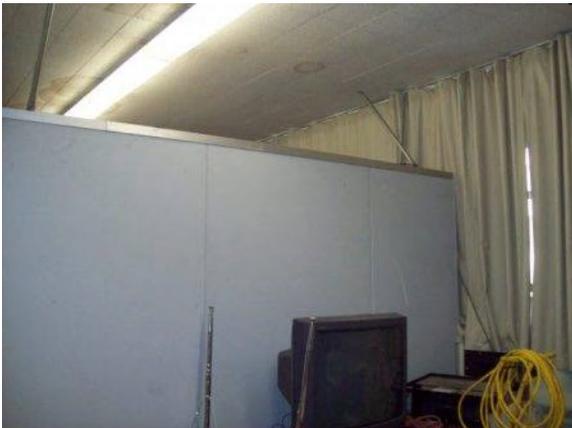
System: C1010 - Partitions

Location: Building interiors.
Material: Interior Partitions
Distress: Beyond Expected Life
Category: Capital Renewal
Priority: 3 - Necessary/Not Yet Critical (Years 2-5)
Correction: Allowance repair/remodel interior partitions
OUSD
Qty: 1-Job
Estimate: \$44,064.00
Assessor Name: Ann Buerger Linden
Date Created: 02/02/2013

Notes: Provide an allowance to repair and remodel interior partitions as needed to accommodate renovations to adjacent systems and update configurations for ADA compliance and operational efficiency.

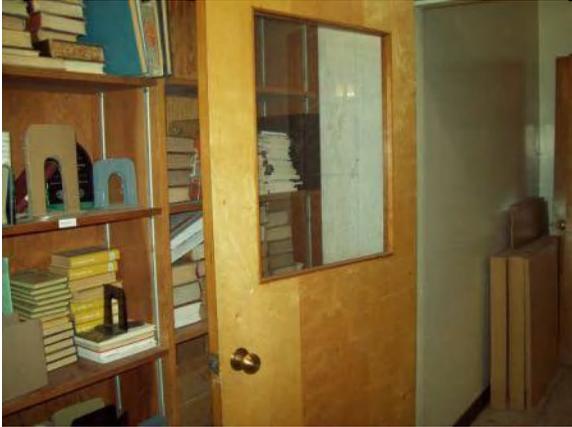
System: C1020 - Interior Doors

Location: All interior doors.
Material: System
Distress: Beyond Expected Life
Category: Capital Renewal
Priority: 3 - Necessary/Not Yet Critical (Years 2-5)
Correction: Renew System
Qty: 1-Ea.
Estimate: \$80,244.51
Assessor Name: Eduardo Lopez
Date Created: 01/21/2013

Notes: Interior doors, frames, and hardware are typically original and in worn condition. System replacement is recommended. Provide interior locking lever hardware at classroom interior doors.

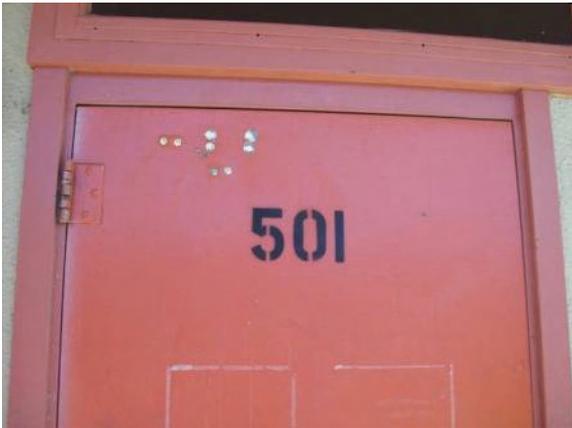
System: C1030 - Fittings

Location: Building wide
Material: Signage
Distress: Inadequate
Category: Capital Renewal
Priority: 3 - Necessary/Not Yet Critical (Years 2-5)
Correction: Replace/Install code compliant signage
Qty: 18,060-S.F.
Estimate: \$3,900.96
Assessor Name: Ann Buerger Linden
Date Created: 02/02/2013

Notes: Provide code compliant signage throughout the building.

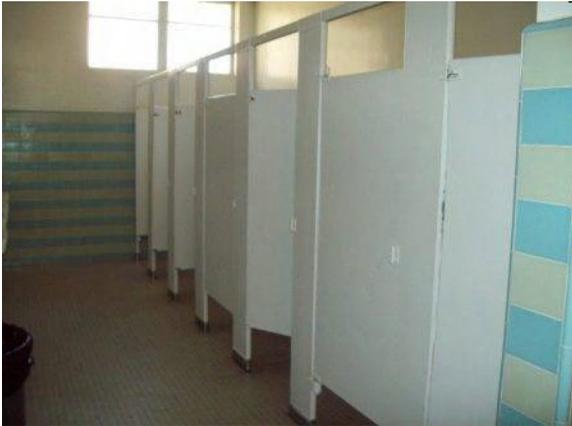
System: C1030 - Fittings

Location: Student girl's and staff restrooms.
Material: Toilet Partitions
Distress: Beyond Expected Life
Category: Capital Renewal
Priority: 3 - Necessary/Not Yet Critical (Years 2-5)
Correction: Replace toilet partitions and accessories
OUSD
Qty: 6-Ea.
Estimate: \$20,224.57
Assessor Name: Ann Buerger Linden
Date Created: 02/02/2013

Notes: The boy's restroom was renovated in 2010. Toilet partitions and accessories in the girl's restroom and staff restrooms are beyond their expected live.

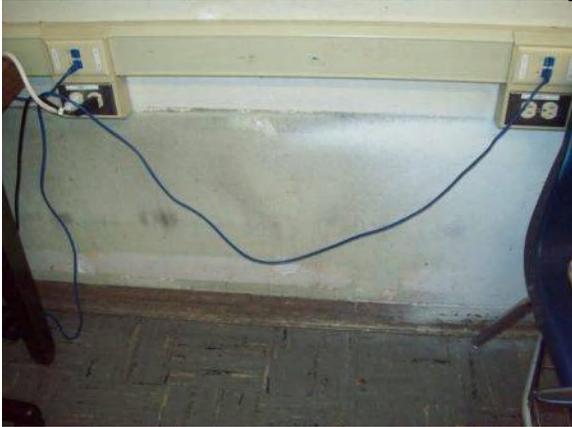
System: C3010 - Wall Finishes

Location: All interior walls.
Material: System
Distress: Beyond Expected Life
Category: Capital Renewal
Priority: 3 - Necessary/Not Yet Critical (Years 2-5)
Correction: Renew System
Qty: 1-Ea.
Estimate: \$234,863.80
Assessor Name: Sonny Satterfield
Date Created: 01/30/2013

Notes: Expected renovations of adjacent building systems such as exterior windows, interior doors, cabinetry and partition repairs/reconfigurations will necessitate refurbishing of all interior wall surfaces.

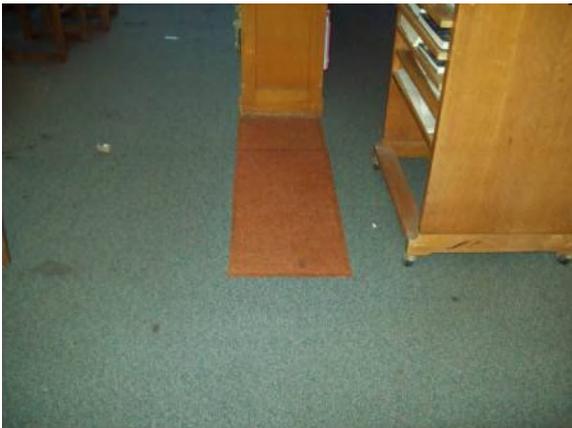
System: C3020210 - Carpet

Location: Media center, computer lab, reading room, classroom 525.
Material: System
Distress: Beyond Expected Life
Category: Capital Renewal
Priority: 3 - Necessary/Not Yet Critical (Years 2-5)
Correction: Renew System
Qty: 1-Ea.
Estimate: \$60,740.06
Assessor Name: Sonny Satterfield
Date Created: 01/30/2013

Notes: Carpeted areas are worn and stained. System renewal is recommended.

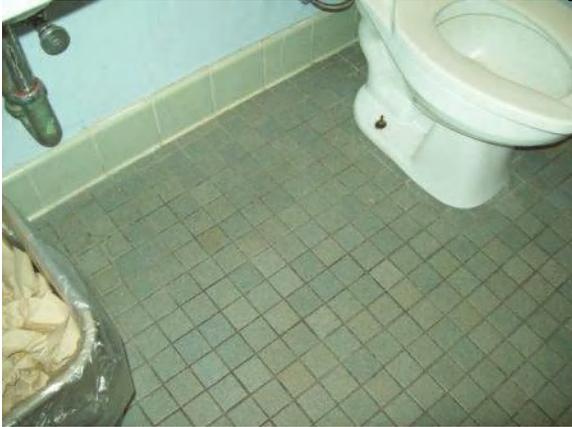
System: C3020210 - Ceramic Tile

Location: Staff toilets.
Material: System
Distress: Beyond Expected Life
Category: Capital Renewal
Priority: 3 - Necessary/Not Yet Critical (Years 2-5)
Correction: Renew System
Qty: 1-Ea.
Estimate: \$21,684.33
Assessor Name: Sonny Satterfield
Date Created: 01/30/2013

Notes: Ceramic tile is original and in worn condition.

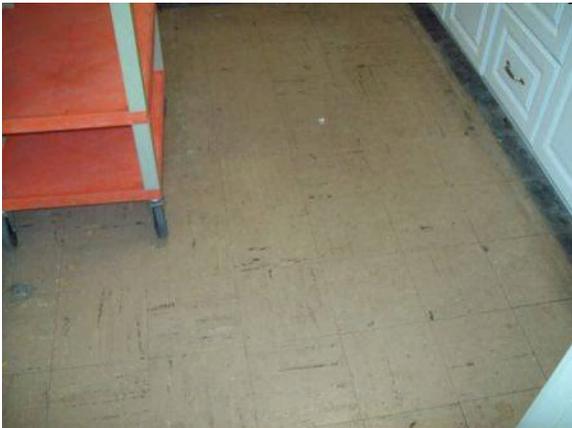
System: C3020410 - VCT

Location: Classrooms, except 507 and part of 505, darkroom, workrooms, storage rooms, library office and kitchenette, corridor at 504-507.
Material: System
Distress: Beyond Expected Life
Category: Capital Renewal
Priority: 3 - Necessary/Not Yet Critical (Years 2-5)
Correction: Renew System
Qty: 1-Ea.
Estimate: \$76,507.20
Assessor Name: Ann Buerger Linden
Date Created: 02/02/2013

Notes: Most vinyl floor tile is ACM. System replacement is recommended.

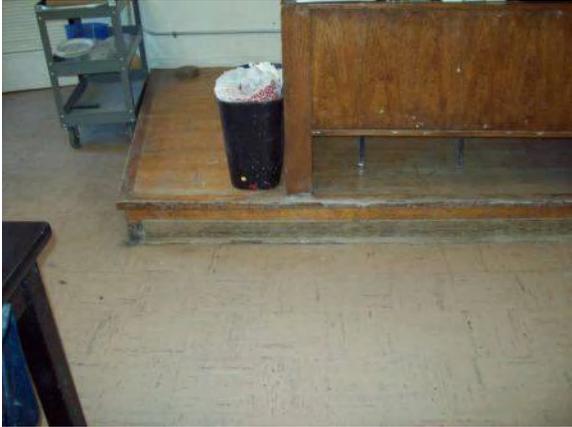
System: C3020410 - Wood

Location: Teacher platforms at classrooms 506, 507, and 508.

Notes: Wood flooring is beyond it's expected life and is very worn.

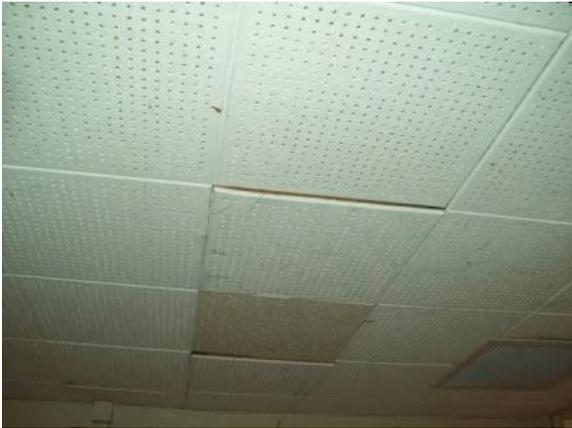
System: C3030 - Ceiling Finishes

Location: Building wide.

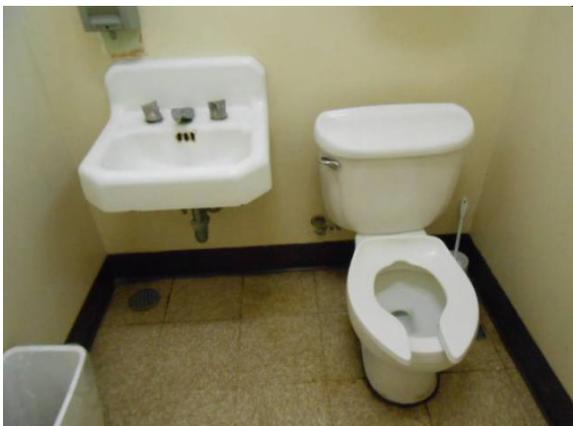
System: D2010 - Plumbing Fixtures

Location: Women & Staff (2) restrooms
Material: Tankless Water Closet
Distress: Beyond Expected Life
Category: Capital Renewal
Priority: 4 - Recommended (Years 6-10)
Correction: Replace tankless water closet
Qty: 9-Ea.
Estimate: \$11,119.16
Assessor Name: Eduardo Lopez
Date Created: 01/22/2013

Notes: Replace during next remodel or renovation.

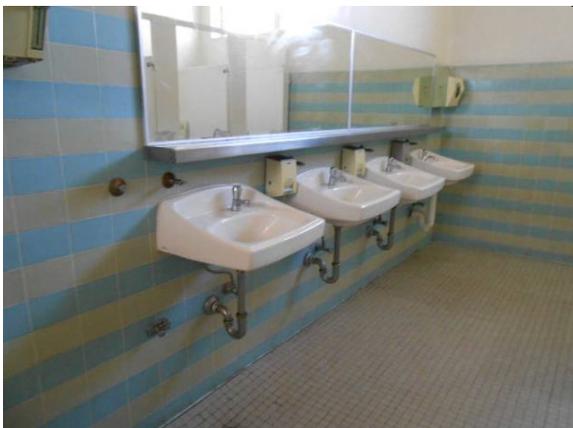
System: D2010 - Plumbing Fixtures

Location: Women & Staff (2) restrooms
Material: Lavatory, Vitreous China
Distress: Beyond Expected Life
Category: Capital Renewal
Priority: 4 - Recommended (Years 6-10)
Correction: Replace lavatory, vitreous china
Qty: 6-Ea.
Estimate: \$6,449.93
Assessor Name: Eduardo Lopez
Date Created: 01/22/2013

Notes: Replace during next remodel or renovation.

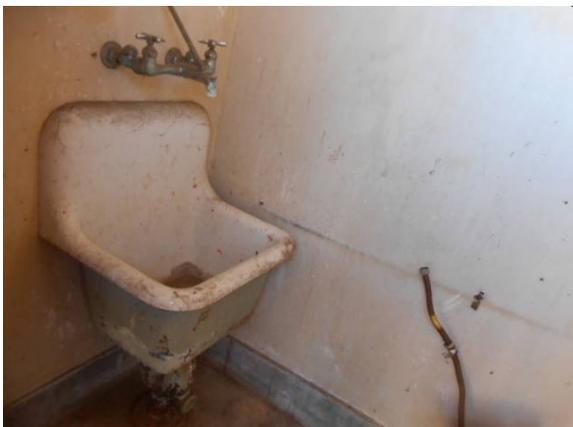
System: D2010 - Plumbing Fixtures

Location: Janitor Closets
Material: Service/Utility Sink
Distress: Beyond Expected Life
Category: Capital Renewal
Priority: 4 - Recommended (Years 6-10)
Correction: Replace sink and fixtures
Qty: 2-Ea.
Estimate: \$6,595.29
Assessor Name: Eduardo Lopez
Date Created: 01/22/2013

Notes: Replace during next remodel or renovation.

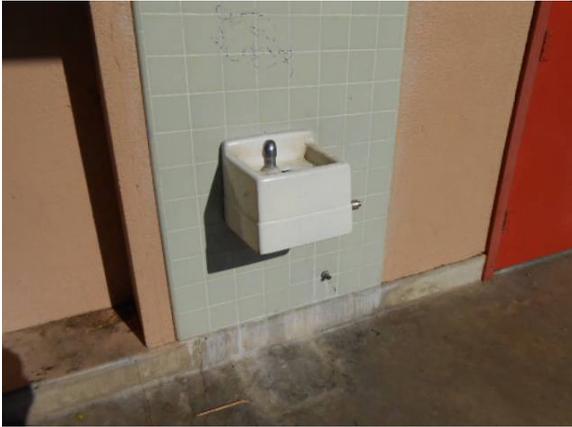
System: D2010 - Plumbing Fixtures

Location: East side of building
Material: Drinking Fountain
Distress: Beyond Expected Life
Category: Capital Renewal
Priority: 4 - Recommended (Years 6-10)
Correction: Replace fountain drinking fountain
Qty: 2-Ea.
Estimate: \$4,813.01
Assessor Name: Eduardo Lopez
Date Created: 01/22/2013

Notes: A drinking fountain is beyond its expected life and it is recommended to be replaced during next remodel or renovation.

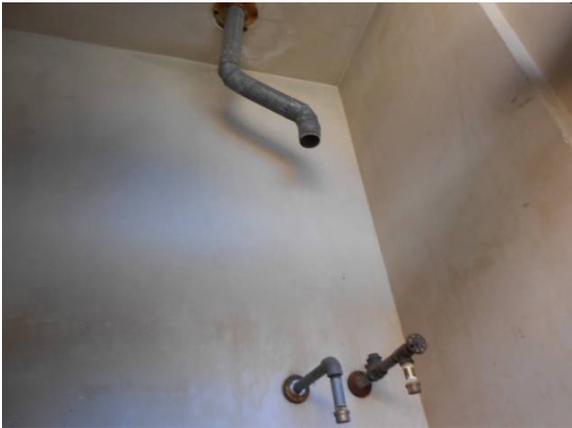
System: D2020 - Domestic Water Distribution

Location: Typical for entire building
Material: System
Distress: Beyond Expected Life
Category: Capital Renewal
Priority: 4 - Recommended (Years 6-10)
Correction: Renew System
Qty: 1-Ea.
Estimate: \$33,756.31
Assessor Name: Eduardo Lopez
Date Created: 01/28/2013

Notes: Domestic Water Distribution is beyond its expected life and is recommended to replace the domestic water distribution system during next remodel or renovation.

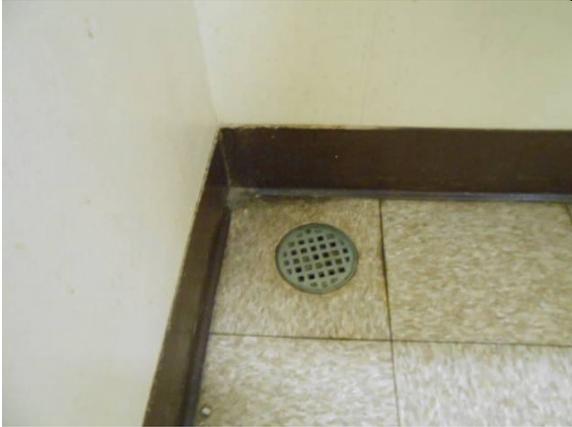
System: D2030 - Sanitary Waste

Location: Typical for entire building
Material: System
Distress: Beyond Expected Life
Category: Capital Renewal
Priority: 4 - Recommended (Years 6-10)
Correction: Renew System
Qty: 1-Ea.
Estimate: \$114,714.23
Assessor Name: Eduardo Lopez
Date Created: 01/28/2013

Notes: Replace all above grade sanitary waste and vent piping during next remodel or renovation; below grade as needed.

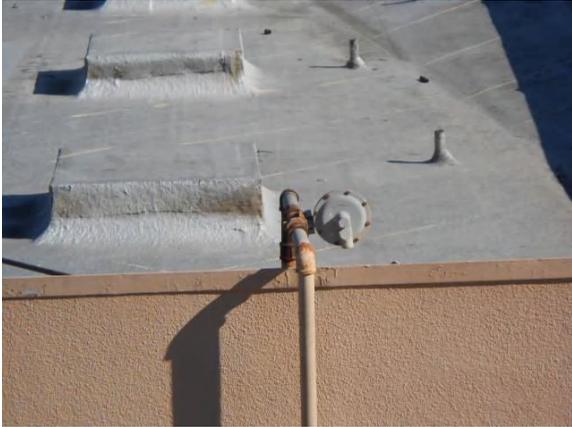
System: D2090 - Other Plumbing Systems-Nat Gas

Location: Typical for entire building
Material: System
Distress: Beyond Expected Life
Category: Capital Renewal
Priority: 4 - Recommended (Years 6-10)
Correction: Renew System
Qty: 1-Ea.
Estimate: \$31,181.67
Assessor Name: Eduardo Lopez
Date Created: 01/28/2013

Notes: The Natural Gas distribution is original to the building age. It is recommended to be replaced during the next major renovation.

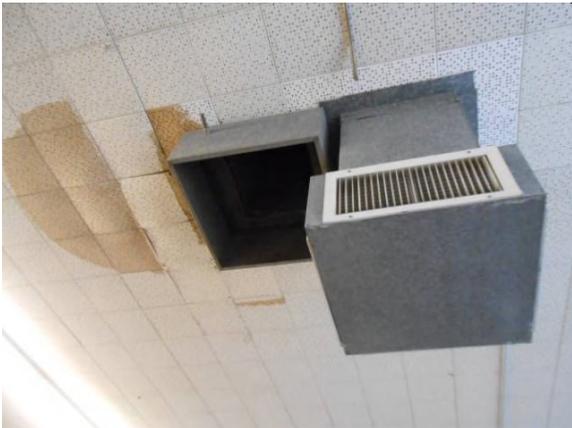
System: D3040 - Distribution Systems

Location: Typical for entire building
Material: System
Distress: Beyond Expected Life
Category: Capital Renewal
Priority: 4 - Recommended (Years 6-10)
Correction: Renew System
Qty: 1-Ea.
Estimate: \$455,996.22
Assessor Name: Eduardo Lopez
Date Created: 01/28/2013

Notes: HVAC system was replaced in 2008, however the ductwork, ventilation diffusers/grilles and fresh air supply is recommended to be upgraded during the next major renovation.

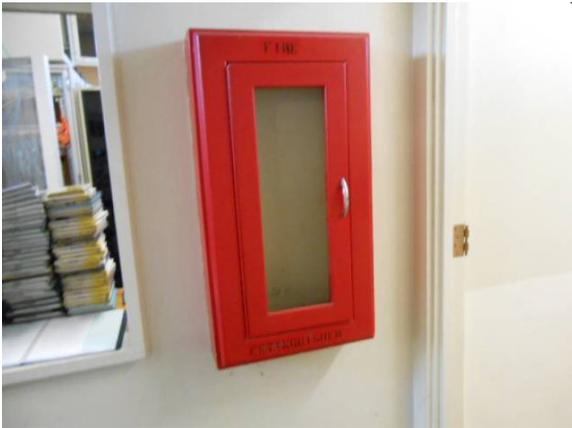
System: D4030 - Fire Protection Specialties

Location: Typical for entire building
Material: System
Distress: Missing
Category: Code Compliance
Priority: 1 - Currently Critical (Immediate)
Correction: Renew System
Qty: 1-Ea.
Estimate: \$4,863.20
Assessor Name: Eduardo Lopez
Date Created: 01/28/2013

Notes: Fire Extinguishers are missing in different locations and should be provided.

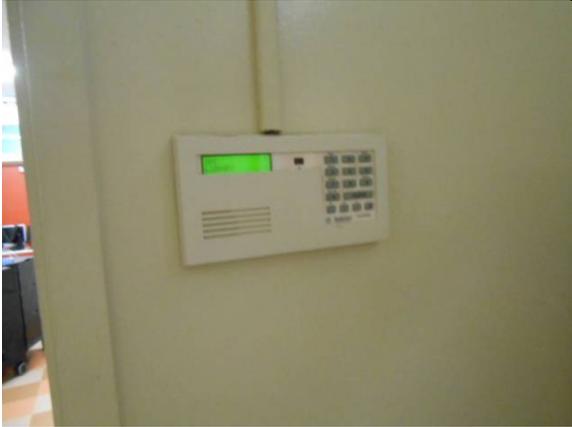
System: D5030910 - Security System, Camers, Access Control

Location: Typical for entire building
Material: System
Distress: Beyond Expected Life
Category: Capital Renewal
Priority: 4 - Recommended (Years 6-10)
Correction: Renew System
Qty: 1-Ea.
Estimate: \$26,786.59
Assessor Name: Eduardo Lopez
Date Created: 01/28/2013

Notes: Building security is needing upgrades. Recommend replacing and enhancing during the next building renovation.

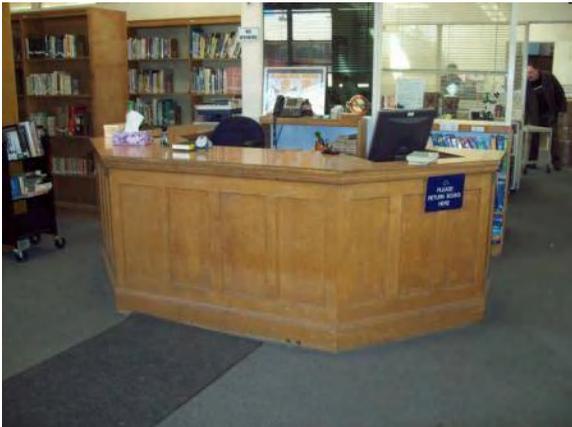
System: E1020 - Institutional Equipment

Location: Media Center
Material: Library Equipment
Distress: Beyond Expected Life
Category: Capital Renewal
Priority: 3 - Necessary/Not Yet Critical (Years 2-5)
Correction: Replace/add library equipment
Qty: 100-L.F.
Estimate: \$111,609.99
Assessor Name: Ann Buerger Linden
Date Created: 02/02/2013

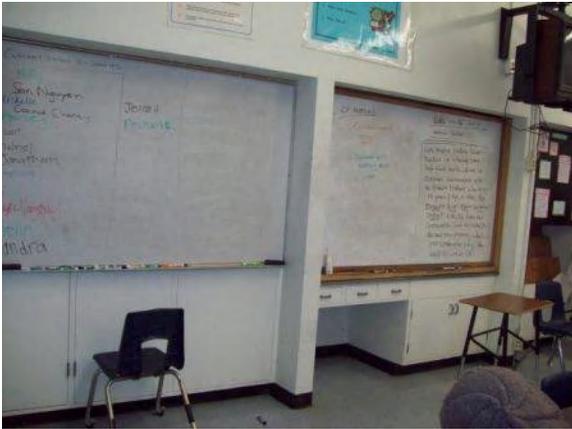
System: E1020 - Institutional Equipment

Location: Classrooms
Material: Other Institutional Equipment
Distress: Beyond Expected Life
Category: Capital Renewal
Priority: 3 - Necessary/Not Yet Critical (Years 2-5)
Correction: Smartboards whiteboards tackboards
Qty: 7-Ea.
Estimate: \$64,051.65
Assessor Name: Ann Buerger Linden
Date Created: 02/02/2013

Notes: Provide new clean whiteboards and tackboards in classrooms. Three classrooms and the media center have Smartboard technology. Provide Smartboard technology in 4 additional classrooms.

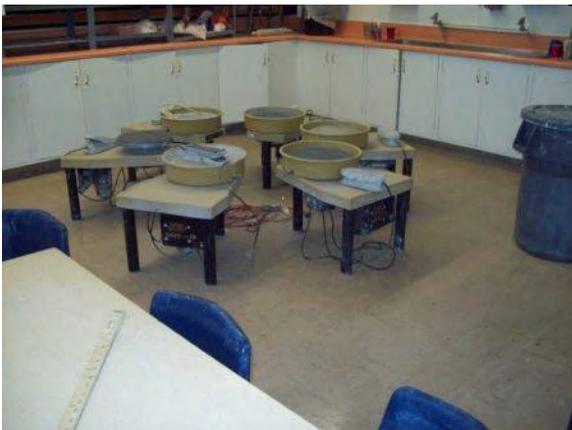
System: E1090 - Other Equipment - Art

Location: Art classrooms
Material: System
Distress: Beyond Expected Life
Category: Capital Renewal
Priority: 3 - Necessary/Not Yet Critical (Years 2-5)
Correction: Renew System
Qty: 1-Ea.
Estimate: \$38,619.50
Assessor Name: Ann Buerger Linden
Date Created: 02/02/2013

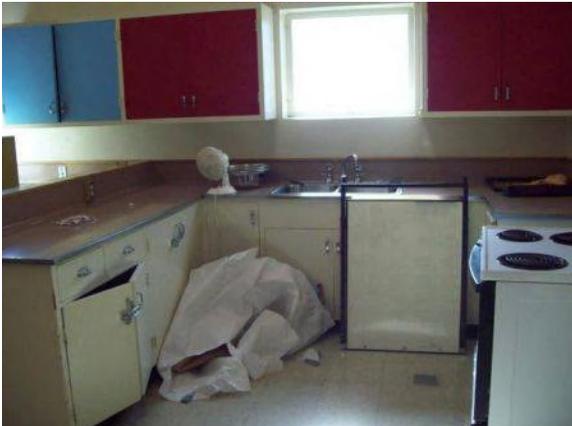
System: E1090 - Other Equipment -Kitchen

Location: Classroom 504
Material: Kitchen Equipment
Distress: Beyond Service Life
Category: Capital Renewal
Priority: 4 - Recommended (Years 6-10)
Correction: Home Economics Kitchen Class Set-up
Qty: 7-Ea.
Estimate: \$83,852.40
Assessor Name: Ann Buerger Linden
Date Created: 02/02/2013

Notes: The home economics kitchen classroom is not currently being used. The installed equipment is beyond its expected life. System replacement is recommended. If the academic program changes, budgeted dollars should be allocated to current classroom specialty equipment requirements.

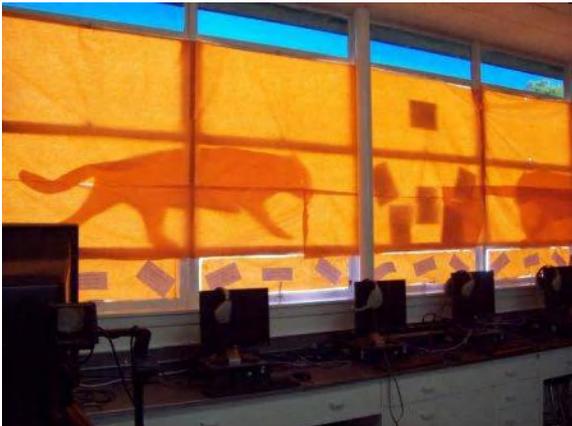
System: E2010 - Fixed Furnishings

Location: At exterior windows in classrooms.
Material: Blinds and Other Window Treatment
Distress: Missing
Category: Capital Renewal
Priority: 1 - Currently Critical (Immediate)
Correction: Replace window blinds
Qty: 2,000-S.F.
Estimate: \$21,686.40
Assessor Name: Ann Buerger Linden
Date Created: 02/02/2013

Notes: Window blinds are typically missing or in poor condition. System renewal is recommended.

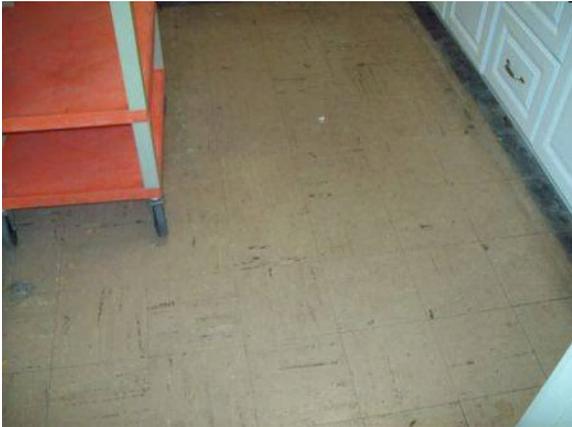
System: F2020 - Hazardous Components Abatement

Location: Friable material in pipe fitting insulation at classrooms 504-508. Non-friable material in exterior stucco, window putty, interior plaster, and 9" floor tile.
Material: Removal of Hazardous Components
Distress: Beyond Expected Life
Category: Capital Renewal
Priority: 3 - Necessary/Not Yet Critical (Years 2-5)
Correction: Abate all ACM in building
Qty: 18,060-S.F.
Estimate: \$159,159.17
Assessor Name: Ann Buerger Linden
Date Created: 02/02/2013

Notes: The AHERA six-month surveillance of asbestos-containing materials - Summer 2012, identifies ACM at this building. Complete abatement is recommended.

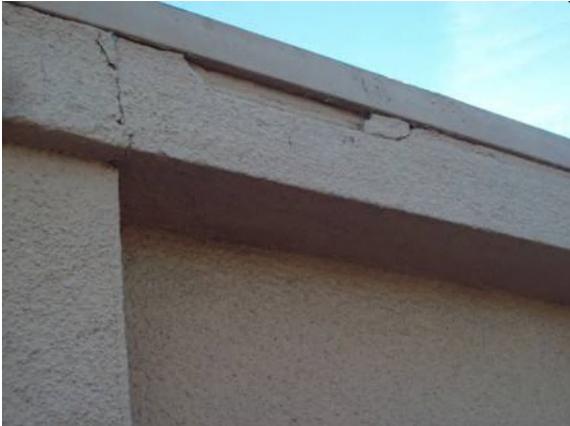
System: B2010 - Exterior Walls

Location: Exterior walls, soffits
Material: Exterior Walls
Distress: Damaged
Category: Deferred Maintenance
Priority: 3 - Necessary/Not Yet Critical (Years 2-5)
Correction: Repair Damaged Exterior Wall
Qty: 5,000-S.F.
Estimate: \$116,856.00
Assessor Name: Ann Buerger Linden
Date Created: 01/31/2013

Notes: Exterior walls are in fair to poor condition. Failed roofing has contributed to water damage to soffits and exterior wall stucco. Selective repairs are recommended.

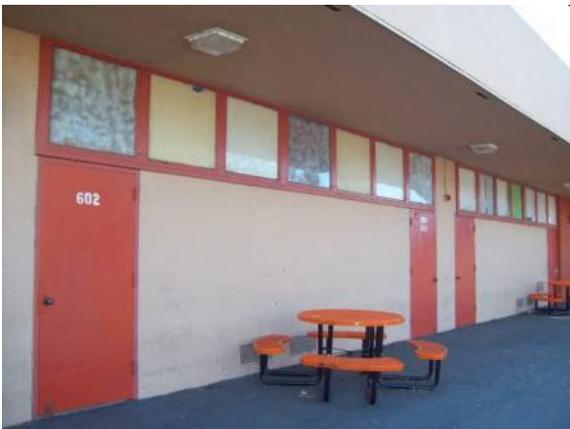
System: B2020 - Exterior Windows

Location: Exterior windows
Material: System
Distress: Beyond Expected Life
Category: Capital Renewal
Priority: 3 - Necessary/Not Yet Critical (Years 2-5)
Correction: Renew System
Qty: 1-Ea.
Estimate: \$64,587.60
Assessor Name: Ann Buerger Linden
Date Created: 01/31/2013

Notes: Windows are fixed at classrooms and staff dining room. Windows are operable at kitchen and snack bar. All are expired.

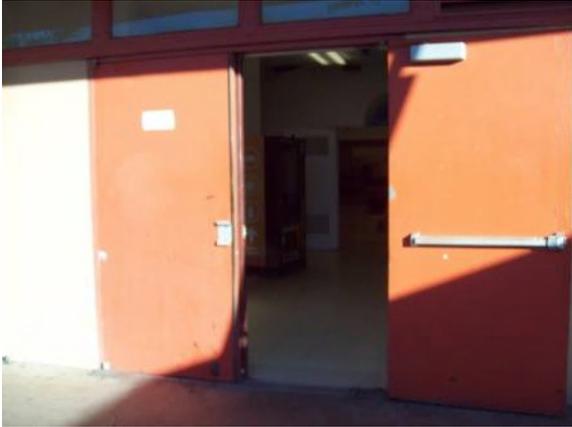
System: B2030 - Exterior Doors

Location: Exterior doors.
Material: System
Distress: Beyond Expected Life
Category: Capital Renewal
Priority: 3 - Necessary/Not Yet Critical (Years 2-5)
Correction: Renew System
Qty: 1-Ea.
Estimate: \$129,177.89
Assessor Name: Eduardo Lopez
Date Created: 01/21/2013

Notes: Exterior doors are typically original. Complete system renewal including doors, frames, and hardware is recommended. Installation of a handi-cap operator at one entrance is suggested. Provide interior locking lever locksets at classrooms.

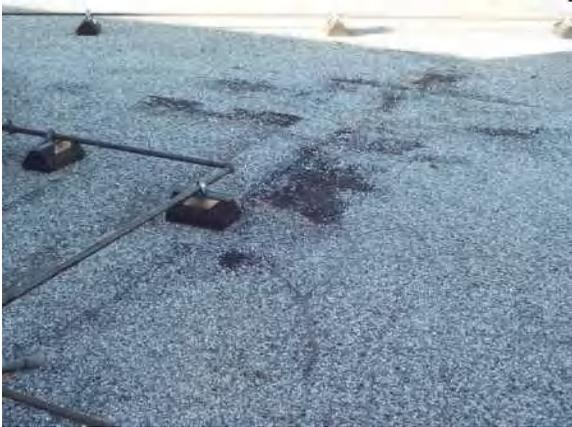
System: B3010105 - Built-Up

Location: Roof
Material: System
Distress: Beyond Expected Life
Category: Capital Renewal
Priority: 1 - Currently Critical (Immediate)
Correction: Renew System
Qty: 1-Ea.
Estimate: \$253,161.22
Assessor Name: Ann Buerger Linden
Date Created: 01/30/2013

Notes: The roof on this building is well beyond its expected life with significant visible deficiencies, particularly at perimeters and penetrations. Cap flashings at the high roof do not sufficiently overlap the exterior wall finish system. Membrane is visibly degraded. Interior finishes and exterior soffits show signs of water infiltration.

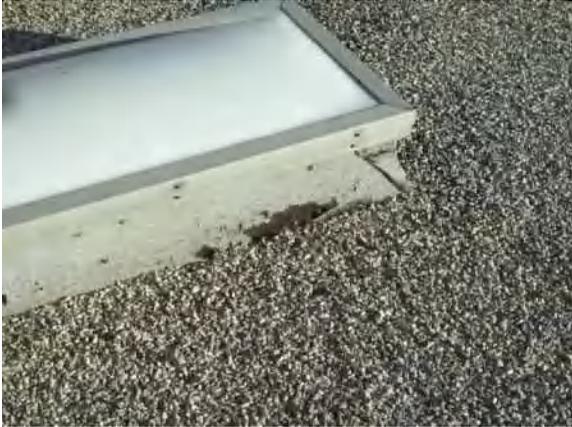
System: B3020 - Roof Openings

Location: Roof
Material: System
Distress: Beyond Expected Life
Category: Capital Renewal
Priority: 3 - Necessary/Not Yet Critical (Years 2-5)
Correction: Renew System
Qty: 1-Ea.
Estimate: \$11,432.81
Assessor Name: Eduardo Lopez
Date Created: 01/21/2013

Notes: Existing roof hatch does not function properly. Skylights are beyond expected life.

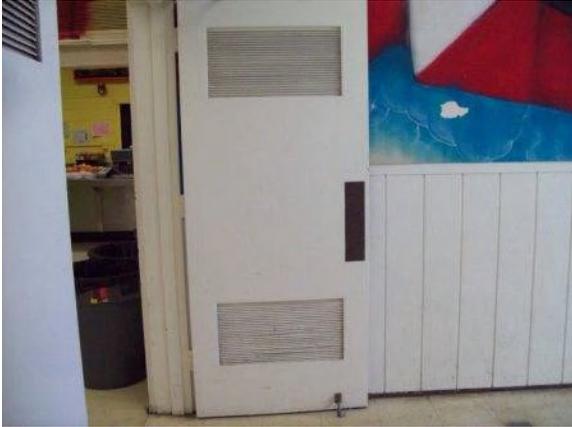
System: C1020 - Interior Doors

Location: Interior - building wide.
Material: System
Distress: Beyond Expected Life
Category: Capital Renewal
Priority: 3 - Necessary/Not Yet Critical (Years 2-5)
Correction: Renew System
Qty: 1-Ea.
Estimate: \$75,168.53
Assessor Name: Eduardo Lopez
Date Created: 01/21/2013

Notes: Interior doors and frames are original. Hardware is worn. Doors and frames have painted over damage. Replacement of doors, frames and hardware is recommended. Install interior locking lever latches.

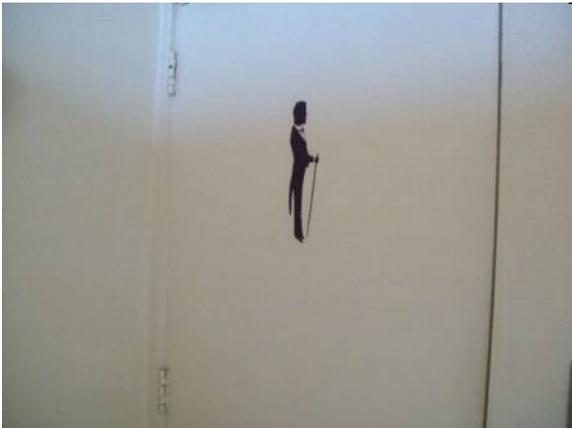
System: C1030 - Fittings

Location: Building wide.
Material: Signage
Distress: Inadequate
Category: Capital Renewal
Priority: 3 - Necessary/Not Yet Critical (Years 2-5)
Correction: Replace/Install code compliant signage
Qty: 8,695-S.F.
Estimate: \$1,878.12
Assessor Name: Ann Buerger Linden
Date Created: 01/30/2013

Notes: Provide code compliant signage throughout the building.

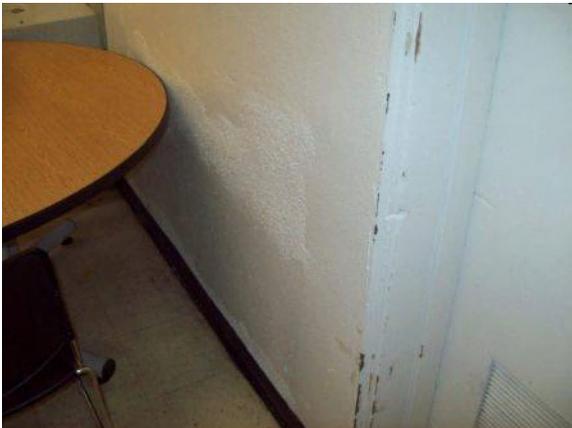
System: C3010 - Wall Finishes

Location: Building wide
Material: System
Distress: Beyond Expected Life
Category: Capital Renewal
Priority: 3 - Necessary/Not Yet Critical (Years 2-5)
Correction: Renew System
Qty: 1-Ea.
Estimate: \$108,542.78
Assessor Name: Eduardo Lopez
Date Created: 01/21/2013

Notes: Although generally well maintained, there are areas of damaged wall finishes. Wall finishes include paint and ceramic tile. Expected renovations of adjacent building systems such as exterior windows, interior doors, cabinetry and partition reconfigurations will necessitate re-painting of all interior wall surfaces.

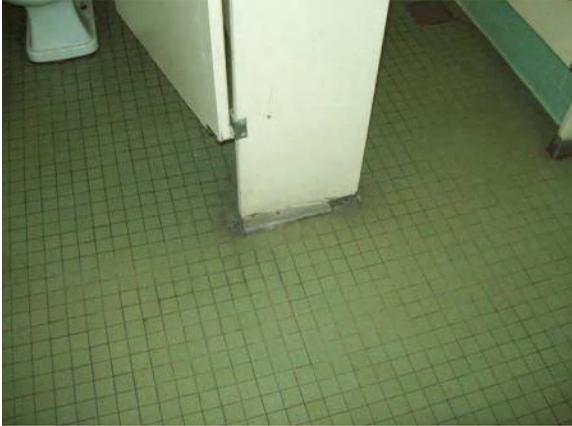
System: C3020210 - Ceramic Tile

Location: Student and staff restrooms.
Material: System
Distress: Beyond Expected Life
Category: Capital Renewal
Priority: 3 - Necessary/Not Yet Critical (Years 2-5)
Correction: Renew System
Qty: 1-Ea.
Estimate: \$7,555.68
Assessor Name: Ann Buerger Linden
Date Created: 01/31/2013

Notes: Ceramic tile is original and beyond its expected life.

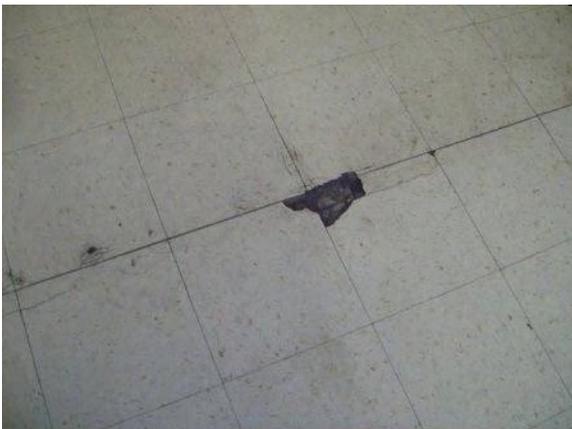
System: C3020410 - VCT

Location: Classrooms, multi-purpose room, kitchen, office, storage rooms, staff dining.
Material: System
Distress: Beyond Expected Life
Category: Capital Renewal
Priority: 3 - Necessary/Not Yet Critical (Years 2-5)
Correction: Renew System
Qty: 1-Ea.
Estimate: \$55,371.10
Assessor Name: Ann Buerger Linden
Date Created: 01/31/2013

Notes: Vinyl floor tile includes both 9" and 12" ACM. Tile is beyond expected life.

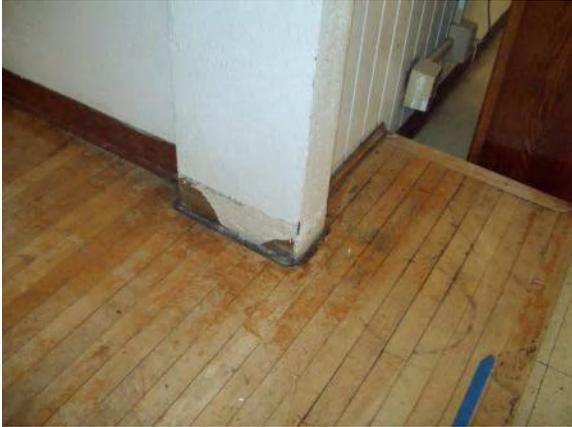
System: C3020410 - Wood

Location: North end multi-purpose room.
Material: System
Distress: Beyond Expected Life
Category: Capital Renewal
Priority: 3 - Necessary/Not Yet Critical (Years 2-5)
Correction: Renew System
Qty: 1-Ea.
Estimate: \$8,491.82
Assessor Name: Ann Buerger Linden
Date Created: 01/31/2013

Notes: Wood platform flooring is in poor condition.

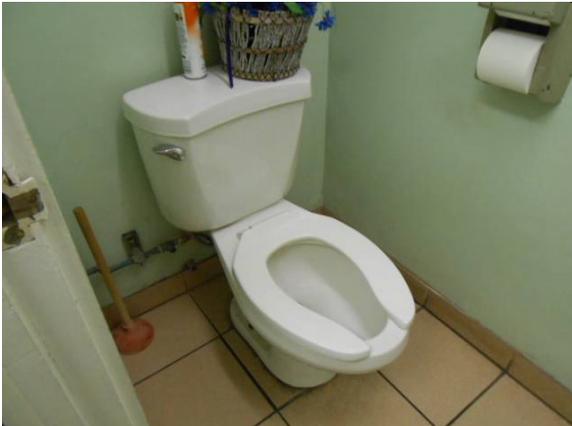
System: D2010 - Plumbing Fixtures

Location: Women, Men & Staff restrooms
Material: Tankless Water Closet
Distress: Beyond Expected Life
Category: Capital Renewal
Priority: 4 - Recommended (Years 6-10)
Correction: Replace tankless water closet
Qty: 5-Ea.
Estimate: \$6,177.31
Assessor Name: Eduardo Lopez
Date Created: 01/22/2013

Notes: Replace during next remodel or renovation.

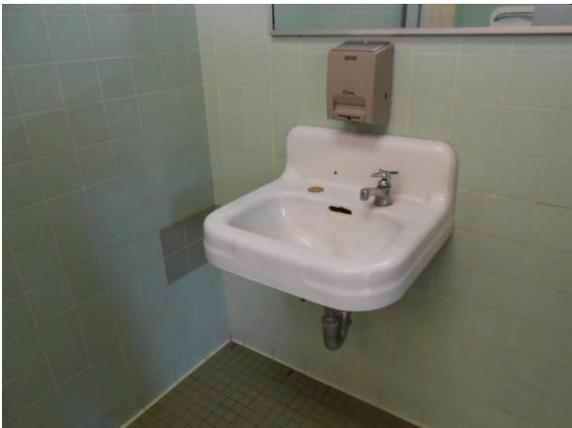
System: D2010 - Plumbing Fixtures

Location: Women, Men & Staff restrooms
Material: Lavatory, Vitreous China
Distress: Beyond Expected Life
Category: Capital Renewal
Priority: 4 - Recommended (Years 6-10)
Correction: Replace lavatory, vitreous china
Qty: 3-Ea.
Estimate: \$3,224.97
Assessor Name: Eduardo Lopez
Date Created: 01/22/2013

Notes: Replace during next remodel or renovation.

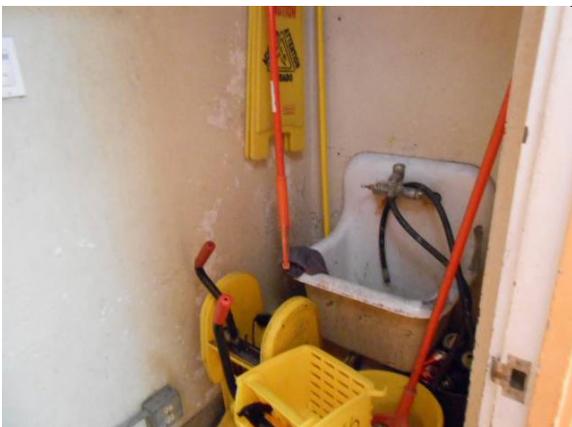
System: D2010 - Plumbing Fixtures

Location: Janitor Closets
Material: Service/Utility Sink
Distress: Beyond Expected Life
Category: Capital Renewal
Priority: 4 - Recommended (Years 6-10)
Correction: Replace sink and fixtures
Qty: 1-Ea.
Estimate: \$3,297.64
Assessor Name: Eduardo Lopez
Date Created: 01/22/2013

Notes: Replace during next remodel or renovation.

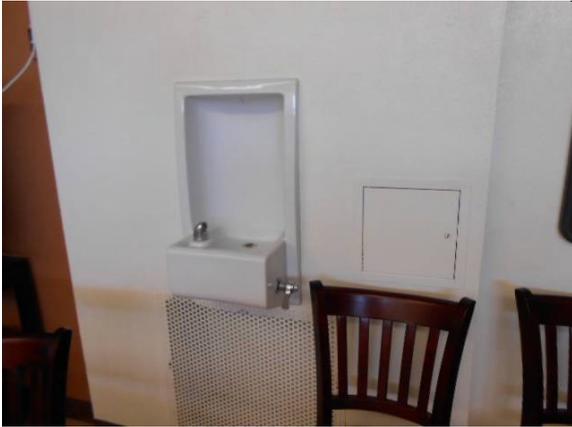
System: D2010 - Plumbing Fixtures

Location: Staff Dinning
Material: Drinking Fountain
Distress: Beyond Expected Life
Category: Capital Renewal
Priority: 4 - Recommended (Years 6-10)
Correction: Replace fountain drinking fountain
Qty: 2-Ea.
Estimate: \$4,813.01
Assessor Name: Eduardo Lopez
Date Created: 01/22/2013

Notes: A drinking fountain is beyond its expected life and it is recommended to be replaced during next remodel or renovation.

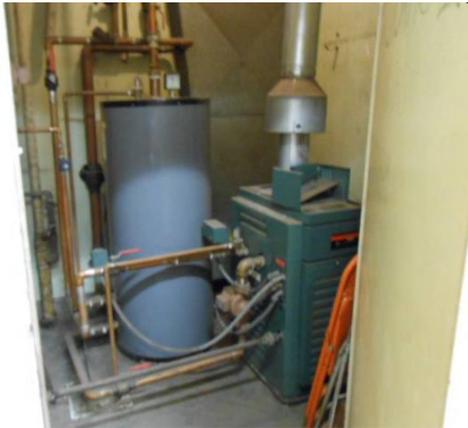
System: D2020 - Domestic Water Distribution

Location: Typical for entire building
Material: System
Distress: Beyond Expected Life
Category: Capital Renewal
Priority: 4 - Recommended (Years 6-10)
Correction: Renew System
Qty: 1-Ea.
Estimate: \$15,565.14
Assessor Name: Eduardo Lopez
Date Created: 01/28/2013

Notes: (2) Domestic hot water were replaced in 2000 & 2003 including a storage tank and is currently furnished for Kitchen and custodial rooms only; however it is recommended to replace the domestic water distribution system during next remodel or renovation.

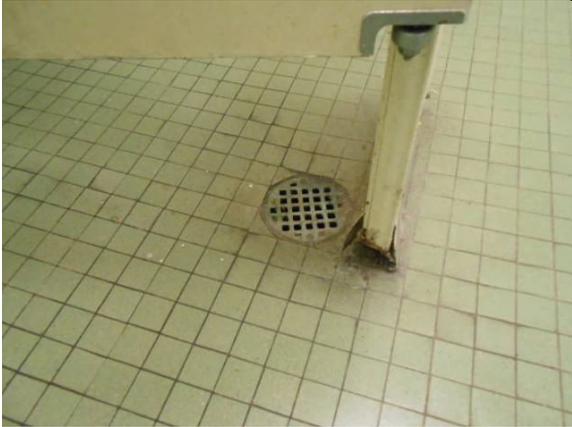
System: D2030 - Sanitary Waste

Location: Typical for entire building
Material: System
Distress: Beyond Expected Life
Category: Capital Renewal
Priority: 4 - Recommended (Years 6-10)
Correction: Renew System
Qty: 1-Ea.
Estimate: \$53,031.69
Assessor Name: Eduardo Lopez
Date Created: 01/28/2013

Notes: Replace all above grade sanitary waste and vent piping during next remodel or renovation; below grade as needed.

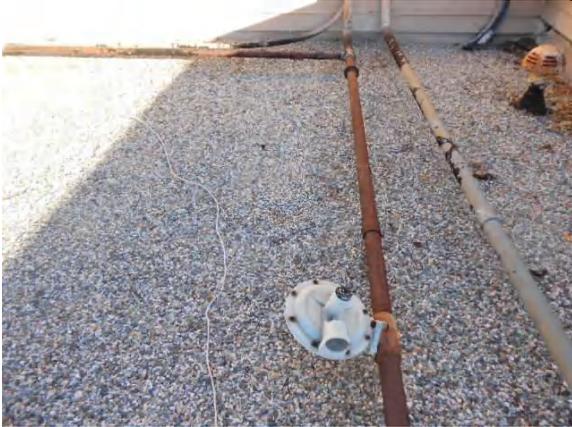
System: D2090 - Other Plumbing Systems-Nat Gas

Location: Typical for entire building
Material: System
Distress: Beyond Expected Life
Category: Capital Renewal
Priority: 4 - Recommended (Years 6-10)
Correction: Renew System
Qty: 1-Ea.
Estimate: \$14,463.19
Assessor Name: Eduardo Lopez
Date Created: 01/28/2013

Notes: The Natural Gas distribution is original to the building age. It is recommended to be replaced during the next major renovation.

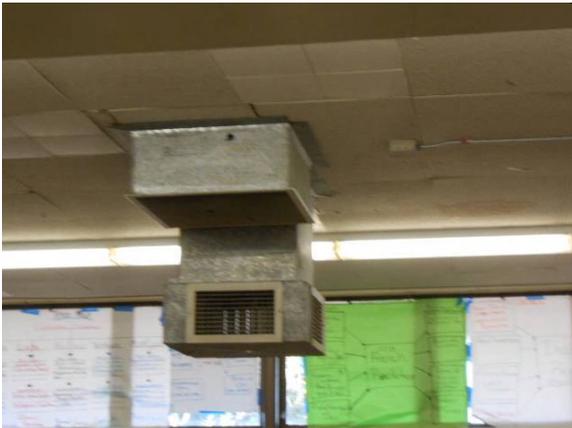
System: D3040 - Distribution Systems

Location: Typical for entire building
Material: System
Distress: Beyond Expected Life
Category: Capital Renewal
Priority: 4 - Recommended (Years 6-10)
Correction: Renew System
Qty: 1-Ea.
Estimate: \$210,749.30
Assessor Name: Eduardo Lopez
Date Created: 01/28/2013

Notes: HVAC system was replaced in 2008, however the ductwork, ventilation diffusers/grilles and fresh air supply is recommended to be upgraded during the next major renovation.

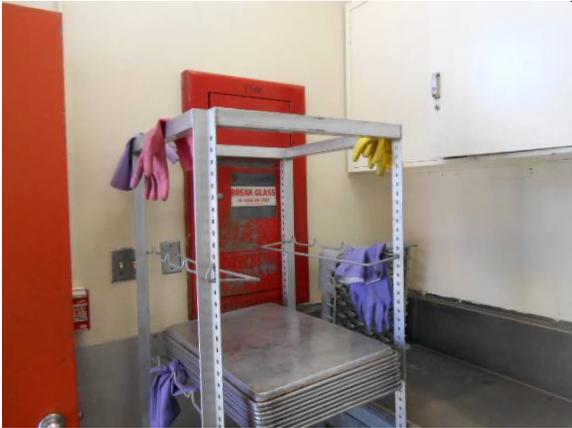
System: D4030 - Fire Protection Specialties

Location: Typical for entire building
Material: System
Distress: Missing
Category: Code Compliance
Priority: 1 - Currently Critical (Immediate)
Correction: Renew System
Qty: 1-Ea.
Estimate: \$2,203.91
Assessor Name: Eduardo Lopez
Date Created: 01/28/2013

Notes: Fire Extinguishers are missing, inaccessible and some cabinets are painted without label. System should be provided.

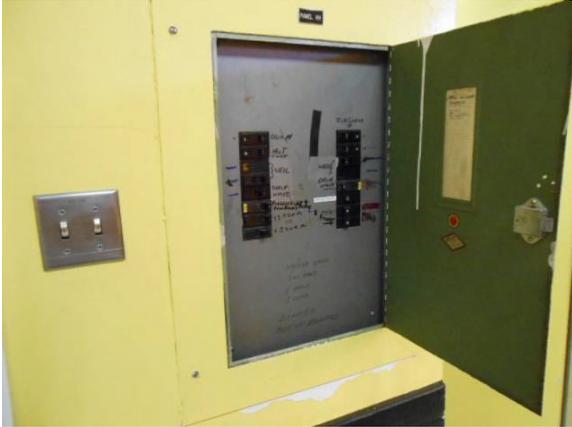
System: D5010 - Electrical Service/Distribution

Location: Typical for entire building
Material: System
Distress: Beyond Expected Life
Category: Capital Renewal
Priority: 4 - Recommended (Years 6-10)
Correction: Renew System
Qty: 1-Ea.
Estimate: \$79,065.42
Assessor Name: Eduardo Lopez
Date Created: 01/28/2013

Notes: The main electrical panels, distribution panel boards and feeders are mostly original to the building age. It is recommended to be replaced during the next major renovation.

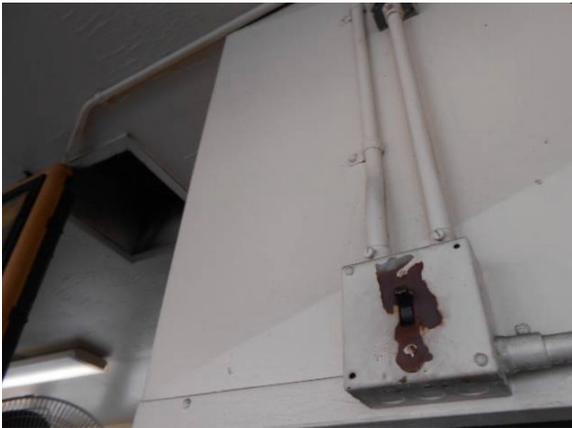
System: D5020 - Branch Wiring

Location: Typical for entire building
Material: System
Distress: Beyond Expected Life
Category: Capital Renewal
Priority: 4 - Recommended (Years 6-10)
Correction: Renew System
Qty: 1-Ea.
Estimate: \$272,596.64
Assessor Name: Eduardo Lopez
Date Created: 01/28/2013

Notes: The branch wiring, electrical panels and devices are mostly original to the building age. It is recommended to be replaced during the next major renovation.

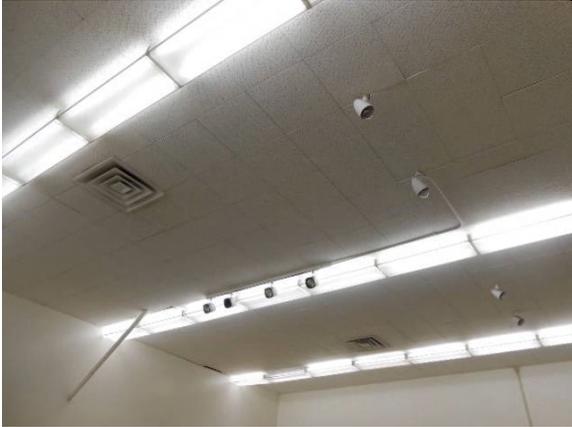
System: D5020 - Lighting

Location: Typical for entire building
Material: System
Distress: Beyond Expected Life
Category: Capital Renewal
Priority: 4 - Recommended (Years 6-10)
Correction: Renew System
Qty: 1-Ea.
Estimate: \$214,330.66
Assessor Name: Eduardo Lopez
Date Created: 01/28/2013

Notes: T8 fluorescent lamps and ballasts were updated; however light fixtures, switches and wiring are original to building age and it is recommended to be replaced during next remodel or renovation.

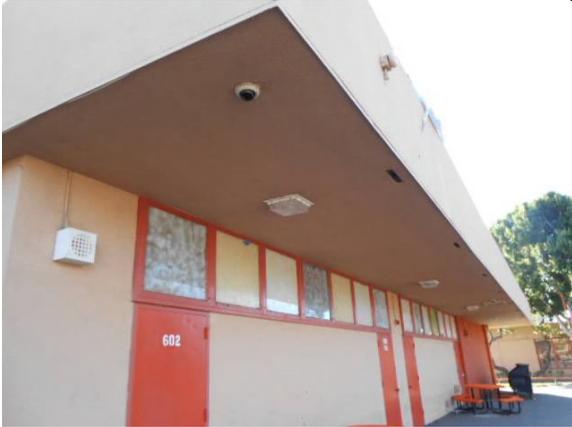
System: D5030910 - Security System, Camers, Access Control

Location: Typical for entire building
Material: System
Distress: Beyond Expected Life
Category: Capital Renewal
Priority: 4 - Recommended (Years 6-10)
Correction: Renew System
Qty: 1-Ea.
Estimate: \$12,397.02
Assessor Name: Eduardo Lopez
Date Created: 01/28/2013

Notes: Building security is needing upgrades. Recommend replacing and enhancing during the next building renovation.
