Orange Unified School District

Facilities Condition Assessment for:

**Orange High School
525 N. Shaffer Street
Orange, CA 92867**

Report: Mar 11, 2013

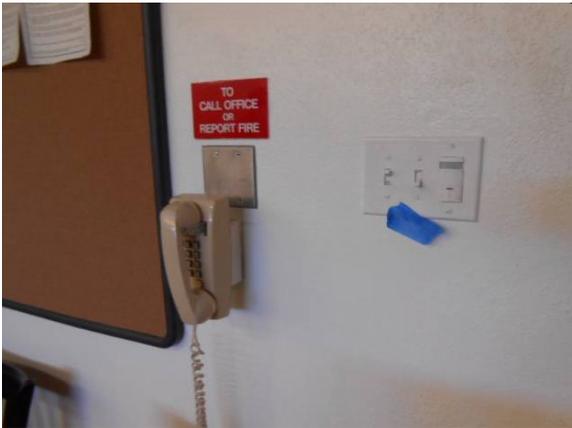
System: D5030920 - LAN System

Location: Kitchen & Snack Bar
Material: Lan System
Distress: Inadequate
Category: Capital Renewal
Priority: 4 - Recommended (Years 6-10)
Correction: Replace LAN System Drop CAT6
Qty: 2-Ea.
Estimate: \$784.70
Assessor Name: Eduardo Lopez
Date Created: 01/28/2013

Notes: Most of the existing LAN/VOIP outlets were updated except for Main Kitchen and Snack Bar Area. Recommend replacing and enhancing during the next major building remodel.

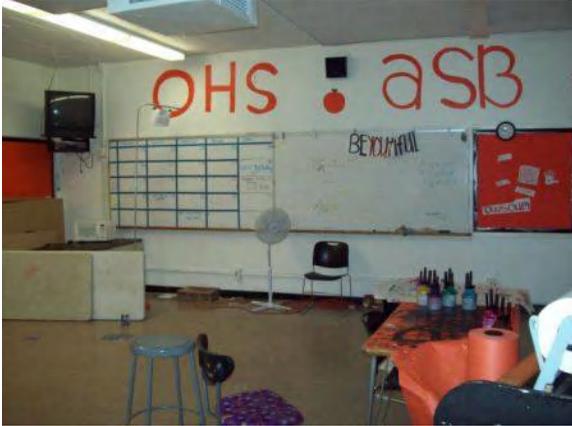
System: E1020 - Institutional Equipment

Location: Classrooms 601 and 602
Material: Other Institutional Equipment
Distress: Inadequate
Category: Capital Renewal
Priority: 4 - Recommended (Years 6-10)
Correction: Smartboards whiteboards tackboards
Qty: 2-Ea.
Estimate: \$22,320.26
Assessor Name: Ann Buerger Linden
Date Created: 01/31/2013

Notes: Provide new tackboards, whiteboards and one Smartboard per classroom.

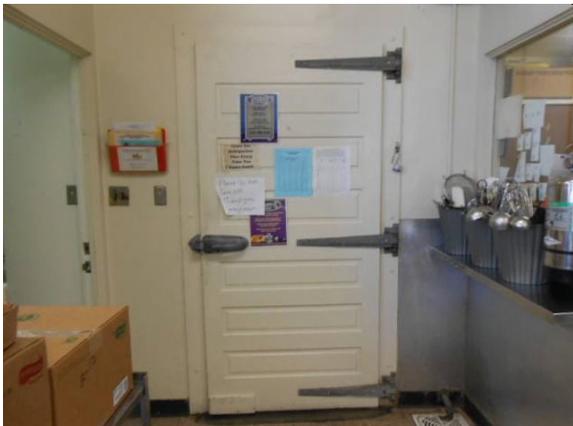
System: E1090360 - Walk-in Cooler/Freezer

Location: Kitchen
Material: System
Distress: Beyond Expected Life
Category: Capital Renewal
Priority: 4 - Recommended (Years 6-10)
Correction: Renew System
Qty: 1-Ea.
Estimate: \$63,889.06
Assessor Name: Eduardo Lopez
Date Created: 01/28/2013

Notes: (2) Walk-in Cooler/Freezer dated 1953 & 1996. It is recommended to replace the original 1953 Walk-in Cooler/Freezer during the next remodel or renovation.

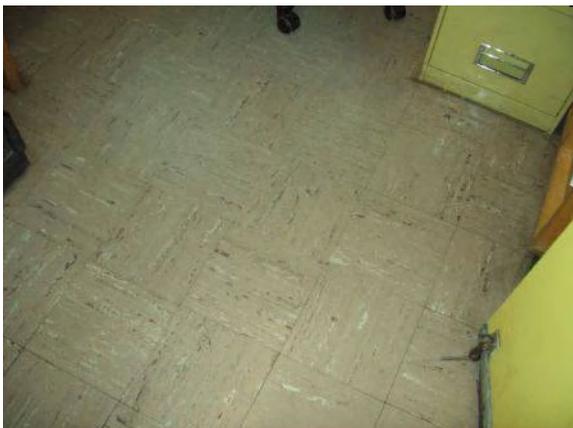
System: F2020 - Hazardous Components Abatement

Location: Friable material in drywall mud, pipe fitting insulation above the kitchen, at kitchen ovens, pipe fitting insulation at the multi-purpose room. Non-friable material in exterior stucco walls and soffits, window putty, interior plaster, 9 and 12 inch floor tile.
Material: Removal of Hazardous Components
Distress: Beyond Expected Life
Category: Capital Renewal
Priority: 3 - Necessary/Not Yet Critical (Years 2-5)
Correction: Abate all ACM in building
Qty: 8,695-S.F.
Estimate: \$76,627.30
Assessor Name: Ann Buerger Linden
Date Created: 01/30/2013

Notes: The AHERA six-month surveillance of asbestos-containing materials - Summer 2012, identifies ACM at this building. Complete abatement is recommended.

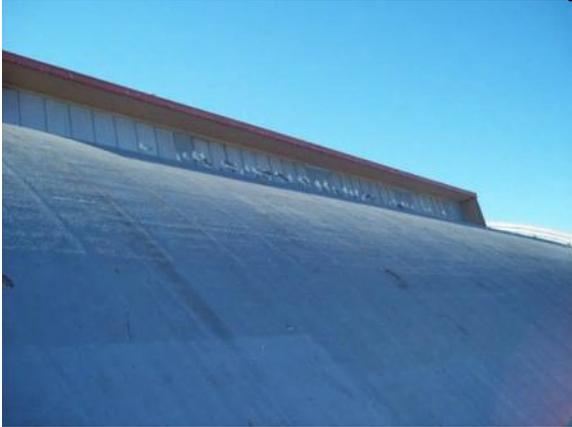
System: B2020 - Exterior Windows

Location: High windows at gym. Pivot windows at restrooms, locker rooms, and offices.

Notes: High windows have been painted shut. All windows are original and in poor conditions.

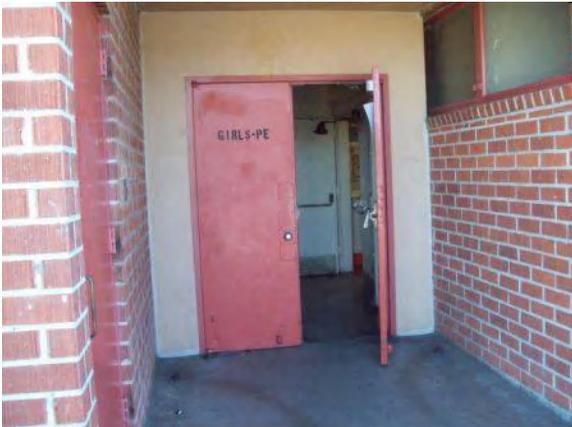
System: B2030 - Exterior Doors

Location: Exterior of building.

Notes: Exterior doors, frames, and hardware are typically in poor condition. Provide interior locking lever hardware at classroom exterior doors.

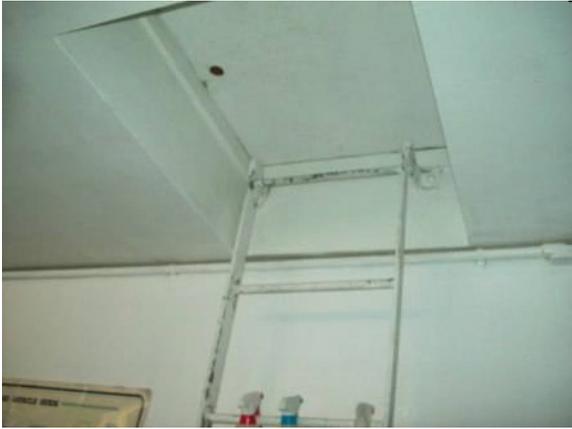
System: B3020 - Roof Openings

Location: Access to east wing from trainer room. No access from main gym building.

Notes: Existing hatch is heavy and nearly impossible to operate. No hatch/ladder assembly is provided at the main west wing. Note that it appears that skylights were once installed over locker areas and have been removed and roofed over. Six skylights over weight room.

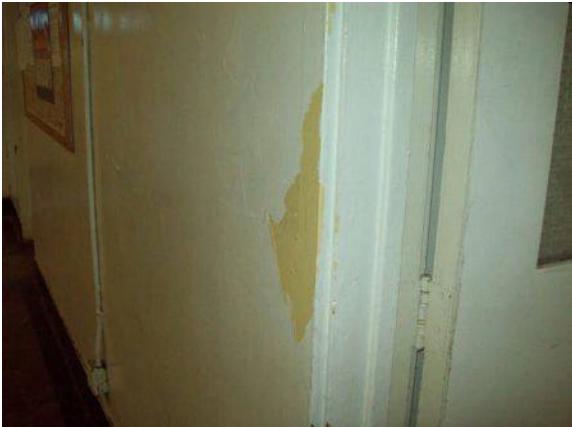
System: C1010 - Partitions

Location: Building wide

Distress: Inadequate

Correction: Allowance repair/remodel interior partitions OUSD

Notes: Provide an allowance to repair and remodel interior partitions as needed to accommodate renovations to adjacent systems and update configurations for ADA compliance and operational efficiency.

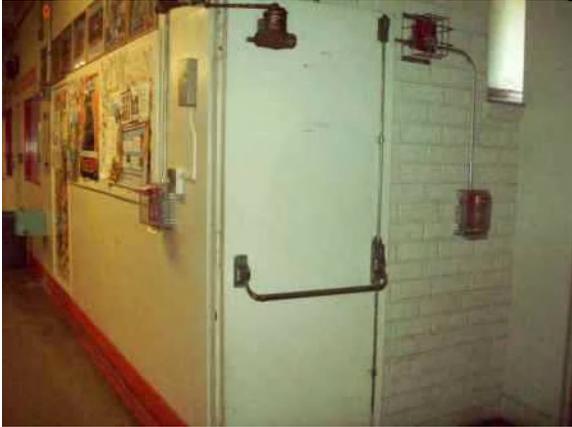
System: C1020 - Interior Doors

Location: Interior doors.
Material: System
Distress: Beyond Expected Life
Category: Capital Renewal
Priority: 3 - Necessary/Not Yet Critical (Years 2-5)
Correction: Renew System
Qty: 1-Ea.
Estimate: \$93,456.96
Assessor Name: Ann Buerger Linden
Date Created: 01/31/2013

Notes: Interior doors are typically in poor condition with obsolete hardware.

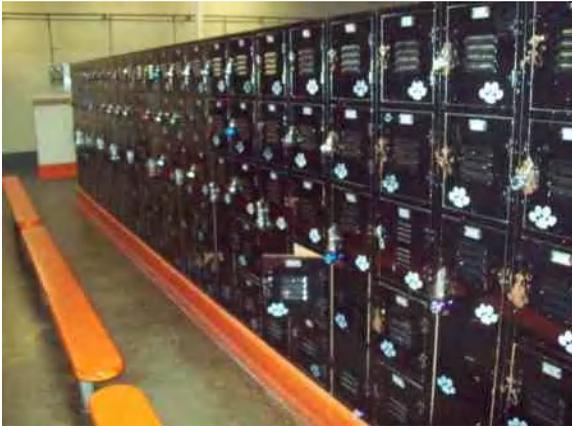
System: C1030 - Fittings

Location: Locker rooms.
Material: Fixed Furnishings - Lockers
Distress: Beyond Expected Life
Category: Capital Renewal
Priority: 3 - Necessary/Not Yet Critical (Years 2-5)
Correction: Student lockers stacked 2-high
Qty: 1,200-Ea.
Estimate: \$844,067.52
Assessor Name: Ann Buerger Linden
Date Created: 01/31/2013

Notes: Lockers are original and in poor condition. Also replace locker room benches.

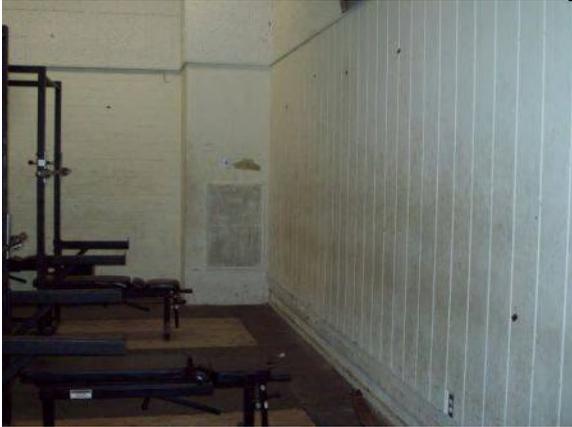
System: C3010 - Wall Finishes

Location: Interior walls building wide.
Material: System
Distress: Beyond Expected Life
Category: Capital Renewal
Priority: 3 - Necessary/Not Yet Critical (Years 2-5)
Correction: Renew System
Qty: 1-Ea.
Estimate: \$319,797.01
Assessor Name: Eduardo Lopez
Date Created: 01/21/2013

Notes: Wall finishes system includes painted masonry and plaster, and ceramic wall tile. Ceramic tile is original and in fair condition. Painted surfaces are in need of refreshing.

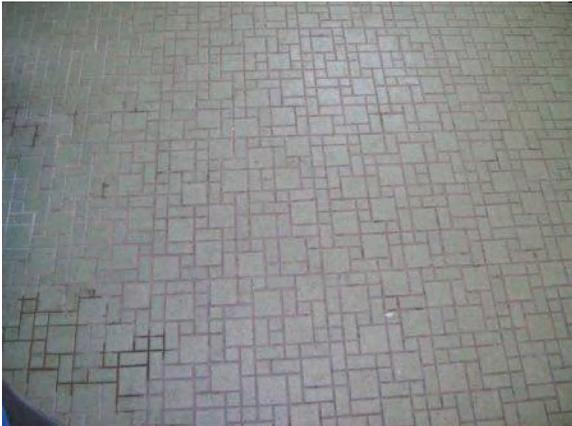
System: C3020210 - Ceramic Tile

Location: Restrooms and showers.
Material: System
Distress: Beyond Expected Life
Category: Capital Renewal
Priority: 3 - Necessary/Not Yet Critical (Years 2-5)
Correction: Renew System
Qty: 1-Ea.
Estimate: \$109,232.64
Assessor Name: Eduardo Lopez
Date Created: 01/21/2013

Notes: Ceramic floor tile is original and worn.

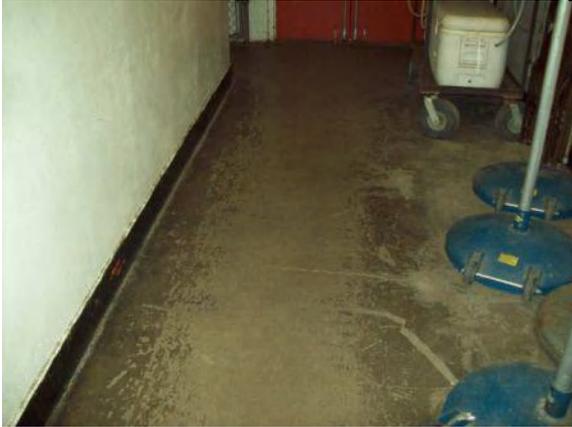
System: C3020210 - Epoxy

Location: Locker rooms.
Material: System
Distress: Beyond Expected Life
Category: Capital Renewal
Priority: 3 - Necessary/Not Yet Critical (Years 2-5)
Correction: Renew System
Qty: 1-Ea.
Estimate: \$91,039.61
Assessor Name: Eduardo Lopez
Date Created: 01/21/2013

Notes: Painted floor finishes are worn and in need of renewal.

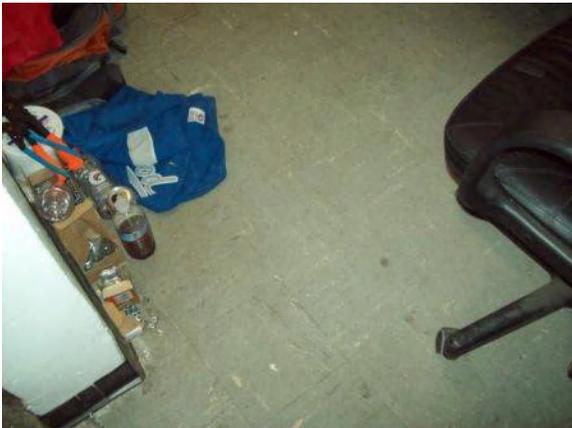
System: C3020410 - VCT

Location: Offices, training room
Material: System
Distress: Beyond Expected Life
Category: Capital Renewal
Priority: 3 - Necessary/Not Yet Critical (Years 2-5)
Correction: Renew System
Qty: 1-Ea.
Estimate: \$17,159.47
Assessor Name: Eduardo Lopez
Date Created: 01/21/2013

Notes: VAT/VCT is typically original and in poor condition.

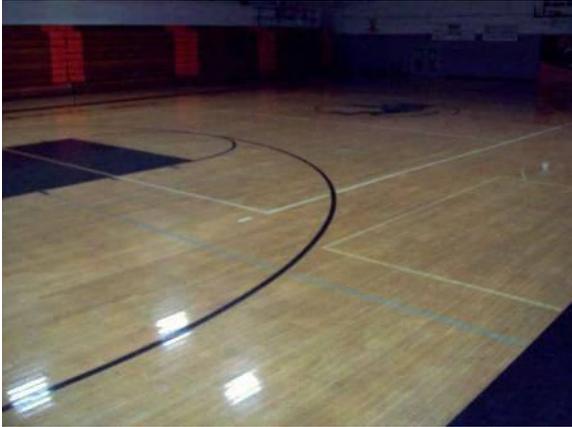
System: C3020410 - Wood

Location: Gymnasium
Material: System
Distress: Beyond Expected Life
Category: Capital Renewal
Priority: 3 - Necessary/Not Yet Critical (Years 2-5)
Correction: Renew System
Qty: 1-Ea.
Estimate: \$262,744.31
Assessor Name: Eduardo Lopez
Date Created: 01/21/2013

Notes: Although well maintained, the wood gym floor is beyond its expected life. Coaches report "dead" spots in the floor. Wood floor replacement is recommended.

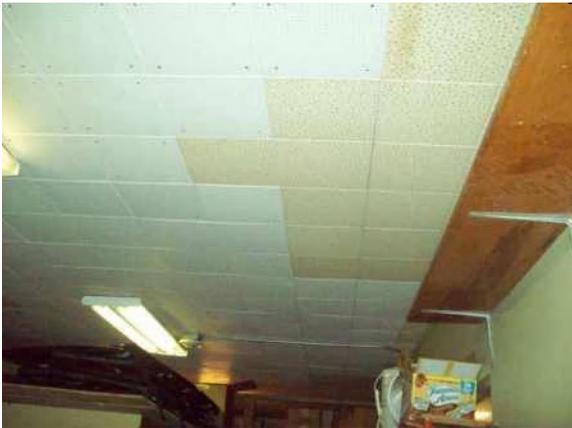
System: C3030 - Ceiling Finishes

Location: Building wide
Material: System
Distress: Beyond Expected Life
Category: Capital Renewal
Priority: 3 - Necessary/Not Yet Critical (Years 2-5)
Correction: Renew System
Qty: 1-Ea.
Estimate: \$248,331.76
Assessor Name: Ann Buerger Linden
Date Created: 01/31/2013

Notes: Ceiling finishes include painted wood structure, 12" glue on tile, and painted plaster. In general, ceiling finishes are in need of replacement.

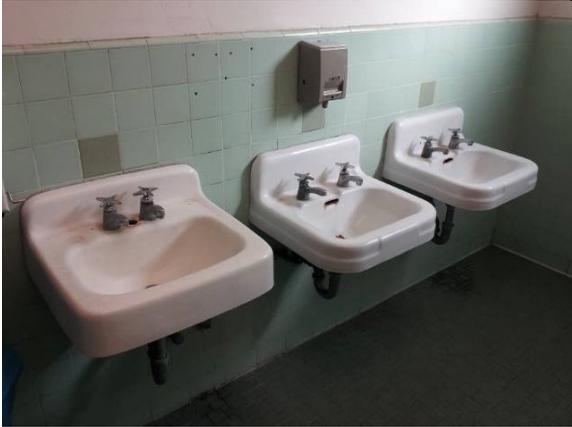
System: D2010 - Plumbing Fixtures

Location: Typical for entire building
Material: System
Distress: Beyond Expected Life
Category: Capital Renewal
Priority: 4 - Recommended (Years 6-10)
Correction: Renew System
Qty: 1-Ea.
Estimate: \$455,541.06
Assessor Name: Eduardo Lopez
Date Created: 01/28/2013

Notes: Showers were replaced; however plumbing fixtures are beyond expected life. Replace during next remodel or renovation.

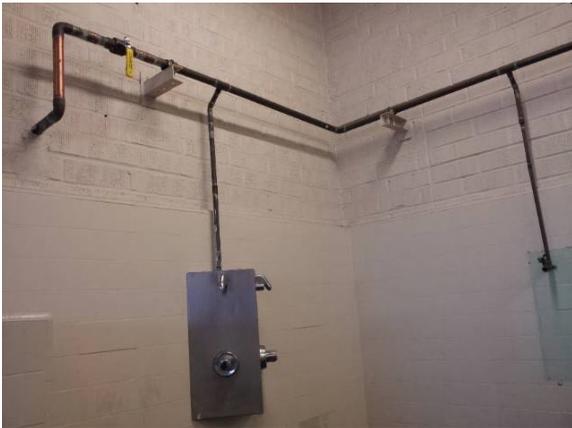
System: D2020 - Domestic Water Distribution

Location: Typical for entire building
Material: System
Distress: Beyond Expected Life
Category: Capital Renewal
Priority: 4 - Recommended (Years 6-10)
Correction: Renew System
Qty: 1-Ea.
Estimate: \$45,913.43
Assessor Name: Eduardo Lopez
Date Created: 01/28/2013

Notes: Domestic hot water and some water distribution lines were replaced; however it is recommended to replace the domestic water distribution system during next remodel or renovation.

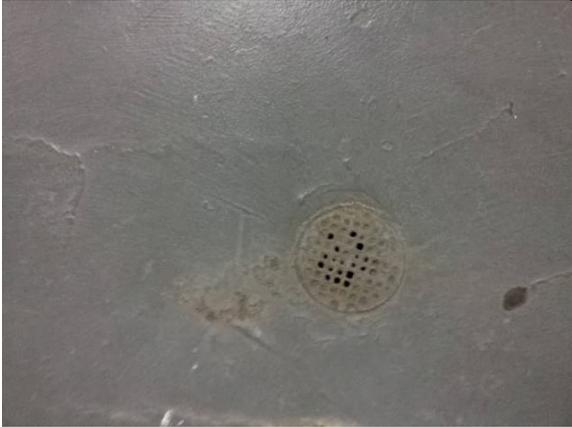
System: D2030 - Sanitary Waste

Location: Typical for entire building
Material: System
Distress: Beyond Expected Life
Category: Capital Renewal
Priority: 4 - Recommended (Years 6-10)
Correction: Renew System
Qty: 1-Ea.
Estimate: \$156,504.90
Assessor Name: Eduardo Lopez
Date Created: 01/28/2013

Notes: Replace all above grade sanitary waste and vent piping during next remodel or renovation; below grade as needed.

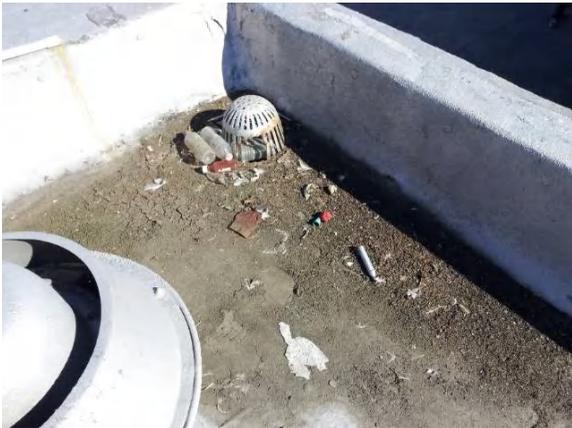
System: D2040 - Rain Water Drainage

Location: Typical for entire building
Material: System
Distress: Beyond Expected Life
Category: Capital Renewal
Priority: 4 - Recommended (Years 6-10)
Correction: Renew System
Qty: 1-Ea.
Estimate: \$25,152.57
Assessor Name: Eduardo Lopez
Date Created: 01/28/2013

Notes: Replace system during next remodel or renovation.

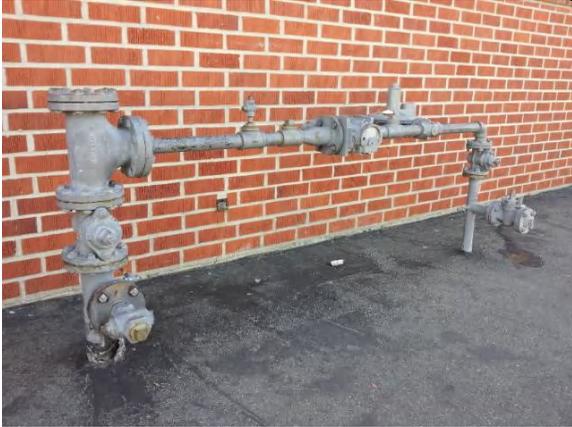
System: D2090 - Other Plumbing Systems-Nat Gas

Location: Typical for entire building
Material: System
Distress: Beyond Expected Life
Category: Capital Renewal
Priority: 4 - Recommended (Years 6-10)
Correction: Renew System
Qty: 1-Ea.
Estimate: \$42,320.20
Assessor Name: Eduardo Lopez
Date Created: 01/28/2013

Notes: The Natural Gas distribution is original to the building age. It is recommended to be replaced during the next major renovation.

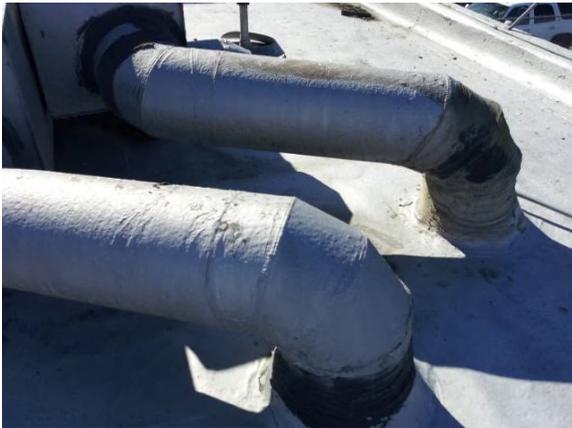
System: D3040 - Distribution Systems

Location: Typical for entire building
Material: System
Distress: Beyond Expected Life
Category: Capital Renewal
Priority: 4 - Recommended (Years 6-10)
Correction: Renew System
Qty: 1-Ea.
Estimate: \$621,228.64
Assessor Name: Eduardo Lopez
Date Created: 01/28/2013

Notes: Ductwork, ventillation diffusers/grilles and fresh air supply is recommended to be upgraded during the next major renovation.

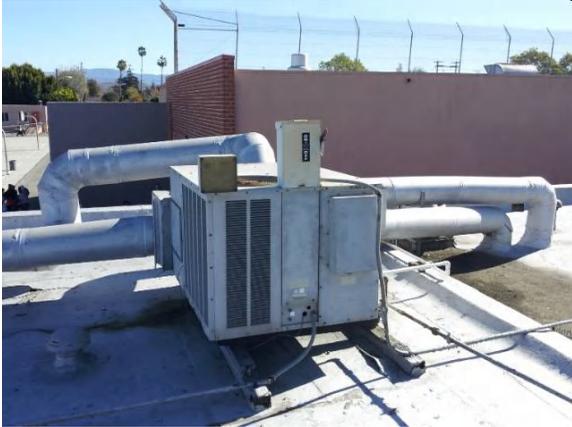
System: D3050 - Terminal & Package Units

Location: Typical for entire building
Material: System
Distress: Beyond Expected Life
Category: Capital Renewal
Priority: 4 - Recommended (Years 6-10)
Correction: Renew System
Qty: 1-Ea.
Estimate: \$689,100.67
Assessor Name: Eduardo Lopez
Date Created: 01/28/2013

Notes: Terminal & Package Units are beyond expected life and it is recommended to replace during next major renovation.

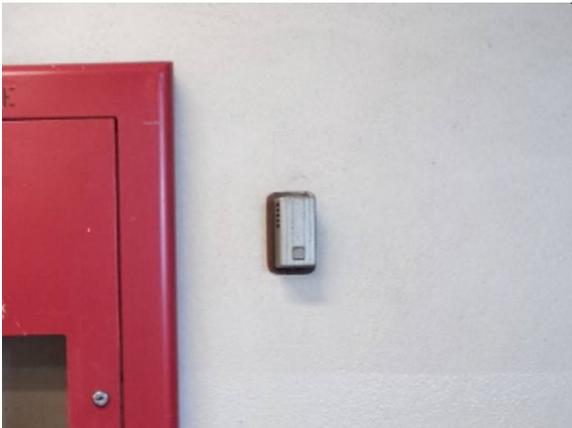
System: D3060 - Controls & Instrumentation

Location: Typical for entire building
Material: System
Distress: Beyond Expected Life
Category: Capital Renewal
Priority: 4 - Recommended (Years 6-10)
Correction: Renew System
Qty: 1-Ea.
Estimate: \$153,710.17
Assessor Name: Eduardo Lopez
Date Created: 01/28/2013

Notes: Control & Instrumentation is beyond expected life and it is recommended to replace during next major renovation.

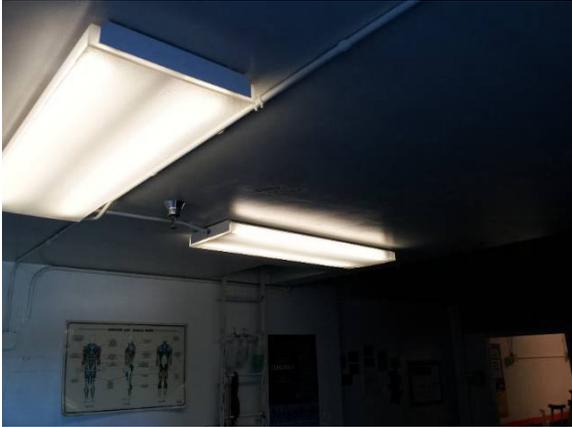
System: D4010 - Sprinklers

Location: Typical for entire building
Material: System
Distress: Beyond Expected Life
Category: Capital Renewal
Priority: 5 - Codes or Standards Compliance
Correction: Renew System
Qty: 1-Ea.
Estimate: \$211,601.02
Assessor Name: Eduardo Lopez
Date Created: 01/28/2013

Notes: Building is partially sprinklered, wet type fire sprinklers is currently located in the Trainer room and it's recommended to be added throughout building wide during next major renovation.

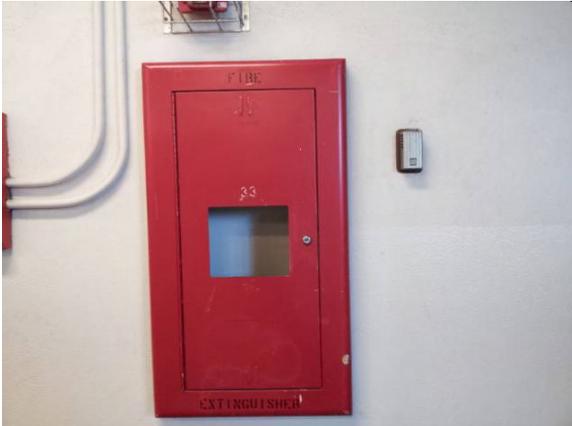
System: D4030 - Fire Protection Specialties

Location: Typical for entire building
Material: System
Distress: Missing
Category: Code Compliance
Priority: 1 - Currently Critical (Immediate)
Correction: Renew System
Qty: 1-Ea.
Estimate: \$6,387.96
Assessor Name: Eduardo Lopez
Date Created: 01/28/2013

Notes: Fire Extinguishers are missing in different locations and should be provided.

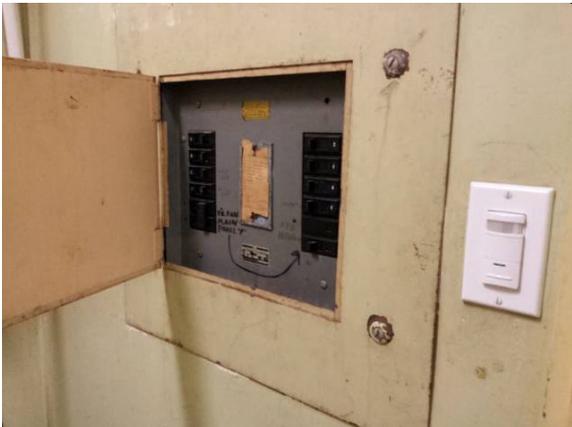
System: D5010 - Electrical Service/Distribution

Location: Typical for entire building
Material: System
Distress: Beyond Expected Life
Category: Capital Renewal
Priority: 4 - Recommended (Years 6-10)
Correction: Renew System
Qty: 1-Ea.
Estimate: \$232,761.12
Assessor Name: Eduardo Lopez
Date Created: 01/28/2013

Notes: The main electrical panels, distribution panel boards and feeders are mostly original to the building age. It is recommended to be replaced during the next major renovation.

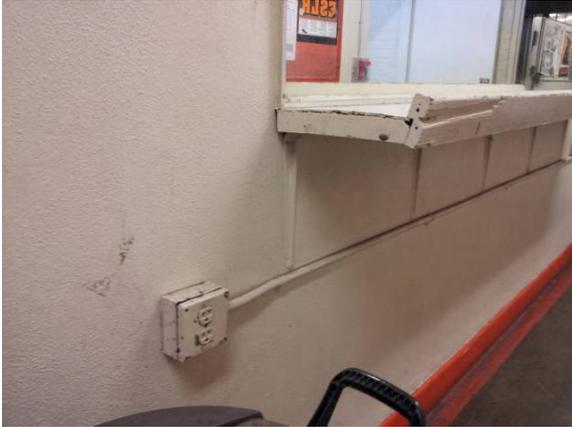
System: D5020 - Branch Wiring

Location: Typical for entire building
Material: System
Distress: Beyond Expected Life
Category: Capital Renewal
Priority: 4 - Recommended (Years 6-10)
Correction: Renew System
Qty: 1-Ea.
Estimate: \$803,285.37
Assessor Name: Eduardo Lopez
Date Created: 01/28/2013

Notes: The branch wiring, electrical panels and devices are mostly original to the building age. It is recommended to be replaced during the next major renovation.

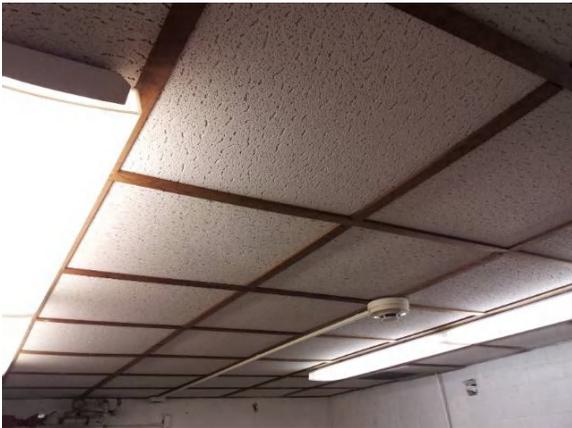
System: D5020 - Lighting

Location: Typical for entire building
Material: System
Distress: Beyond Expected Life
Category: Capital Renewal
Priority: 4 - Recommended (Years 6-10)
Correction: Renew System
Qty: 1-Ea.
Estimate: \$631,609.07
Assessor Name: Eduardo Lopez
Date Created: 01/28/2013

Notes: T8 fluorescent lamps and ballasts were updated; however light fixtures, switches and wiring are original to building age and it is recommended to be replaced during next remodel or renovation.

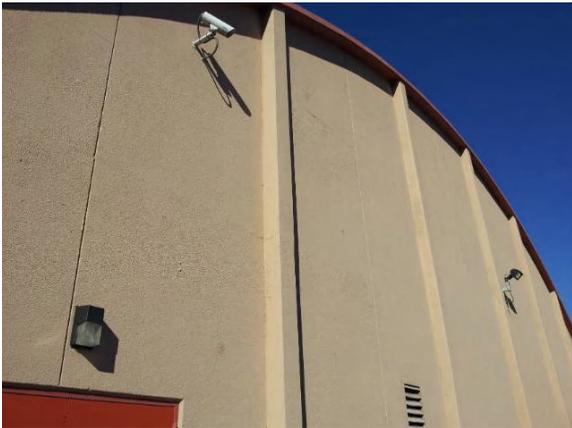
System: D5030910 - Security System, Camers, Access Control

Location: Typical for entire building
Material: System
Distress: Beyond Expected Life
Category: Capital Renewal
Priority: 4 - Recommended (Years 6-10)
Correction: Renew System
Qty: 1-Ea.
Estimate: \$36,658.15
Assessor Name: Eduardo Lopez
Date Created: 01/28/2013

Notes: Security is mostly in the exterior and is needing upgrades to include interior. Recommend replacing and enhancing during the next building renovation.

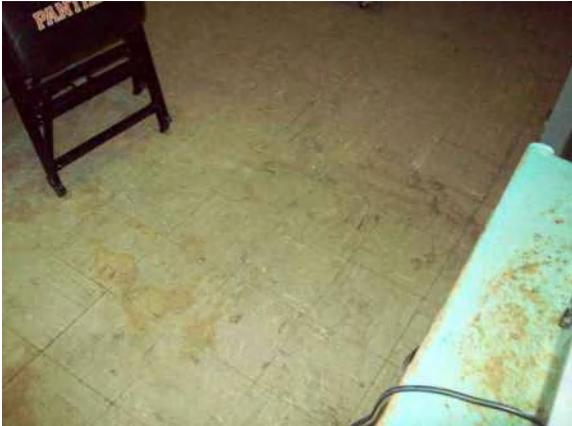
System: F2020 - Hazardous Components Abatement

Location: Friable material exists in pipe insulation and floor coverings. Non-friable material is identified in floor tiles, exterior stucco, and window putty.
Material: Removal of Hazardous Components
Distress: Beyond Expected Life
Category: Capital Renewal
Priority: 3 - Necessary/Not Yet Critical (Years 2-5)
Correction: Abate all ACM in building
Qty: 25,205-S.F.
Estimate: \$222,126.62
Assessor Name: Ann Buerger Linden
Date Created: 01/31/2013

Notes: The AHERA six-month surveillance of asbestos-containing materials - Summer 2012, identifies ACM at this building. Complete abatement is recommended.

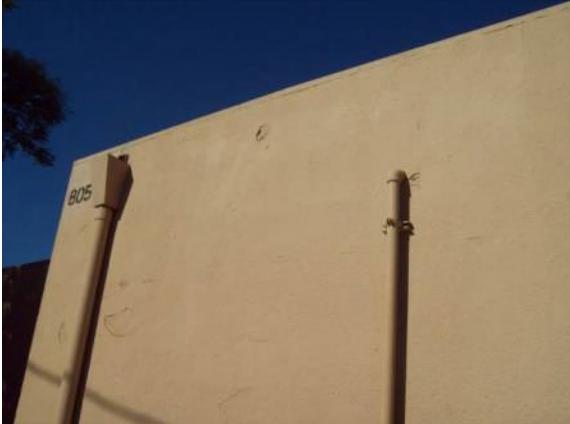
Location: Exterior walls. Plaster soffit in breezeway
Material: Exterior Walls
Distress: Damaged
Category: Capital Renewal
Priority: 3 - Necessary/Not Yet Critical (Years 2-5)
Correction: Repair Damaged Exterior Wall
Qty: 5,000-S.F.
Estimate: \$116,856.00
Assessor Name: Ann Buerger Linden
Date Created: 01/31/2013

Notes: Exterior walls are in fair to poor condition with cracking and peeling paint and stucco. The breezeway plaster soffit has a fair amount of cracking.

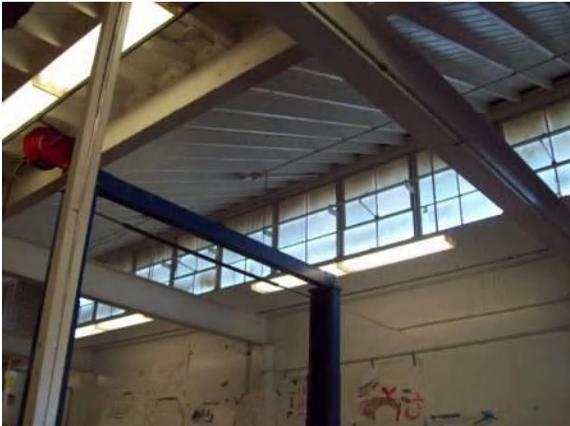
Location: Exterior walls and clerestory windows at roof of shops areas.
Material: System
Distress: Beyond Expected Life
Category: Capital Renewal
Priority: 3 - Necessary/Not Yet Critical (Years 2-5)
Correction: Renew System
Qty: 1-Ea.
Estimate: \$191,489.76
Assessor Name: Eduardo Lopez
Date Created: 01/21/2013

Notes: Existing windows include clerestory windows at shops with handcrank chain operators, fixed and operable windows elsewhere. Windows are original and in poor conditions. System renewal is recommended.

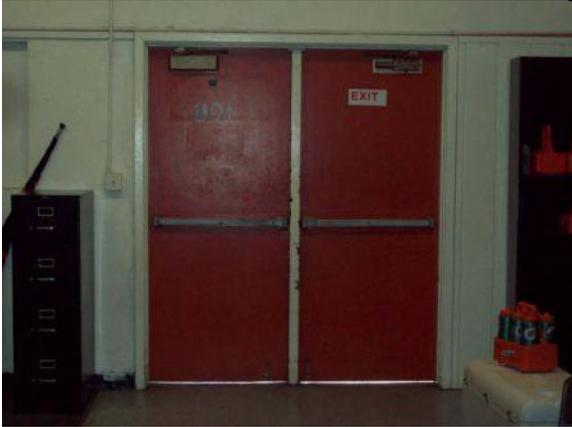
Location: Building exterior. Doors opening onto the center breezeway are considered exterior doors.

Notes: Exterior doors are in generally fair to poor condition. Exterior doors include three overhead doors at shops. Provide inside locking lever latches at exterior classroom doors.

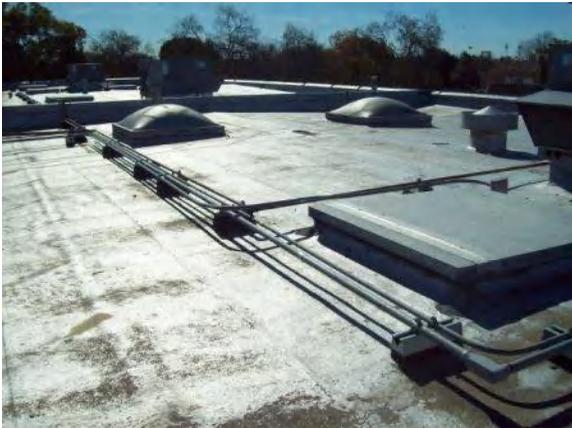
Location: Roofs

Notes: Roofing systems are expired. There is evidence of leaking inside the buildings.

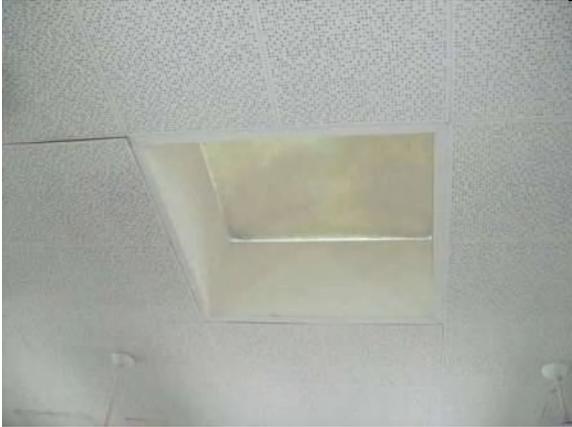
Location: Roofs
Material: System
Distress: Beyond Expected Life
Category: Capital Renewal
Priority: 3 - Necessary/Not Yet Critical (Years 2-5)
Correction: Renew System
Qty: 1-Ea.
Estimate: \$55,495.00
Assessor Name: Eduardo Lopez
Date Created: 01/21/2013

Notes: Numerous skylights are installed in the 800 buildings. Leaking is evident at several of them. Install code compliant roof hatch/access ladder assemblies (3 ea.) to more safely facilitate roof and rooftop equipment maintenance.

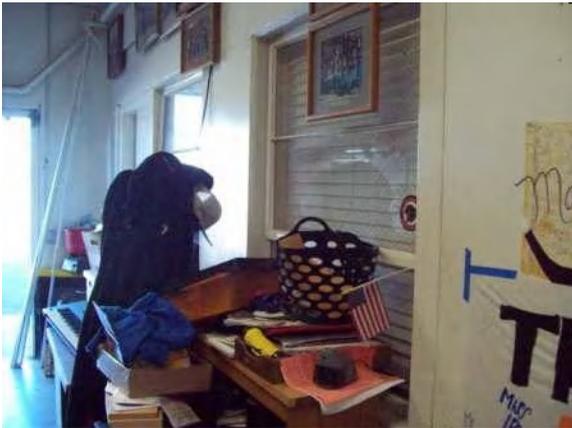
Location: Building interiors
Material: Interior Partitions
Distress: Beyond Expected Life
Category: Capital Renewal
Priority: 3 - Necessary/Not Yet Critical (Years 2-5)
Correction: Allowance repair/remodel interior partitions
OUSD
Qty: 1-Job
Estimate: \$44,064.00
Assessor Name: Ann Buerger Linden
Date Created: 01/31/2013

Notes: Provide an allowance to repair and remodel interior partitions as needed to accommodate renovations to adjacent systems and update configurations for ADA compliance and operational efficiency.

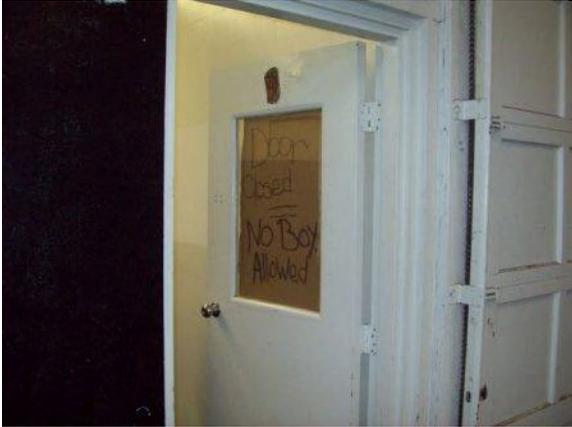
Location: Building wide.
Material: System
Distress: Beyond Expected Life
Category: Capital Renewal
Priority: 3 - Necessary/Not Yet Critical (Years 2-5)
Correction: Renew System
Qty: 1-Ea.
Estimate: \$136,715.04
Assessor Name: Eduardo Lopez
Date Created: 01/21/2013

Notes: Interior doors are in generally poor condition. As classroom programs have changed, some door styles are not suitable for their present application. System renewal is recommended.

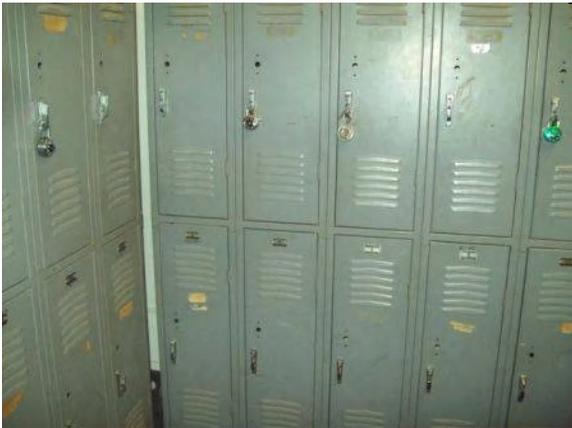
Location: Weight locker room, ROTC storage room 31.
Material: Fixed Furnishings - Lockers
Distress: Beyond Expected Life
Category: Capital Renewal
Priority: 3 - Necessary/Not Yet Critical (Years 2-5)
Correction: Student lockers stacked 2-high
Qty: 80-Ea.
Estimate: \$55,520.64
Assessor Name: Ann Buerger Linden
Date Created: 01/31/2013

Notes: Lockers are typically in very poor conditions with rust, missing or malfunctioning hardware, etc.

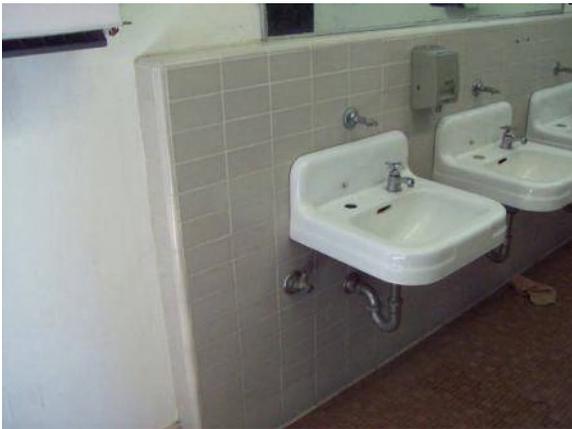
Location: Building wide interiors.
Material: System
Distress: Beyond Expected Life
Category: Capital Renewal
Priority: 3 - Necessary/Not Yet Critical (Years 2-5)
Correction: Renew System
Qty: 1-Ea.
Estimate: \$293,000.37
Assessor Name: Eduardo Lopez
Date Created: 01/21/2013

Notes: Wall finishes include paint, ceramic tile, and some panelling. Expected renovations throughout the building, including ACM removal, millwork and marker/tack board replacement, etc, will necessitate interior wall finish system renewal.

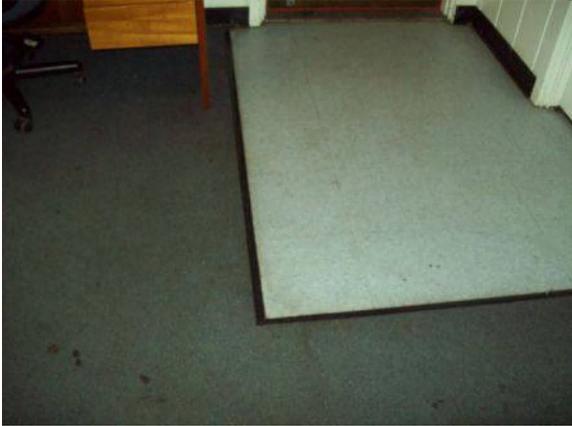
Location: Classrooms 801 and 807
Material: System
Distress: Beyond Expected Life
Category: Capital Renewal
Priority: 3 - Necessary/Not Yet Critical (Years 2-5)
Correction: Renew System
Qty: 1-Ea.
Estimate: \$46,902.24
Assessor Name: Eduardo Lopez
Date Created: 01/21/2013

Notes: Carpet is in poor condition.

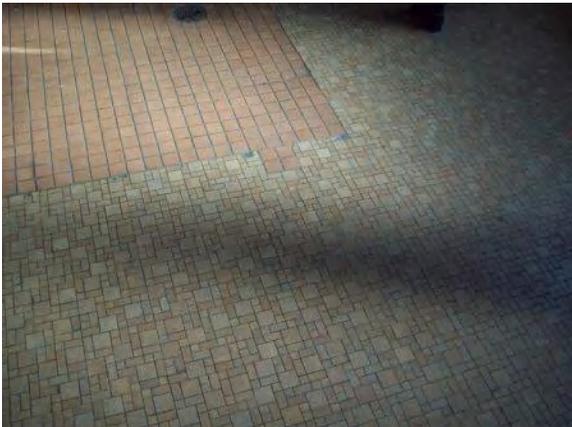
Location: Restrooms
Material: System
Distress: Beyond Expected Life
Category: Capital Renewal
Priority: 3 - Necessary/Not Yet Critical (Years 2-5)
Correction: Renew System
Qty: 1-Ea.
Estimate: \$22,686.05
Assessor Name: Ann Buerger Linden
Date Created: 01/31/2013

Notes: Ceramic tile floors are typically original. Replacement is recommended.

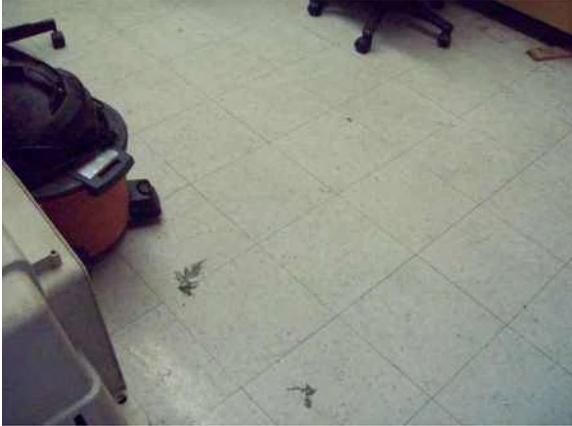
Location: Ag classroom No 7 and adjacent work room.
Material: Vinyl
Distress: Beyond Expected Life
Category: Capital Renewal
Priority: 1 - Currently Critical (Immediate)
Correction: Replace VCT Flooring and Resilient Base
Qty: 1,232-S.F.
Estimate: \$4,824.69
Assessor Name: Ann Buerger Linden
Date Created: 01/31/2013

Notes: The existing 12" floor tile is reportedly ACM. System replacement is recommended.

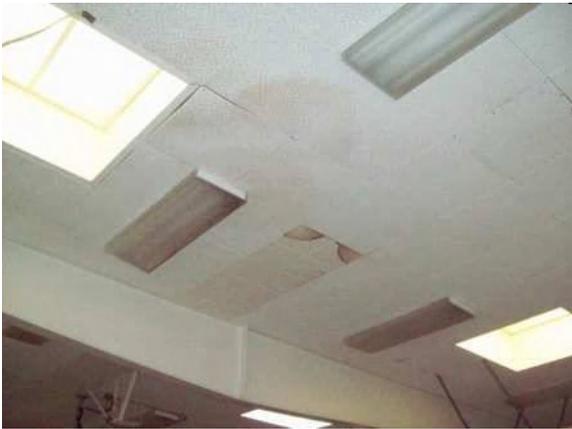
Location: Building wide.
Material: System
Distress: Beyond Expected Life
Category: Capital Renewal
Priority: 3 - Necessary/Not Yet Critical (Years 2-5)
Correction: Renew System
Qty: 1-Ea.
Estimate: \$520,595.92
Assessor Name: Eduardo Lopez
Date Created: 01/21/2013

Notes: Ceiling finishes include 12" glued on tile, painted wood structure, painted plaster, and suspended ceiling in the choral classroom. Ceilings are in generally poor condition. The suspended ceiling is new, however it is stained from roof leaks.

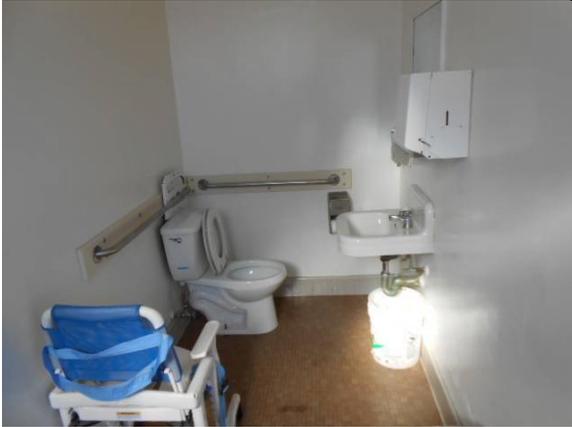
Location: Women & Staff restrooms at South end
Material: Tankless Water Closet
Distress: Beyond Expected Life
Category: Capital Renewal
Priority: 4 - Recommended (Years 6-10)
Correction: Replace tankless water closet
Qty: 5-Ea.
Estimate: \$6,177.31
Assessor Name: Eduardo Lopez
Date Created: 01/22/2013

Notes: Plumbing Fixtures were replaced in 2004 but these two restrooms. Replace during next remodel or renovation.

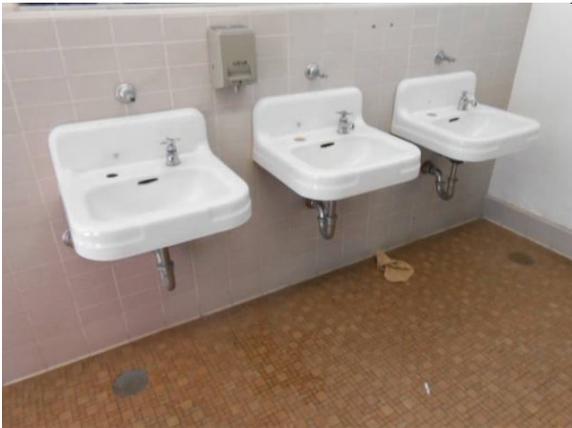
Location: Women & Staff restrooms at South end
Material: Lavatory, Vitreous China
Distress: Beyond Expected Life
Category: Capital Renewal
Priority: 4 - Recommended (Years 6-10)
Correction: Replace lavatory, vitreous china
Qty: 4-Ea.
Estimate: \$4,299.96
Assessor Name: Eduardo Lopez
Date Created: 01/22/2013

Notes: Plumbing Fixtures were replaced in 2004 but these two restrooms. Replace during next remodel or renovation.

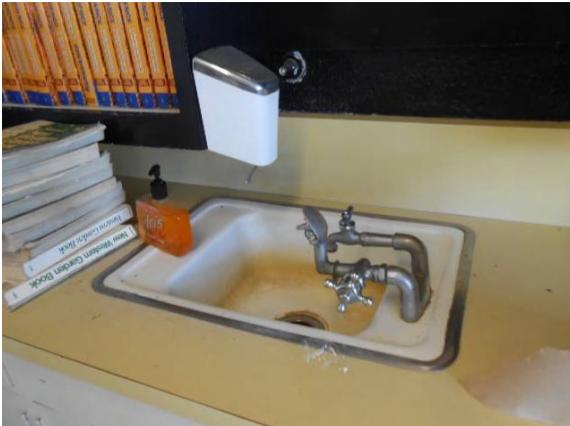
Location: Work Room from Classroom 808
Material: Sink, Stainless Steel
Distress: Beyond Expected Life
Category: Capital Renewal
Priority: 4 - Recommended (Years 6-10)
Correction: Replace sink, stainless steel
Qty: 2-Ea.
Estimate: \$2,819.26
Assessor Name: Eduardo Lopez
Date Created: 01/24/2013

Notes: Sinks are mostly original and beyond expected life and it is recommended to be replaced during next remodel or renovation.

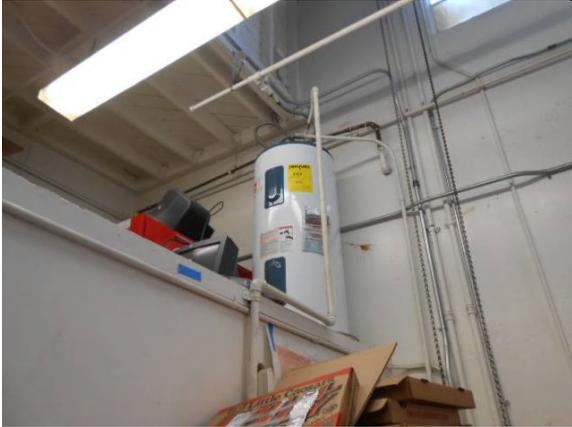
Location: Typical for entire building
Material: System
Distress: Beyond Expected Life
Category: Capital Renewal
Priority: 4 - Recommended (Years 6-10)
Correction: Renew System
Qty: 1-Ea.
Estimate: \$42,281.90
Assessor Name: Eduardo Lopez
Date Created: 01/28/2013

Notes: Domestic hot water was recently replaced; however it is recommended to replace the domestic water distribution system during next remodel or renovation.

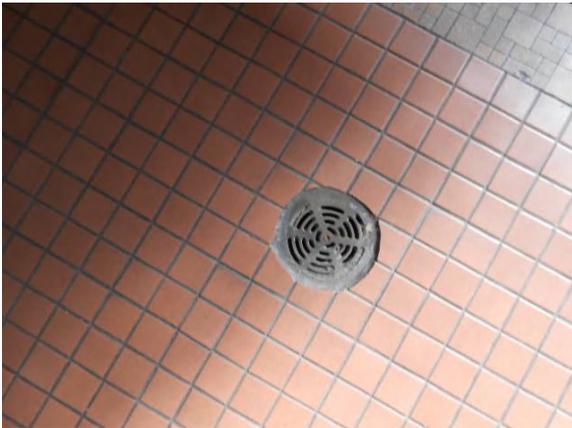
Location: Typical for entire building
Material: System
Distress: Beyond Expected Life
Category: Capital Renewal
Priority: 4 - Recommended (Years 6-10)
Correction: Renew System
Qty: 1-Ea.
Estimate: \$143,031.75
Assessor Name: Eduardo Lopez
Date Created: 01/28/2013

Notes: Replace all above grade sanitary waste and vent piping during next remodel or renovation; below grade as needed.

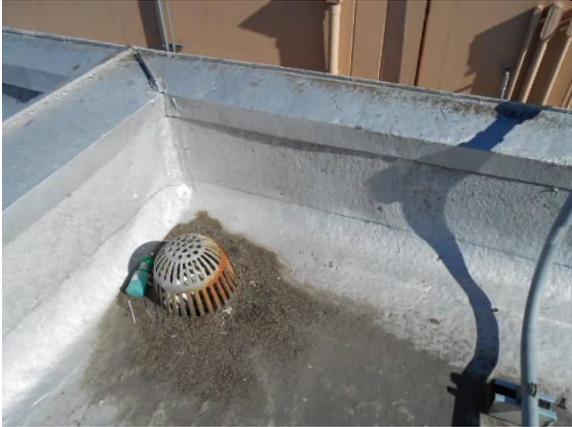
Location: Typical for entire building
Material: System
Distress: Beyond Expected Life
Category: Capital Renewal
Priority: 4 - Recommended (Years 6-10)
Correction: Renew System
Qty: 1-Ea.
Estimate: \$23,122.92
Assessor Name: Eduardo Lopez
Date Created: 01/28/2013

Notes: Replace system during next remodel or renovation.

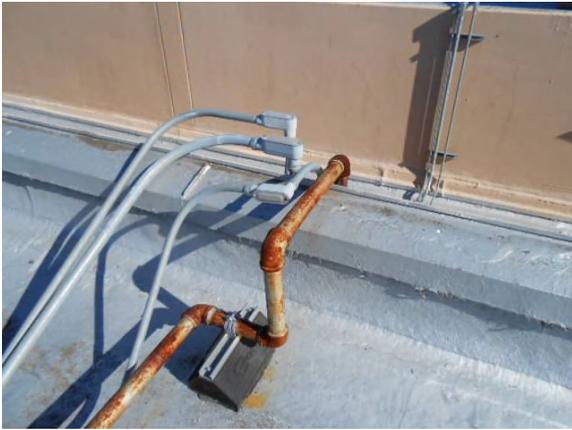
Location: Typical for entire building
Material: System
Distress: Beyond Expected Life
Category: Capital Renewal
Priority: 4 - Recommended (Years 6-10)
Correction: Renew System
Qty: 1-Ea.
Estimate: \$38,978.63
Assessor Name: Eduardo Lopez
Date Created: 01/28/2013

Notes: The Natural Gas distribution is original to the building age. It is recommended to be replaced during the next major renovation.

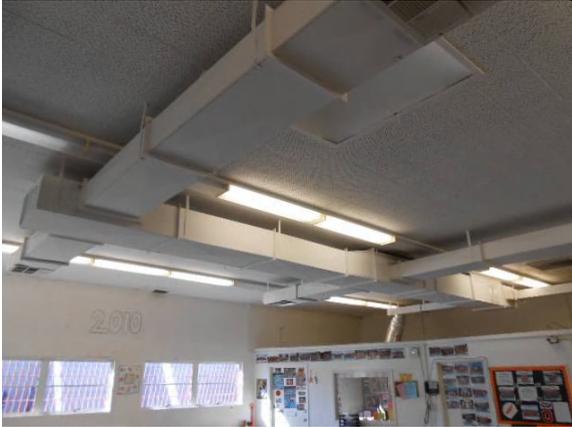
Location: All Classrooms except 804, 805 & 807
Material: System
Distress: Beyond Expected Life
Category: Capital Renewal
Priority: 4 - Recommended (Years 6-10)
Correction: Renew System
Qty: 1-Ea.
Estimate: \$568,823.71
Assessor Name: Eduardo Lopez
Date Created: 01/28/2013

Notes: HVAC system was replaced in 2008 including ductwork for two classrooms 804, 805 & 807; however the ductwork, ventilation diffusers/grilles and fresh air supply is recommended to be upgraded throughout the building during next remodel or renovation.

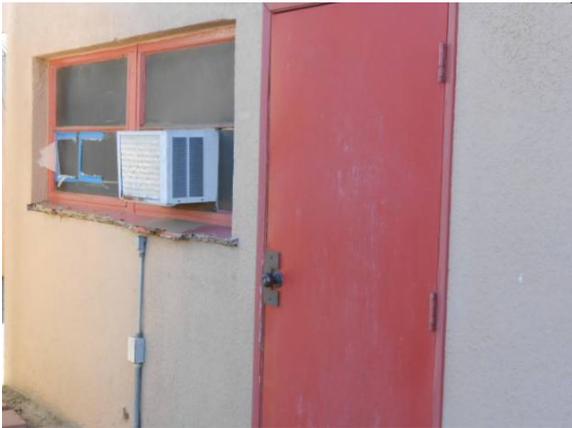
Location: Work Room from Classroom 808
Material: Air Conditioner, Window 1 Ton
Distress: Damaged
Category: Deferred Maintenance
Priority: 2 - Potentially Critical (Year 1)
Correction: Replace air conditioner, window, 1 ton
Qty: 1-Ea.
Estimate: \$1,494.50
Assessor Name: Eduardo Lopez
Date Created: 01/28/2013

Notes: Recommend replacing existing window A/C unit with additional or auxiliary A/C. Include cost for an evaluation by a PE for HVAC system in the next renovation project.

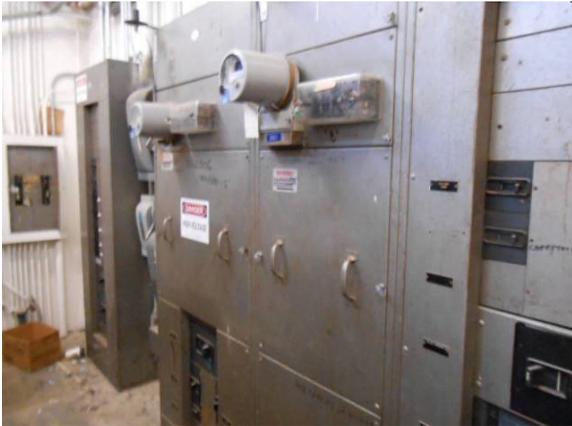
Location: Typical for entire building
Material: System
Distress: Beyond Expected Life
Category: Capital Renewal
Priority: 4 - Recommended (Years 6-10)
Correction: Renew System
Qty: 1-Ea.
Estimate: \$213,391.47
Assessor Name: Eduardo Lopez
Date Created: 01/28/2013

Notes: The main electrical panels, distribution panel boards and feeders are mostly original to the building age. It is recommended to be replaced during the next major renovation.

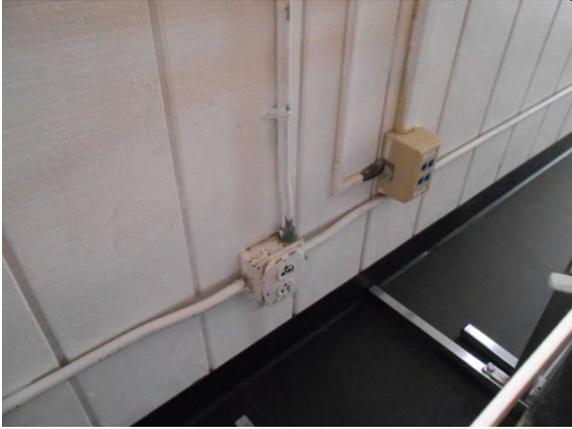
Location: Typical for entire building
Material: System
Distress: Beyond Expected Life
Category: Capital Renewal
Priority: 4 - Recommended (Years 6-10)
Correction: Renew System
Qty: 1-Ea.
Estimate: \$735,969.36
Assessor Name: Eduardo Lopez
Date Created: 01/28/2013

Notes: The branch wiring, electrical panels and devices are mostly original to the building age. It is recommended to be replaced during the next major renovation.

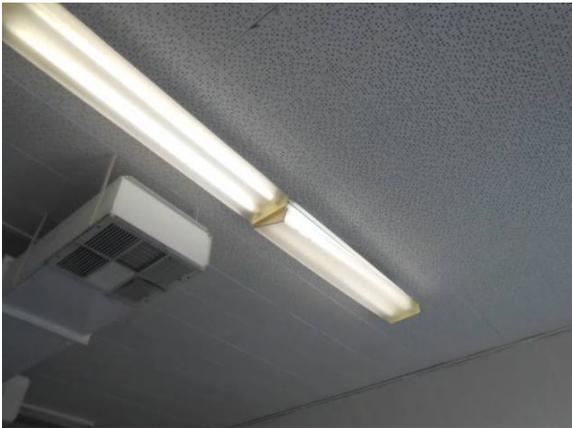
Location: Typical for entire building
Material: System
Distress: Beyond Expected Life
Category: Capital Renewal
Priority: 4 - Recommended (Years 6-10)
Correction: Renew System
Qty: 1-Ea.
Estimate: \$578,733.53
Assessor Name: Eduardo Lopez
Date Created: 01/28/2013

Notes: T8 fluorescent lamps and ballasts were updated; however light fixtures, switches and wiring are original to building age and it is recommended to be replaced during next remodel or renovation.

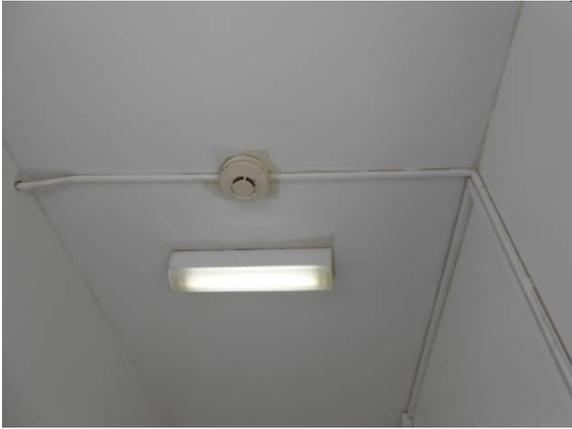
Location: Typical for entire building
Material: Smoke Detector
Distress: Inadequate
Category: Capital Renewal
Priority: 5 - Codes or Standards Compliance
Correction: Install Smoke Detectors
Qty: 25-Ea.
Estimate: \$61,507.45
Assessor Name: Eduardo Lopez
Date Created: 01/28/2013

Notes: Fire Alarm System is missing smoke detectors, they are located in Classroom 803, Storage, Men & Women Toilets and Offices only and it is recommended to be provided throughout the building during next major remodel or renovation.

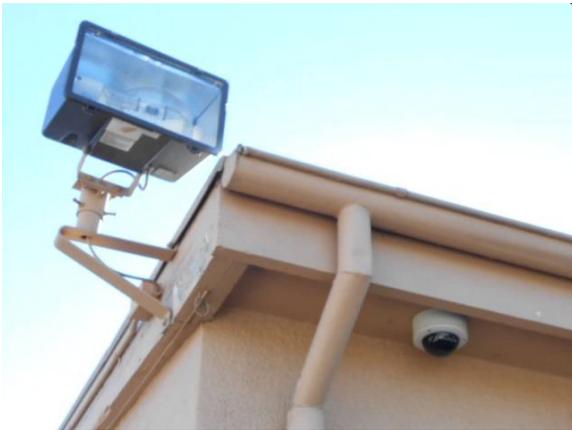
Location: Typical for entire building
Material: System
Distress: Beyond Expected Life
Category: Capital Renewal
Priority: 4 - Recommended (Years 6-10)
Correction: Renew System
Qty: 1-Ea.
Estimate: \$33,633.33
Assessor Name: Eduardo Lopez
Date Created: 01/28/2013

Notes: Security is mostly in the exterior and is needing upgrades to include interior. Recommend replacing and enhancing during the next building renovation.

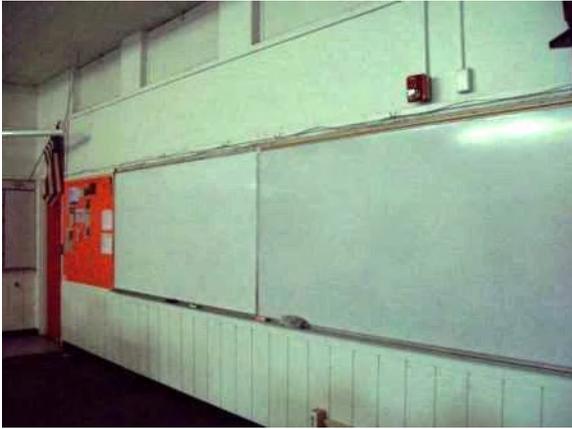
System: E1020 - Institutional Equipment

Location: Classrooms 801, 802, 808
Material: Other Institutional Equipment
Distress: Beyond Expected Life
Category: Capital Renewal
Priority: 3 - Necessary/Not Yet Critical (Years 2-5)
Correction: Smartboards whiteboards tackboards
Qty: 3-Ea.
Estimate: \$33,480.39
Assessor Name: Ann Buerger Linden
Date Created: 01/31/2013

Notes: Provide Smartboard technology and clean whiteboards and tackboards at these classrooms. (Classrooms 806A, 806B and 807 are modernized.)

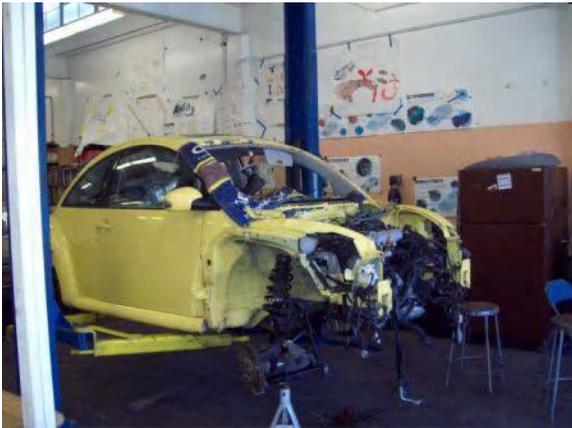
System: E1090 - Other Equipment - Auto Shop

Location: Auto shop classroom
Material: System
Distress: Beyond Expected Life
Category: Capital Renewal
Priority: 3 - Necessary/Not Yet Critical (Years 2-5)
Correction: Renew System
Qty: 1-Ea.
Estimate: \$100,333.73
Assessor Name: Ann Buerger Linden
Date Created: 01/31/2013

Notes: Provide system renewal for auto shop equipment.

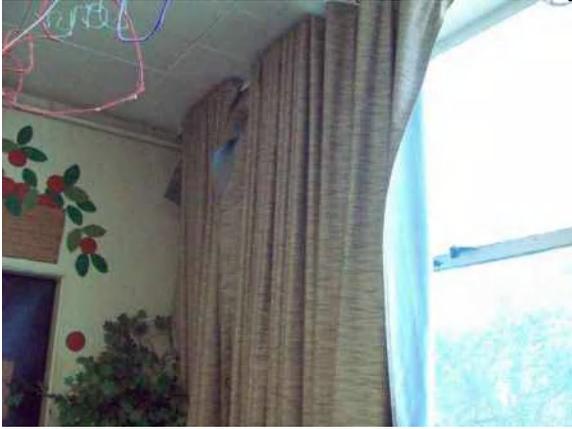
System: E2010 - Fixed Furnishings

Location: Ag classroom
Material: Blinds and Other Window Treatment
Distress: Beyond Expected Life
Category: Capital Renewal
Priority: 1 - Currently Critical (Immediate)
Correction: Replace window blinds
Qty: 180-S.F.
Estimate: \$1,951.78
Assessor Name: Ann Buerger Linden
Date Created: 01/31/2013

Notes: Existing drape is obsolete. Provide blinds to control glare and to facilitate A/V presentations.
