Orange Unified School District

Facilities Condition Assessment for:

**Orange High School
525 N. Shaffer Street
Orange, CA 92867**

Report: Mar 11, 2013

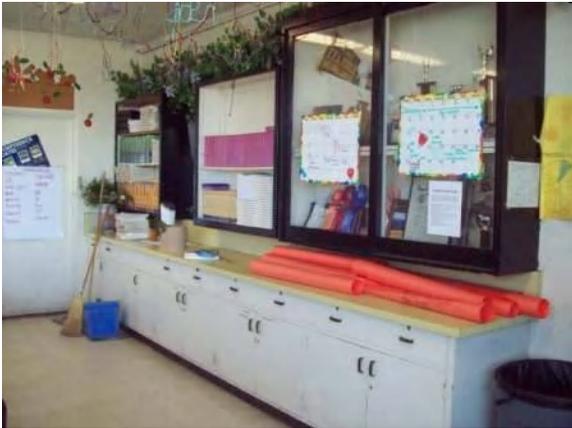
System: E2010 - Fixed Furnishings

Location: Classrooms and work rooms.
Material: Fixed Casework
Distress: Beyond Expected Life
Category: Capital Renewal
Priority: 3 - Necessary/Not Yet Critical (Years 2-5)
Correction: Replace Casework OUSD
Qty: 120-L.F.
Estimate: \$141,633.79
Assessor Name: Ann Buerger Linden
Date Created: 01/31/2013

Notes: Classroom casework is typically original and in worn conditions.

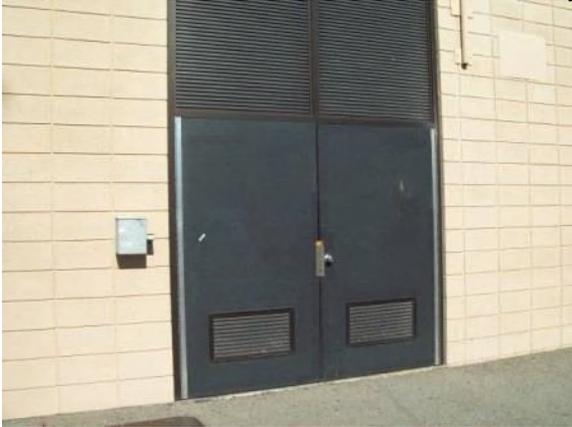
System: B2030 - Exterior Doors

Location: Exterior doors.

Notes: Replace exterior doors and hardware.

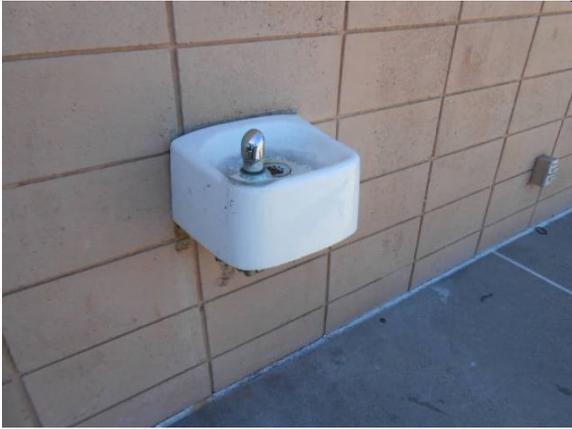
System: D2010810 - Drinking Fountain Systems

Location: East side of building
Material: System
Distress: Beyond Expected Life
Category: Capital Renewal
Priority: 4 - Recommended (Years 6-10)
Correction: Renew System
Qty: 1-Ea.
Estimate: \$3,102.11
Assessor Name: Eduardo Lopez
Date Created: 01/29/2013

Notes: Drinking Fountain is original to building construction date and it is recommended to be replaced during next remodel or renovation.

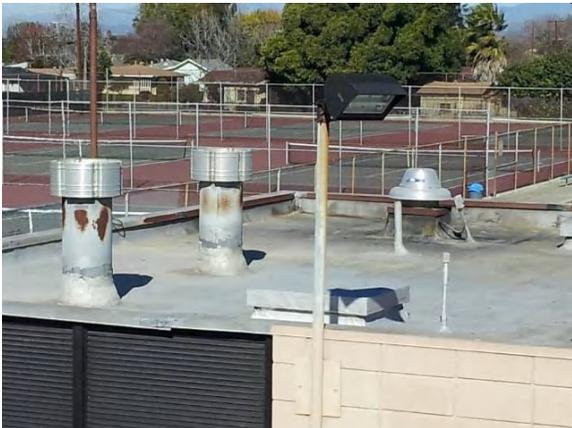
System: D3040 - Distribution Systems

Location: Typical for entire building
Material: System
Distress: Beyond Expected Life
Category: Capital Renewal
Priority: 4 - Recommended (Years 6-10)
Correction: Renew System
Qty: 1-Ea.
Estimate: \$18,004.38
Assessor Name: Eduardo Lopez
Date Created: 01/29/2013

Notes: Distribution System is beyond its expected life and it is recommended to be replaced during the next major renovation.

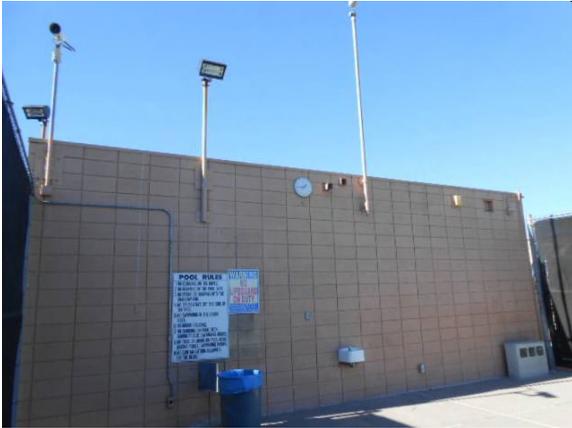
System: D5020 - Branch Wiring

Location: Typical for entire building
Material: System
Distress: Beyond Expected Life
Category: Capital Renewal
Priority: 4 - Recommended (Years 6-10)
Correction: Renew System
Qty: 1-Ea.
Estimate: \$18,511.26
Assessor Name: Eduardo Lopez
Date Created: 01/29/2013

Notes: The branch wiring, electrical panels and devices are mostly original to the building age. It is recommended to be replaced during the next major renovation.

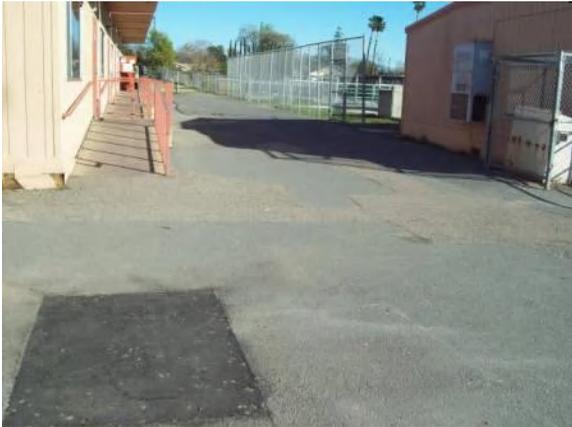
System: G2010 - Roadways

Location: Campus site
Material: System
Distress: Beyond Expected Life
Category: Capital Renewal
Priority: 3 - Necessary/Not Yet Critical (Years 2-5)
Correction: Renew System
Qty: 1-Ea.
Estimate: \$163,403.38
Assessor Name: Eduardo Lopez
Date Created: 01/21/2013

Notes: Roadways on campus are in deteriorated conditions with much patching and cracking. Many asphalt paved roadways also serve as pedestrian paths and tripping hazards are prevalent.

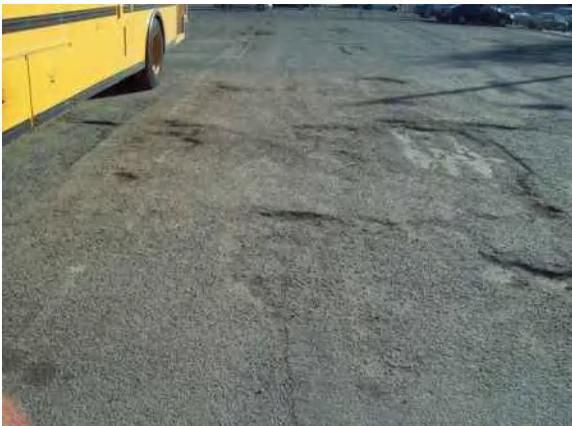
System: G2020 - Parking Lots

Location: West side of site parallel to Shaffer street, north of the Little Theater.
Material: System
Distress: Beyond Expected Life
Category: Capital Renewal
Priority: 3 - Necessary/Not Yet Critical (Years 2-5)
Correction: Renew System
Qty: 1-Ea.
Estimate: \$179,216.61
Assessor Name: Eduardo Lopez
Date Created: 01/21/2013

Notes: The parking lot is in poor condition. Pavement is cracked and grainy with some potholing. Previous surface treatments are delaminating. Striping is in poor condition.

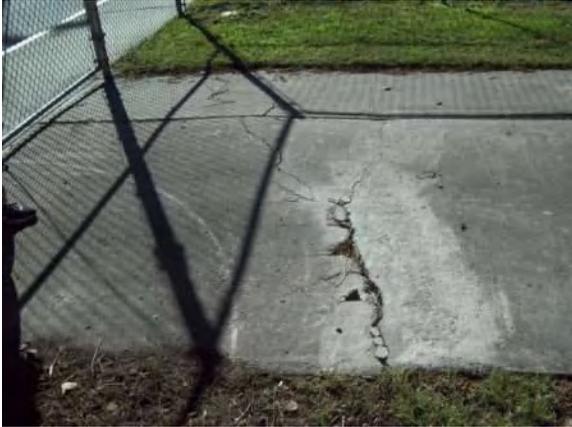
System: G2030 - Pedestrian Paving

Location: Site.
Material: System
Distress: Beyond Expected Life
Category: Capital Renewal
Priority: 3 - Necessary/Not Yet Critical (Years 2-5)
Correction: Renew System
Qty: 1-Ea.
Estimate: \$1,467,994.89
Assessor Name: Eduardo Lopez
Date Created: 01/21/2013

Notes: Pedestrian pavings are in generally poor condition across the campus with tripping hazards present in highly travelled areas. Heaved areas are sometimes ground down. Patches are not holding up well. Areas in front of the Little Theater and Administrative entrance have been replaced w/in 10 years.

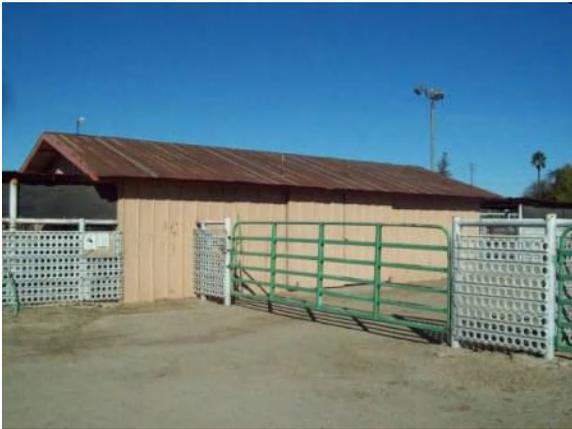
System: G2040000 - Agricultural Animal Facilities

Location: East central portion of site.
Material: System
Distress: Beyond Expected Life
Category: Capital Renewal
Priority: 3 - Necessary/Not Yet Critical (Years 2-5)
Correction: Renew System
Qty: 1-Ea.
Estimate: \$126,720.00
Assessor Name: Ann Buerger Linden
Date Created: 02/03/2013

Notes: System renewal for agricultural animal facilities is recommended.

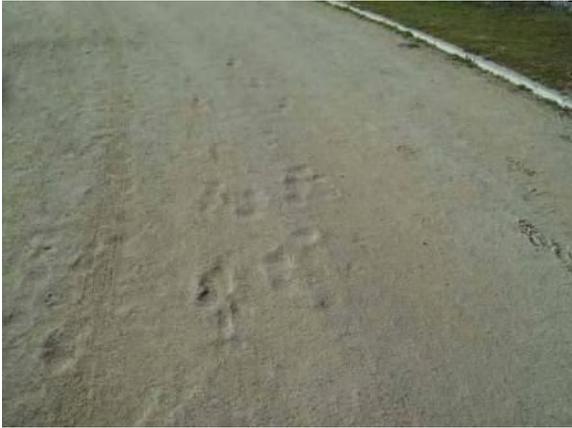
System: G2040940 - Playing Fields

Location: Northwest corner of site.
Material: Running Track
Distress: Inadequate
Category: Safety
Priority: 3 - Necessary/Not Yet Critical (Years 2-5)
Correction: Running Track competition grade
Qty: 1-Ea.
Estimate: \$1,791,446.40
Assessor Name: Ann Buerger Linden
Date Created: 02/03/2013

Notes: The existing running track is dirt. It is uneven and rutted, creating unsafe conditions for training and competition. A synthetic surface with permanent markings is recommended.

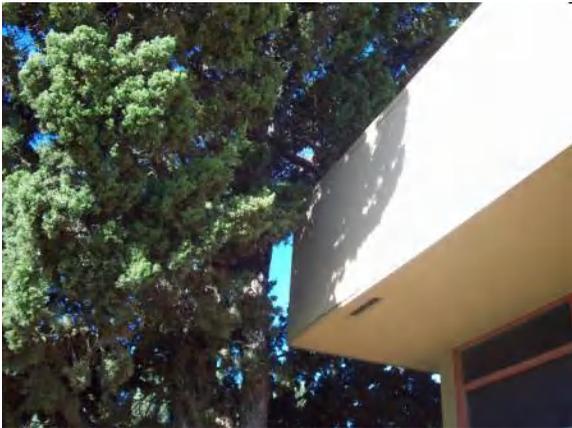
System: G2050 - Landscaping and Irrigation

Location: Campus site
Material: System
Distress: Beyond Expected Life
Category: Capital Renewal
Priority: 3 - Necessary/Not Yet Critical (Years 2-5)
Correction: Renew System
Qty: 1-Ea.
Estimate: \$530,462.00
Assessor Name: Eduardo Lopez
Date Created: 01/21/2013

Notes: No significant landscape and irrigation improvements have been made in many years. The irrigation system consists of 3 clocks. Landscaping is mature and in need of renewal. Many trees hang over building roofs, creating roof maintenance problems. Tree roots have heaved pavements.

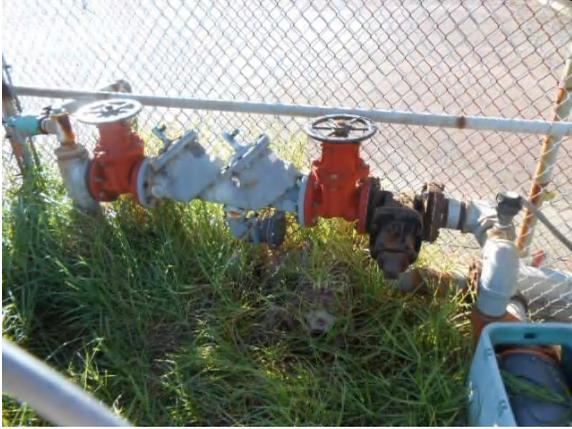
System: G3010 - Water Supply

Location: Site Water Supply
Material: System
Distress: Beyond Expected Life
Category: Capital Renewal
Priority: 4 - Recommended (Years 6-10)
Correction: Renew System
Qty: 1-Ea.
Estimate: \$347,411.88
Assessor Name: Eduardo Lopez
Date Created: 01/29/2013

Notes: System is beyond its expected life and it is recommended to be replaced during next remodel or renovation.

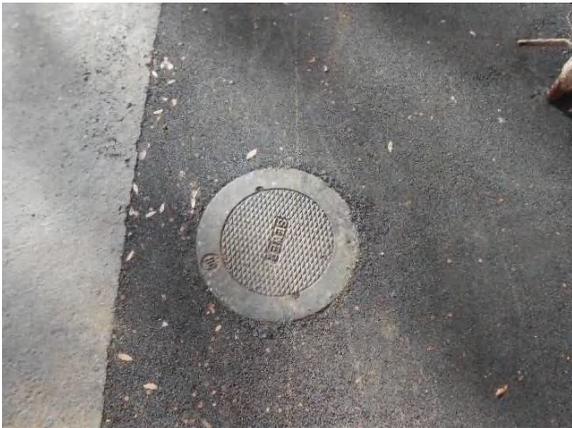
System: G3020 - Sanitary Sewer

Location: Site Sanitary Sewer
Material: System
Distress: Beyond Expected Life
Category: Capital Renewal
Priority: 3 - Necessary/Not Yet Critical (Years 2-5)
Correction: Renew System
Qty: 1-Ea.
Estimate: \$253,970.06
Assessor Name: Eduardo Lopez
Date Created: 01/29/2013

Notes: System is beyond its expected life and it is recommended to be replaced during next remodel or renovation.

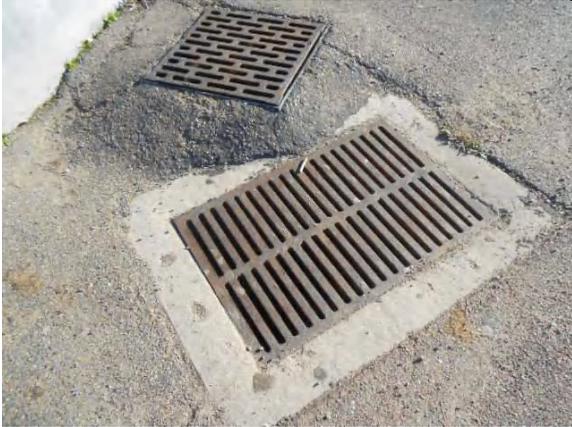
System: G3030 - Storm Sewer

Location: Site Storm Sewer
Material: System
Distress: Beyond Expected Life
Category: Capital Renewal
Priority: 4 - Recommended (Years 6-10)
Correction: Renew System
Qty: 1-Ea.
Estimate: \$134,172.86
Assessor Name: Eduardo Lopez
Date Created: 01/29/2013

Notes: Rainwater surface runoff is collected by few catch basins mostly in the athletic field area. Water puddles around the campus, especially near building 100 where water goes into the building and sandbags are used. Storm Sewer System is beyond its expected life and it is recommended to be replaced and improved.

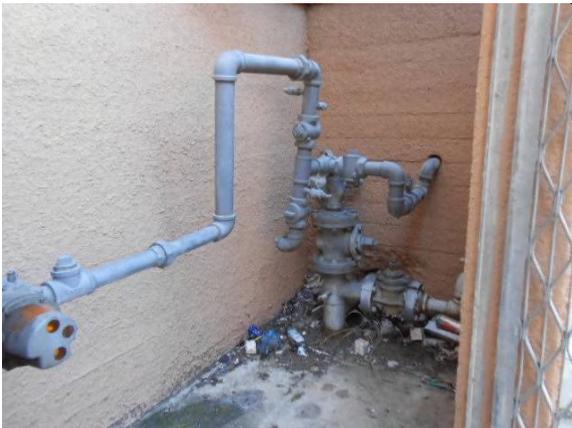
System: G3060 - Fuel Distribution - Natural Gas

Location: Site Natural Gas Distribution
Material: System
Distress: Beyond Expected Life
Category: Capital Renewal
Priority: 4 - Recommended (Years 6-10)
Correction: Renew System
Qty: 1-Ea.
Estimate: \$67,086.43
Assessor Name: Eduardo Lopez
Date Created: 01/29/2013

Notes: System is beyond its expected life and it is recommended to be replaced during next remodel or renovation.

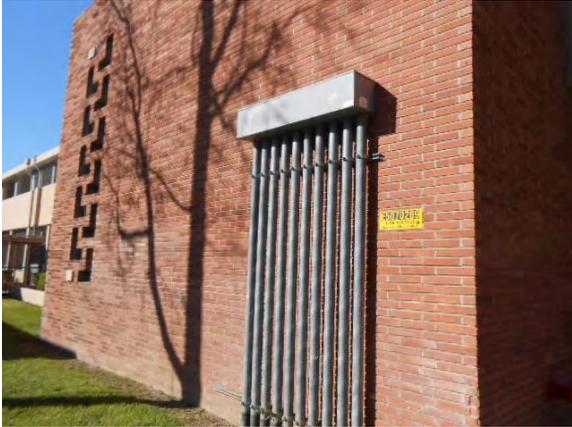
System: G4010 - Electrical Distribution

Location: Site Main Electrical Distrubution and UG feeders to buildings
Material: System
Distress: Beyond Expected Life
Category: Capital Renewal
Priority: 4 - Recommended (Years 6-10)
Correction: Renew System
Qty: 1-Ea.
Estimate: \$596,590.06
Assessor Name: Eduardo Lopez
Date Created: 01/29/2013

Notes: Site electrical incoming power switchgear, panels, equipment and underground feeders to buildings are beyond expected life; all are recommended to be replaced as part of the next major renovation.

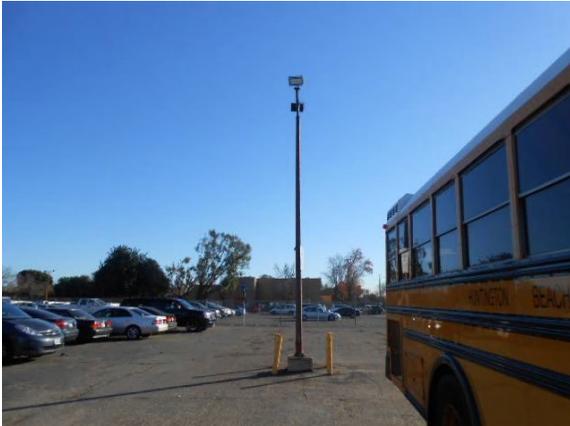
System: G4020 - Site Lighting

Location: Site Light Poles
Material: Outdoor Pole Lights
Distress: Inadequate
Category: Capital Renewal
Priority: 4 - Recommended (Years 6-10)
Correction: Replace light pole, 2 fixtures (conc. base not inc)
Qty: 30-Ea.
Estimate: \$320,360.83
Assessor Name: Eduardo Lopez
Date Created: 01/29/2013

Notes: Most poles light fixtures were replaced with LED type in 2013; however light poles remain beyond expected life and is recommended to provide additional light pole for security of vehicles and pedestrian traffic and additional athletic field lighting.

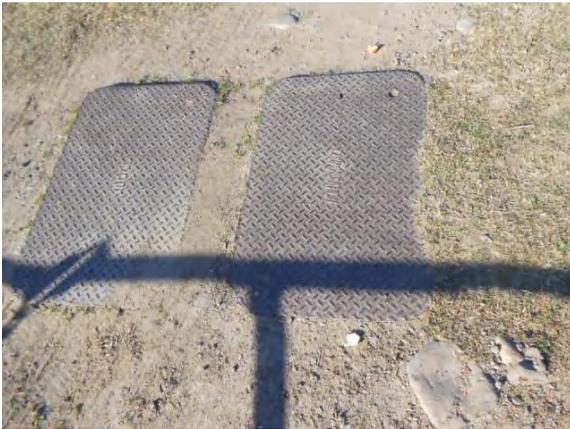
System: G4030 - Site Communications and Security

Location: Site Communications and Security
Material: Site Communications
Distress: Inadequate
Category: Capital Renewal
Priority: 4 - Recommended (Years 6-10)
Correction: Replace communications and security cabling
Qty: 200-C.L.F.
Estimate: \$275,927.04
Assessor Name: Eduardo Lopez
Date Created: 01/29/2013

Notes: Recommend upgrades and replacing as needed all communications and security cabling and equipment for enhancements.
